ACTIVITY PROFILE

079/80

SOIL AND WATERSHED
MANAGEMENT OFFICE,
ROLPA

LUMBINI STATE GOVERNMENT
MINISTRY OF FORESTS AND ENVIRONMENT
SOIL AND WATERSHED MANAGEMENT OFFICE
MULPANI, ROLPA

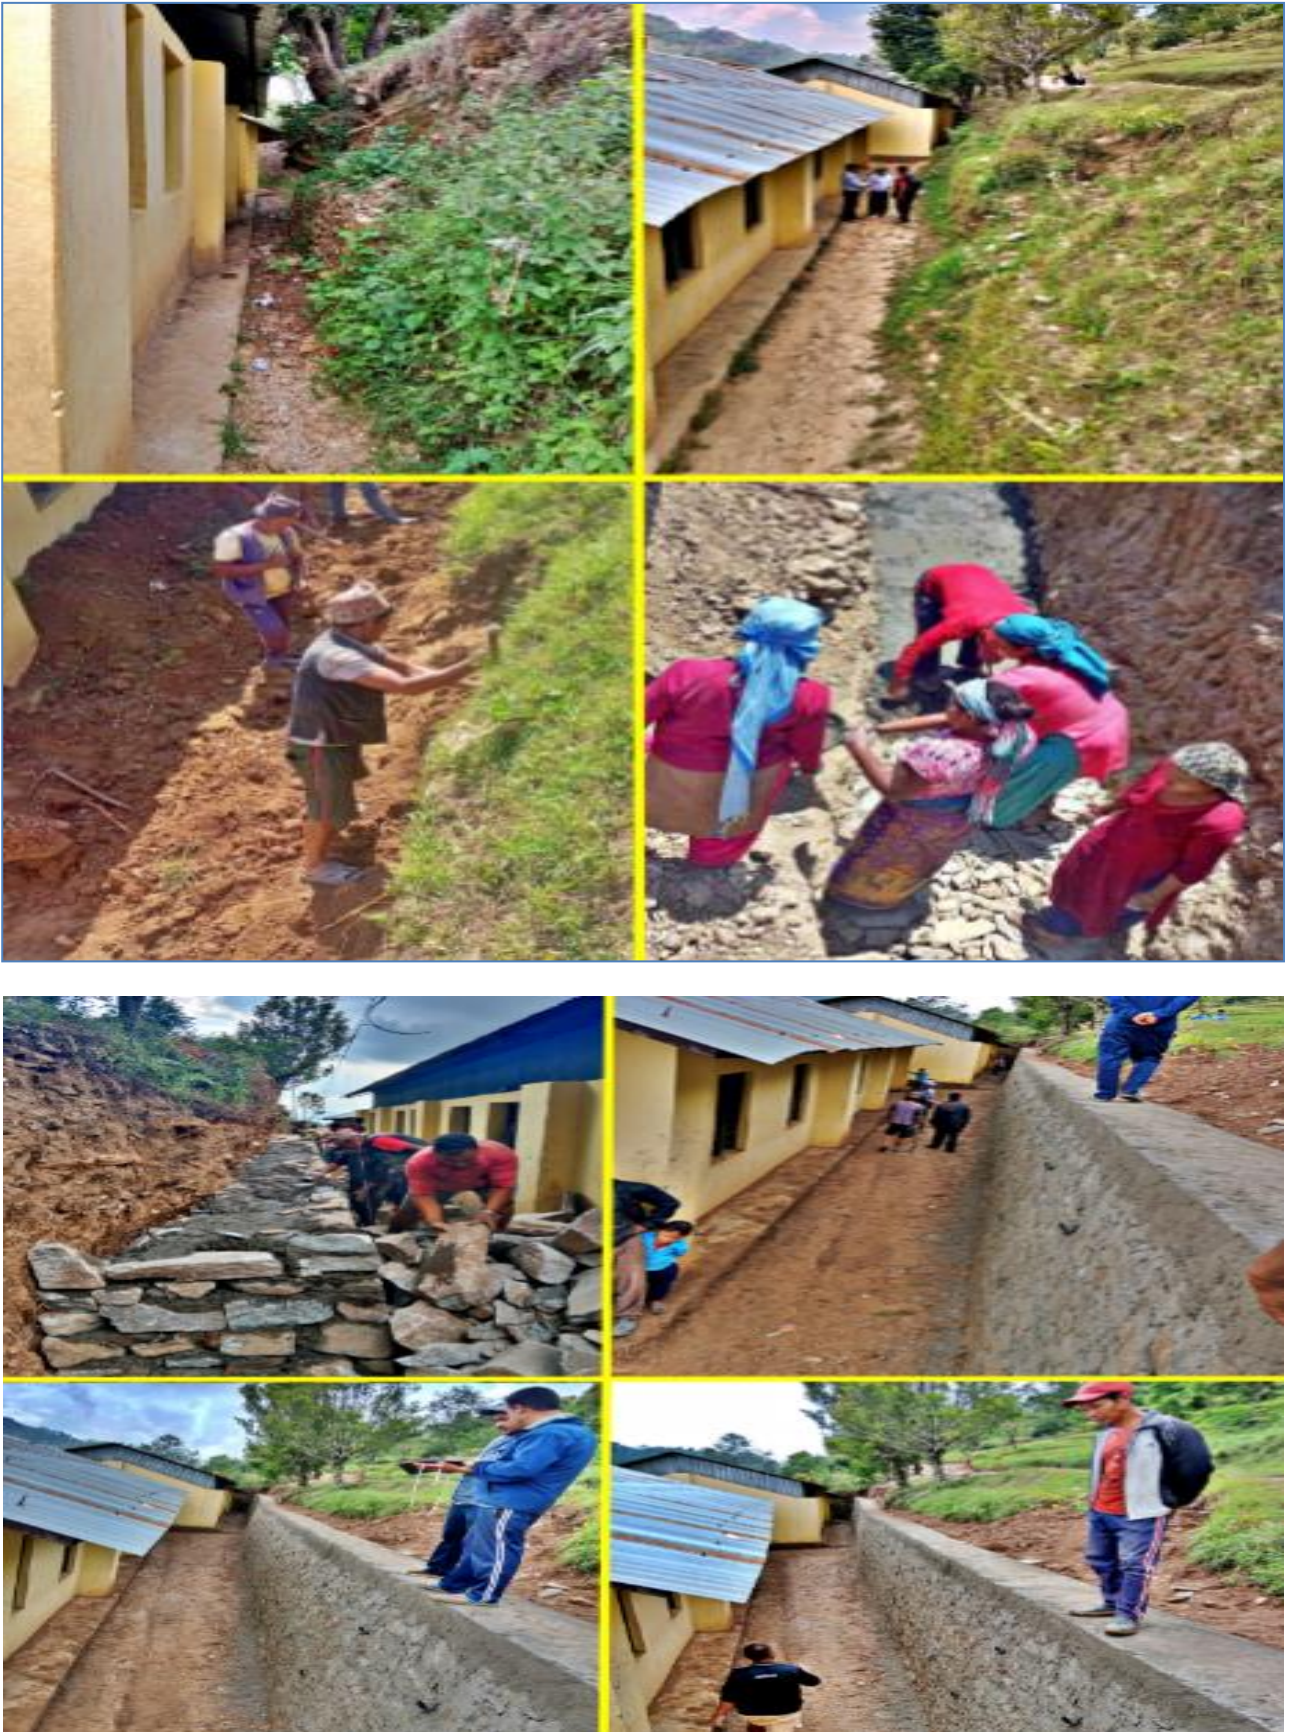
Figure 8: Bhanbhane Landslide Treatment

1	Program: Gully, Landslide and Torrent Control				
2	Location: District/Municipality: Rolpa/Rolpa	Ward No: 10	Place: Bhanbhane	F/Y: 079/80	
	Co-ordinates:	Latitude: 28.327837	Longitude: 82.665396		
3	Existing Site Problem: The landslide behind the School possess a risk of damage to the school Building				
4	Cost:				
a	Estimated	Total: 1153892.85	Office: 999942.15	Users: 153950.70	Others:
b	Actual Expenditure	Total: 1186148.99	Office: 983585.69	Users: 203363.30	Others:
5	Objectives:	a) to reduce soil erosion and mass movement from landslide b) to reduce the risk of damage to the school building			
6	Technique Applied:	a) Structural: Stone Masonary Retaining Wall Construction (39.35m*0.67m*2.35m)			
7	Implementation Process:	Co-ordination with Local Representatives, School Management Committee, User Group and other concerned authorities; Field Visits; Survey, Design & Cost Estimation; Provide funds for the purchase of Construction Materials, Skilled Labour, Hoarding Board from Program cost; Unskilled Labour cost was contributed jointly through program cost and people participation; Monitoring & Evaluation

8	Employment:	684 md			
9	Gender/Social Consideration:	Both men and women were equally involved; More emphasis was given to the genuine participation of disadvantaged groups			
10	Effect/Impact:	To some extent, erosion and mass movement has been reduced; Reduce the risk of damage to the school building; Approximately 0.7 ha of School area has been conserved			
11	Benefitted HH:	Total: 100	Dalit: 30	Janajati: 30	Others: 40
12	Problem/Obstacles Faced:	No			
13	Maintenance/Sustainability:	5% amount of total payable amount has been deducted for the maintenance work, if some damage occurs.			
14	Lesson Learned:	If real needs of the community are to be addressed, villagers readily participate throughout the activity implementation process, thus greater achievements are possible even with small external support.			
15	Others; Name of:	User Group: Janta Aa.Bi. Bhanbhane Wall Nirman Upabhokta Samiti			
		Chair Person: Bal Bdr. Mahara

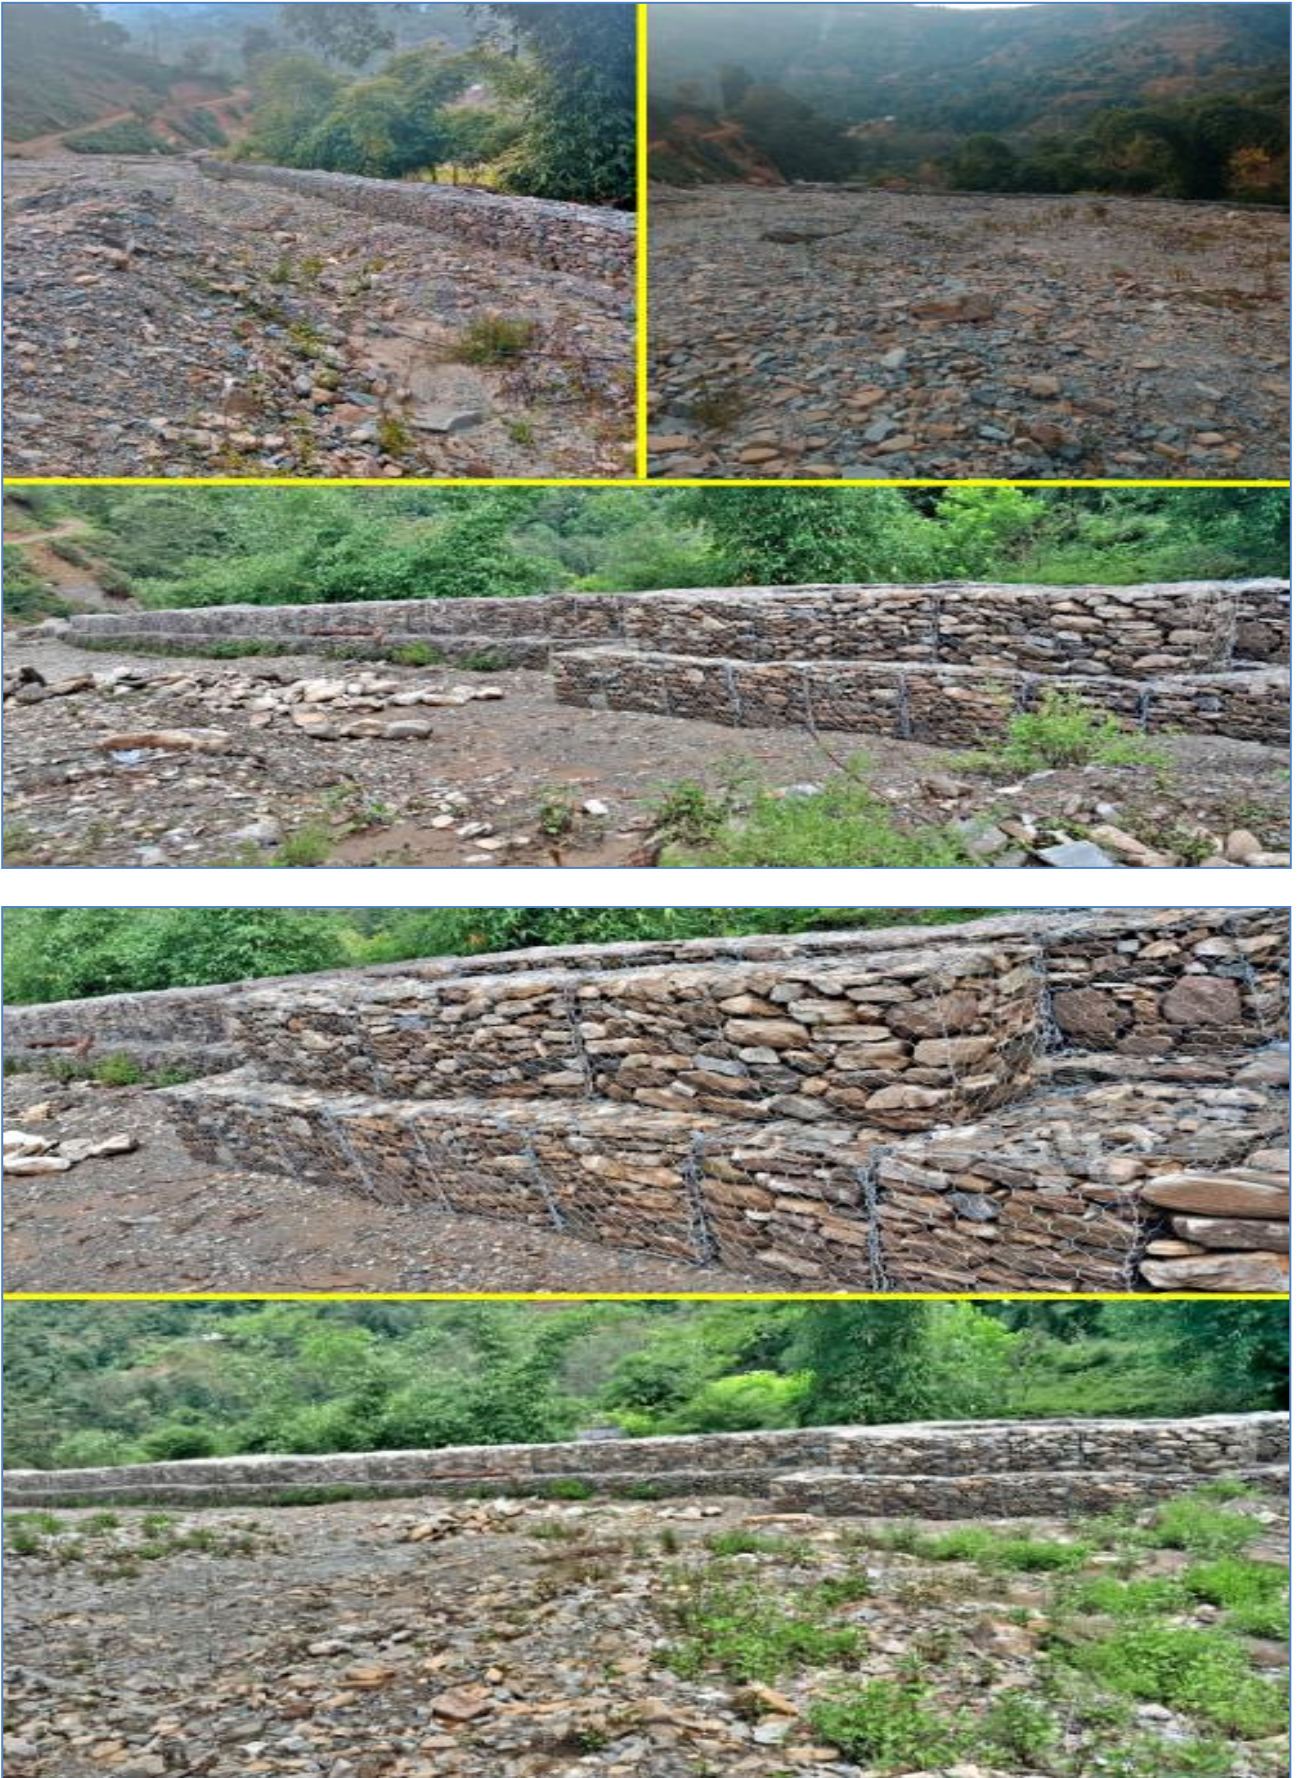
Figure 9: Bhoksiwang Dhangsi Khola Torrent Control

1	Program: Gully, Landslide and Torrent Control				
2	Location: District/Municipality: Rolpa/Rolpa	Ward No: 10	Place: Bhoksiwang	F/Y: 079/80	
	Co-ordinates:	Latitude: 28.371679	Longitude: 82.6646		
3	Existing Site Problem: The torrent possess a risk of damage to the nearby settlement & agricultural land by bank cutting				
4	Cost:				
a	Estimated	Total: 891771.43	Office: 799956.10	Users: 91815.33	Others:
b	Actual Expenditure	Total: 887378.49	Office: 796239.27	Users: 91139.23	Others:
5	Objectives:	a) to reduce torrent bank cutting b) to reduce devastating effects on the downstream and surrounding area			
6	Technique Applied:	a) Structural: Gabion Embankment Construction (Gabion Box 90 Nos; Box size 2m*1m*1m=30 Nos.; Box size 1.5m*1m*1m=60 Nos. were used to construct 60m long Embankment)			
7	Implementation Process:	Co-ordination with Local Representatives, User Groups and other concerned authorities; Field Visits; Survey, Design & Cost Estimation; Provide funds for the purchase of Gabion Boxes, Skilled Labour, Hoarding Board from Program cost; Unskilled Labour Cost was contributed jointly through program cost and people participation; Monitoring & Evaluation

8	Employment:	553 md			
9	Gender/Social Consideration:	Both men and women were equally involved; More emphasis was given to the genuine participation of disadvantaged groups			
10	Effect/Impact:	To some extent, torrent bank cutting has been controlled; Reduce the risk of damage to the nearby settlement & surrounding area; Approximately 0.5 ha of agricultural land has been conserved			
11	Benefitted HH:	Total: 70	Dalit: 30	Janajati: 40	Others:
12	Problem/Obstacles Faced:	No			
13	Maintenance/Sustainability:	5% amount of total payable amount has been deducted for the maintenance work, if some damage occurs.			
14	Lesson Learned:	If real needs of the community are to be addressed, villagers readily participate throughout the activity implementation process, thus greater achievements are possible even with small external support. The physical structures constructed should be accompanied by bio-engineering techniques to sustain the structures.

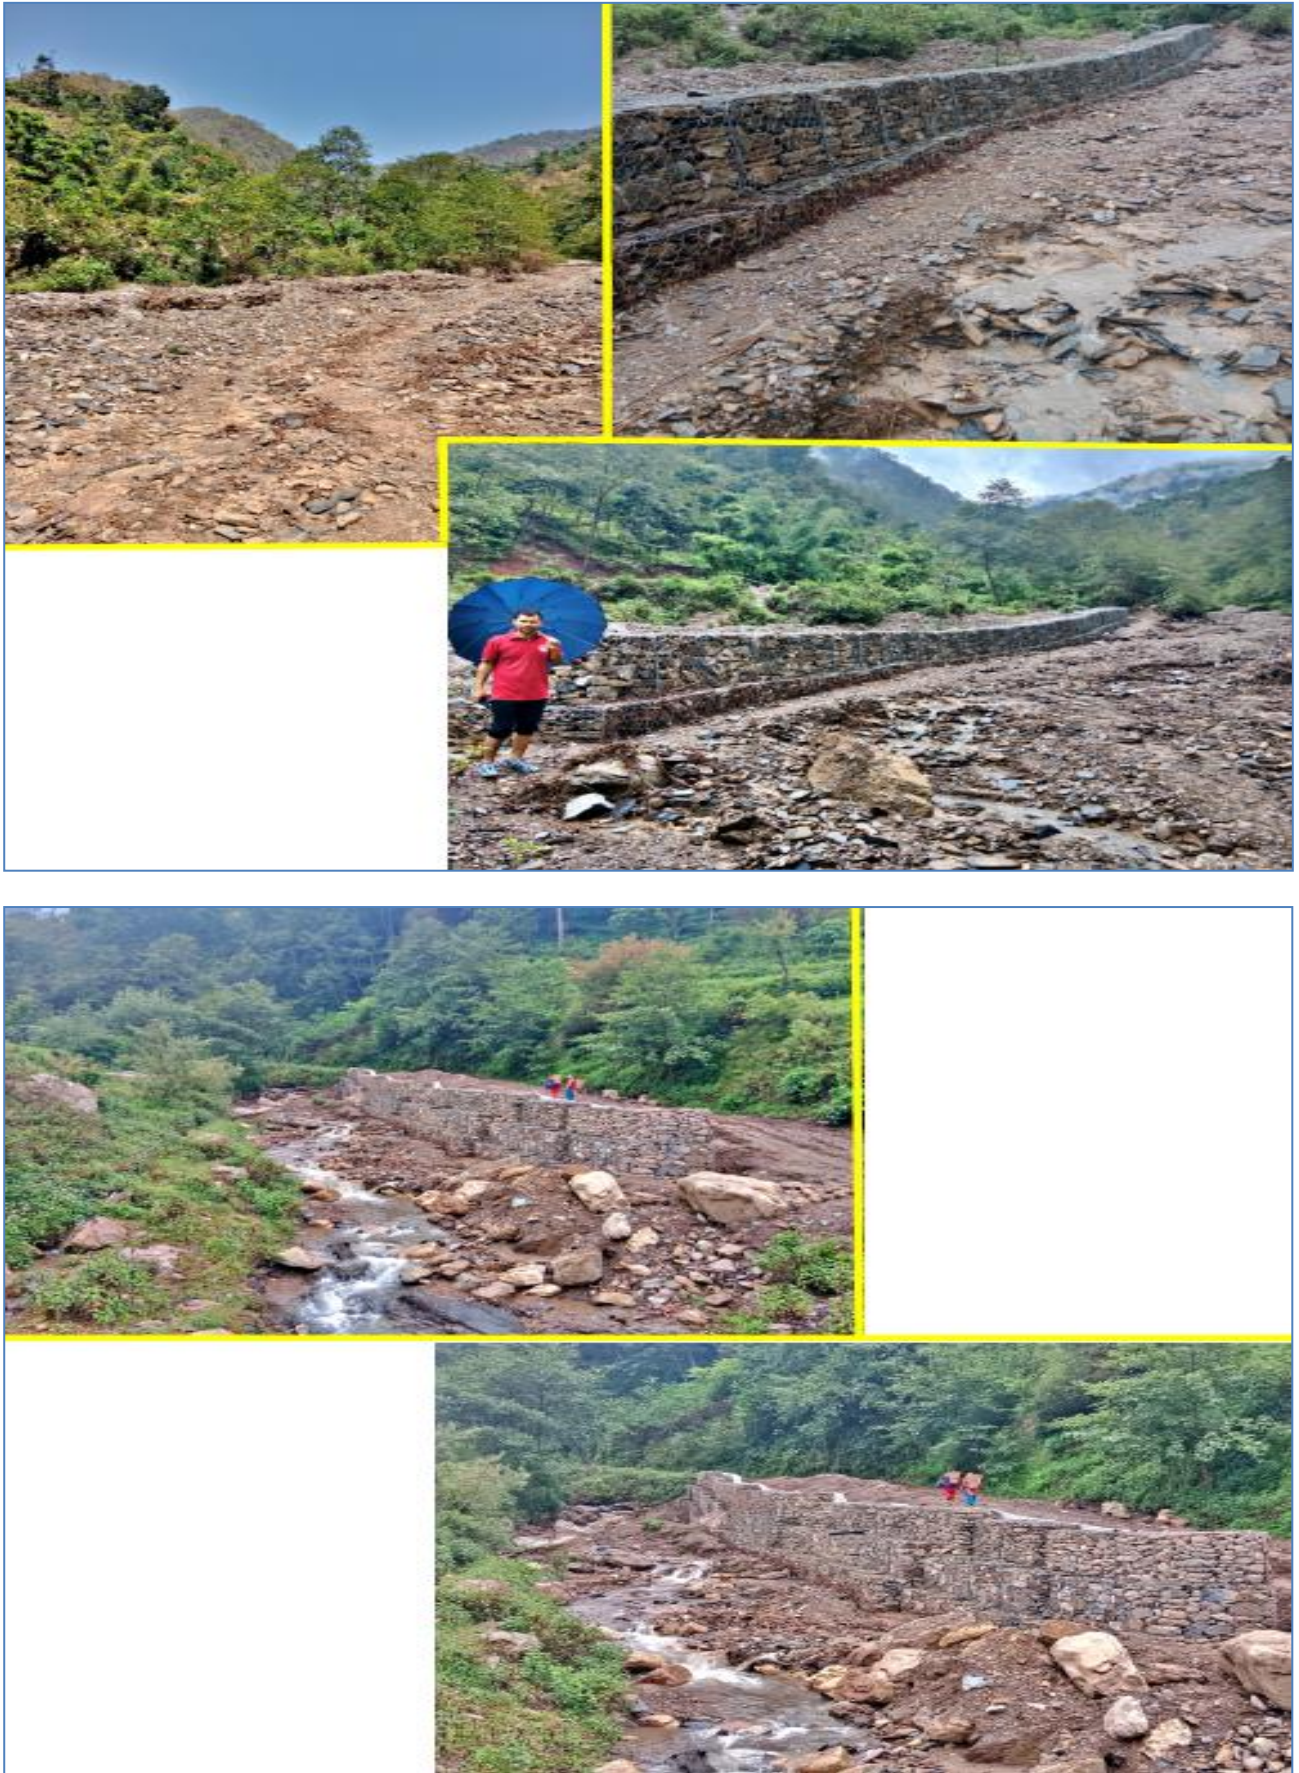
Figure 11: Laharikhola Torrent Control

1	Program: Gully, Landslide and Torrent Control				
2	Location: District/Municipality: Rolpa/Rolpa	Ward No: 1	Place: Laharikhola	F/Y: 079/80	
	Co-ordinates:	Latitude: 28.289346, 28.293964		Longitude: 82.658796, 82.646463	
3	Existing Site Problem: The Laharikhola Torrent possess a risk of damage to the rural road, nearby settlement, playground and agricultural land				
4	Cost:				
a	Estimated	Total: 2265058.14	Office: 1999984.16	Users: 265073.98	Others:
b	Actual Expenditure	Total: 2259121.31	Office: 1995061.09	Users: 264060.22	Others:
5	Objectives:	a) to reduce torrent bank cutting b) to reduce devastating effects on the downstream and surrounding area			
6	Technique Applied:	a) Structural: Gabion Embankment Construction (Gabion Box 184 Nos; Box size 2m*1m*1m=102 Nos.; Box size 1.5m*1m*1m=82 Nos. were used to construct 82m long embankment)			
7	Implementation Process:	Co-ordination with Local Representatives, User Groups and other concerned authorities; Field Visits; Survey, Design & Cost Estimation; Provide funds for the purchase of Gabion Boxes, Skilled Labour, Hoarding Board from Program cost; Unskilled Labour cost was contributed jointly through program cost and people participation; Monitoring & Evaluation

8	Employment:	1387 md			
9	Gender/Social Consideration:	Both men and women were equally involved; More emphasis was given to the genuine participation of disadvantaged groups			
10	Effect/Impact:	To some extent, torrent bank cutting has been controlled; Reduce the risk of damage to the rural road, playground and nearby settlement; Approximately 0.8 ha of agricultural land has been conserved			
11	Benefitted HH:	Total: 59	Dalit: 17	Janajati: 22	Others: 20
12	Problem/Obstacles Faced:	No			
13	Maintenance/Sustainability:	5% amount of total payable amount has been deducted for the maintenance work, if some damage occurs.			
14	Lesson Learned:	If real needs of the community are to be addressed, villagers readily participate throughout the activity implementation process, thus greater achievements are possible even with small external support. The physical structures constructed should be accompanied by bio-engineering techniques to sustain the structures.

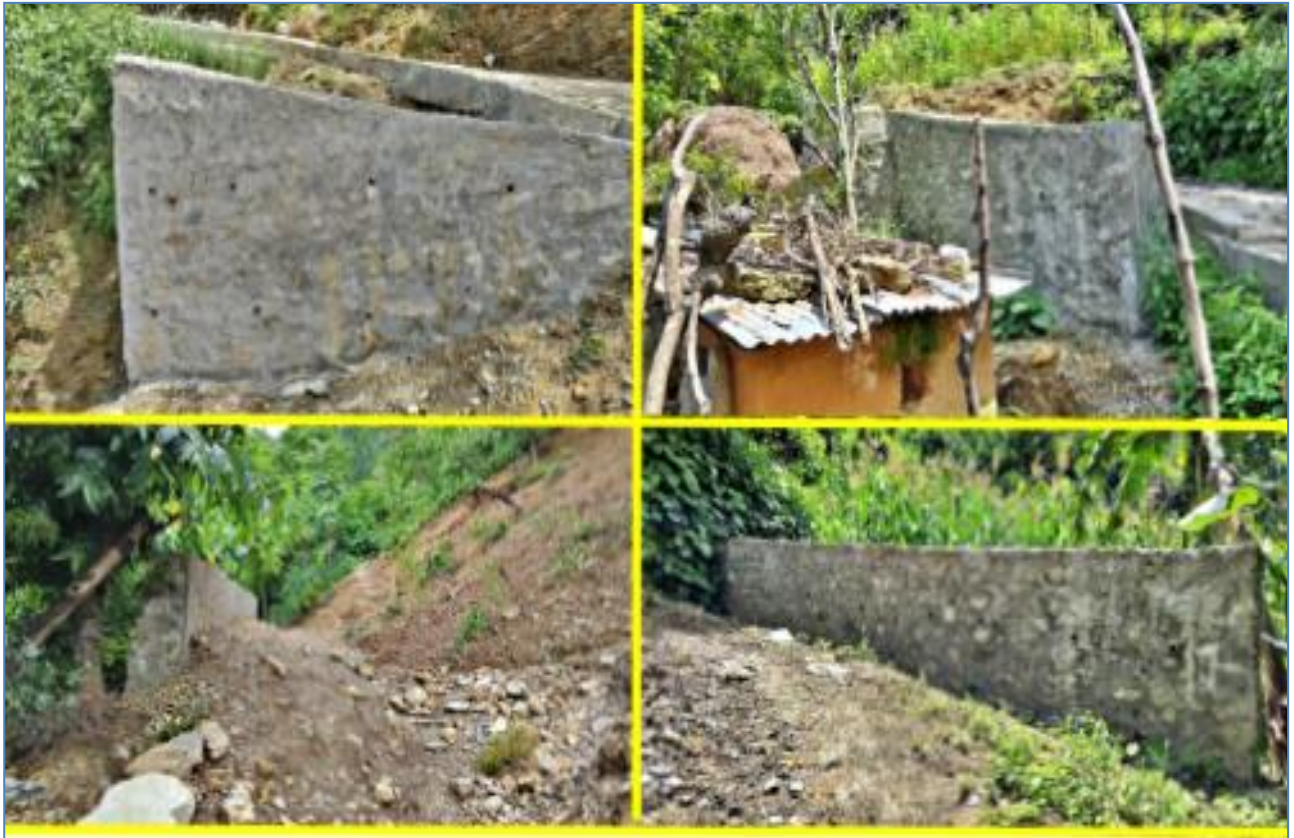
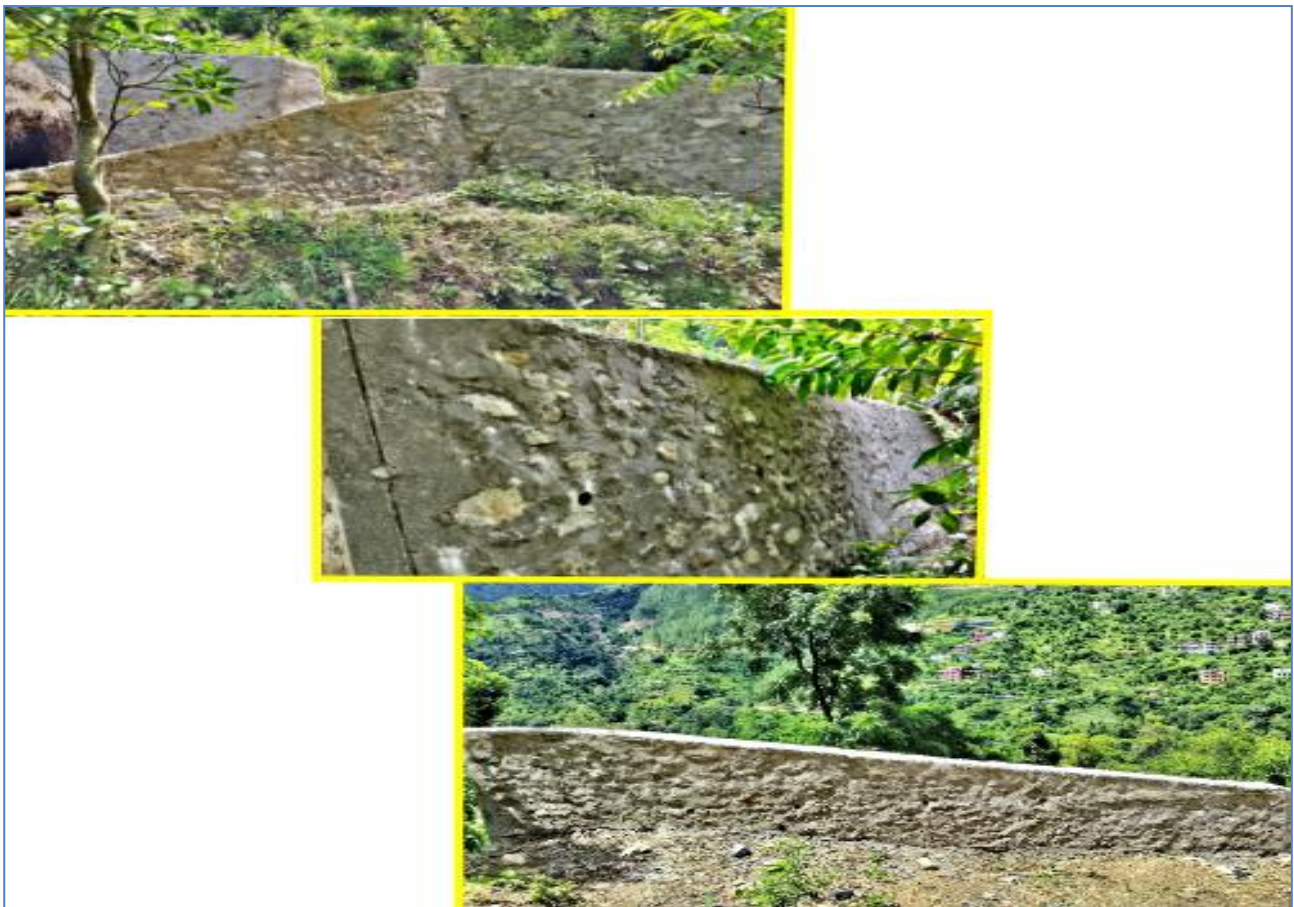
Figure 12: Runtawang Landslide Treatment

1	Program: Gully, Landslide and Torrent Control				
2	Location: District/Municipality: Rolpa /Rolpa	Ward No: 4	Place: Runtawang	F/Y: 079/80	
	Co-ordinates:	Latitude: 28.3035	Longitude: 82.645267		
3	Existing Site Problem: The landslide and gully formation caused by the newly constructed road possess a risk of damage to the settlement, rural road and agricultural land				
4	Cost:				
a	Estimated	Total: 545966.51	Office: 499933.08	Users: 46033.44	Others:
b	Actual Expenditure	Total: 542910.32	Office: 498815.57	Users: 44094.75	Others:
5	Objectives:	a) to reduce soil erosion and mass movement b) to reduce devastating effects on the downstream and surrounding area			
6	Technique Applied:	a) Structural: Stone Masonary Retaining Wall Construction (altogether 5 nos. of wall =37.8m long)			
7	Implementation Process:	Co-ordination with Local Representatives, User Groups and other concerned authorities; Field Visits; Survey, Design & Cost Estimation; Provide funds for the purchase of Construction materials Skilled labour, Hoarding Board from Program cost; Unskilled Labour cost was contributed jointly through program cost and people participation; Monitoring & Evaluation

8	Employment:	347md			
9	Gender/Social Consideration:	Both men and women were equally involved; More emphasis was given to the genuine participation of disadvantaged groups			
10	Effect/Impact:	To some extent, erosion and mass movement has been reduced; Reduce the risk of damage to the settlement, rural road and agricultural land; Approximately 0.3 ha of agricultural land has been conserved			
11	Benefitted HH:	Total: 16	Dalit: 1	Janajati: 8	Others: 7
12	Problem/Obstacles Faced:	No			
13	Maintenance/Sustainability:	5% amount of total payable amount has been deducted for the maintenance work, if some damage occurs.			
14	Lesson Learned:	If real needs of the community are to be addressed, villagers readily participate throughout the activity implementation process, thus greater achievements are possible even with small external support. The physical structures constructed should be accompanied by bio-engineering techniques to sustain the structures.

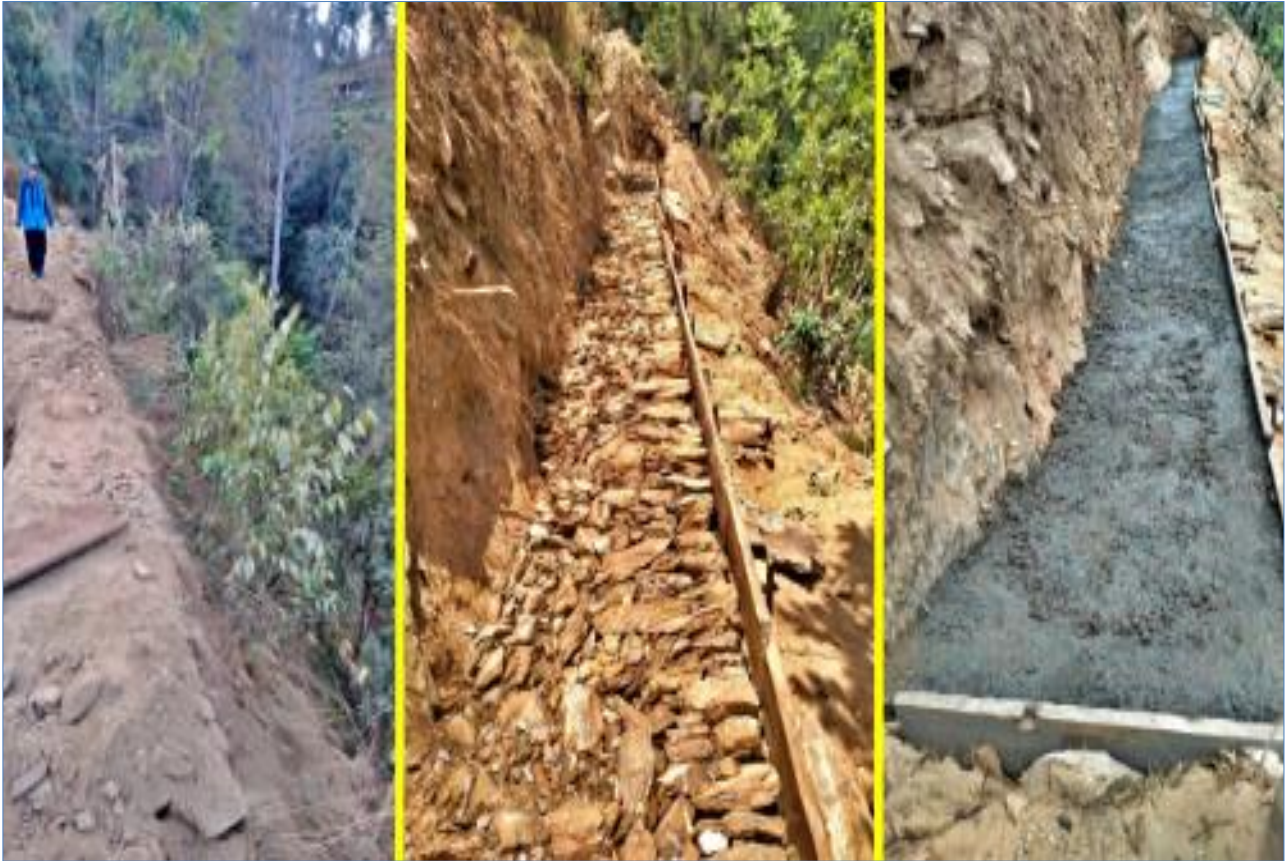
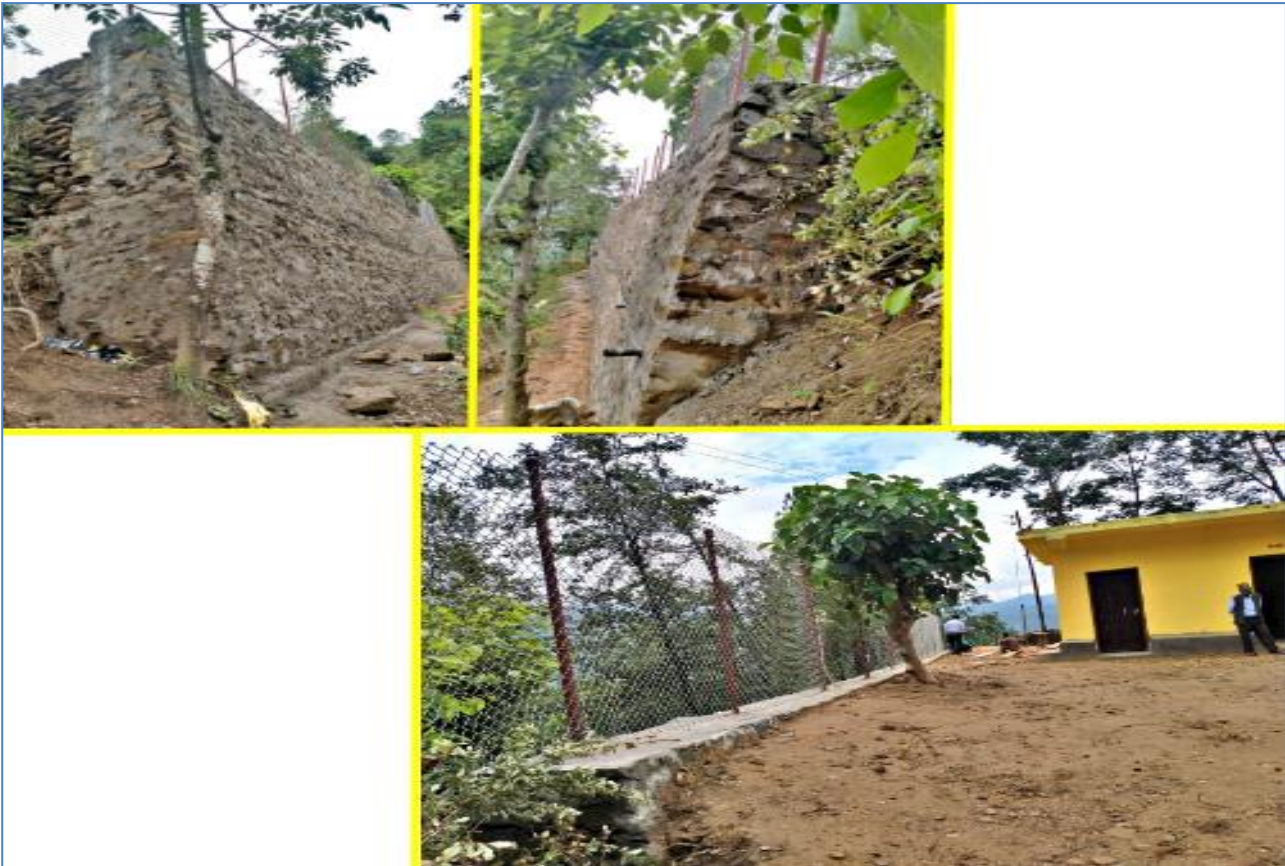
Figure 14: Simarangsi Landslide Treatment

1	Program: Gully, Landslide and Torrent Control				
2	Location: District/Rural Municipality: Rolpa /Pariwartan	Ward No: 2	Place: Simarangsi	F/Y: 079/80	
	Co-ordinates:	Latitude: 28.433256	Longitude: 82.54132		
3	Existing Site Problem: The Landslide behind the school possess a high risk of damage to the Schol Building				
4	Cost:				
a	Estimated	Total: 1090936.57	Office: 999975.59	Users: 90960.99	Others:
b	Actual Expenditure	Total: 1087791.39	Office: 999012.57	Users: 88778.82	Others:
5	Objectives:	a) to reduce soil erosion and mass movement b) to reduce devastating effects on the downstream and surrounding area			
6	Technique Applied:	a) Structural: Stone Masonary Retaining Wall Construction (21.02m*0.70m*3.20m)			
7	Implementation Process:	Co-ordination with Local Representatives, User Groups and other concerned authorities; Field Visits; Survey, Design & Cost Estimation; Provide funds for the purchase of Construction Materials, Skilled Labour, Hoarding Board from Program cost; Unskilled Labour cost was contributed jointly through program cost and people participation; Monitoring & Evaluation

8	Employment:	694 md			
9	Gender/Social Consideration:	Both men and women were equally involved; More emphasis was given to the genuine participation of disadvantaged groups			
10	Effect/Impact:	To some extent, erosion and mass movement has been reduced; Reduce the risk of damage to the settlement, rural road and agricultural land; Approximately 0.5 ha of school area has been conserved			
11	Benefitted HH:	Total: 50	Dalit: 10	Janajati: 20	Others: 30
12	Problem/Obstacles Faced:	Transportational difficulties; Stone, sand & aggregates needed for construction work have to be collected and transported from very far distance			
13	Maintenance/Sustainability:	5% amount of total payable amount has been deducted for the maintenance work, if some damage occurs.			
14	Lesson Learned:	If real needs of the community are to be addressed, villagers readily participate throughout the activity implementation process, thus greater achievements are possible even with small external support. The physical structures constructed should be accompanied by bio-engineering techniques to sustain the structures.

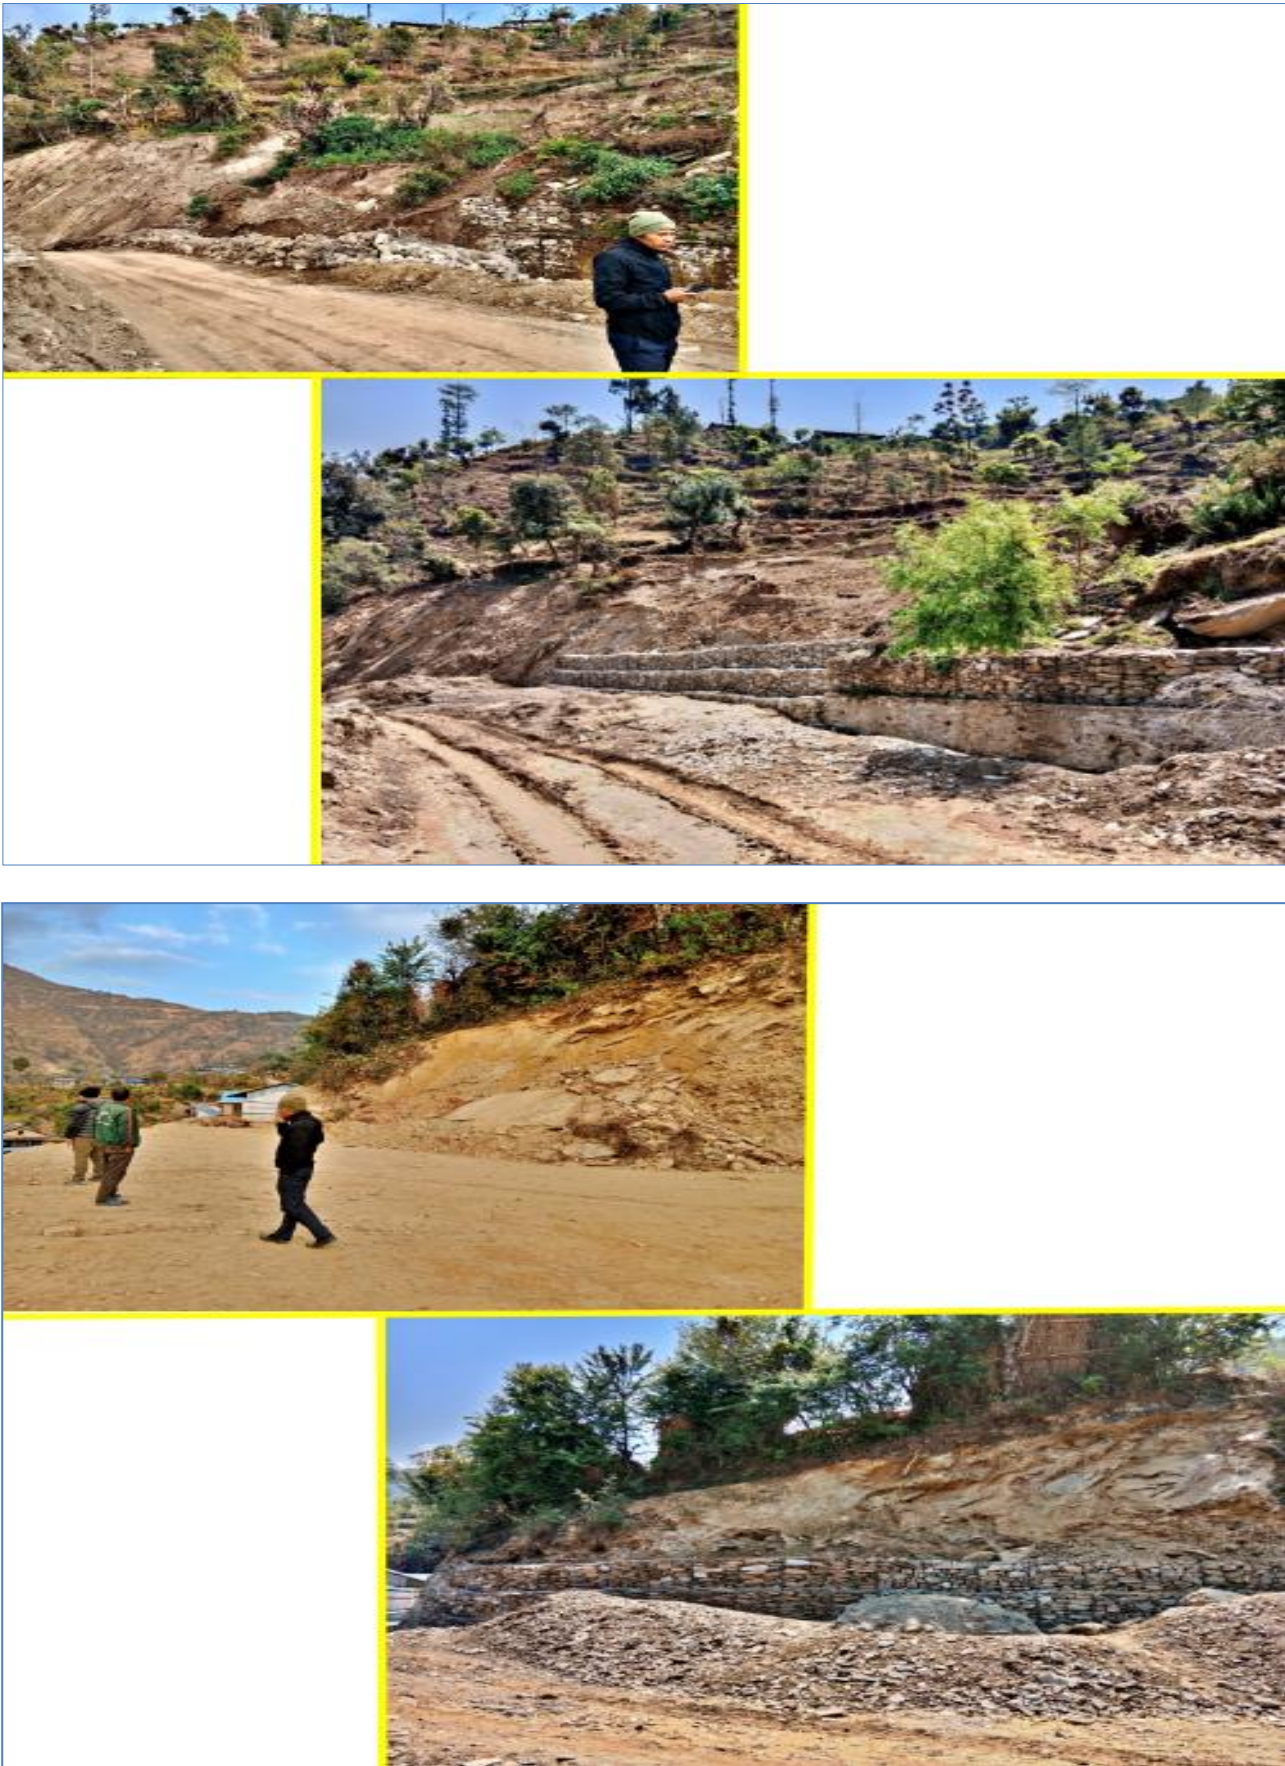
Figure 17: Sandada Landslide Treatment

1	Program: Gully, Landslide and Torrent Control				
2	Location: District/Rural Municipality: Rolpa /Gangadev	Ward No: 7	Place: Sandada, Raank	F/Y: 079/80	
	Co-ordinates:	Latitude: 28.45197	Longitude: 82.459883		
3	Existing Site Problem: The Landslide possess a risk of damage to the settlement, rural road and agricultural land				
4	Cost:				
a	Estimated	Total: 1661586.06	Office: 1499989.70	Users: 161596.36	Others:
b	Actual Expenditure	Total: 1630569.11	Office: 1469983.03	Users: 160586.08	Others:
5	Objectives:	a) to reduce soil erosion and mass movement b) to reduce devastating effects on the downstream and surrounding area			
6	Technique Applied:	a) Structural: Gabion Retaining Wall Construction (Gabion Box 144 Nos; Box size 2m*1m*1m=77 Nos. 1.5m*1m*1m=67 Nos.; were used to construct 42m long Gabion Retaining Wall)			
7	Implementation Process:	Co-ordination with Local Representatives, User Groups and other concerned authorities; Field Visits; Survey, Design & Cost Estimation; Provide funds for the purchase of Gabion Boxes, Skilled Labour, Hoarding Board from Program cost; Unskilled Labour cost was contributed jointly through program cost and people participation; Monitoring & Evaluation

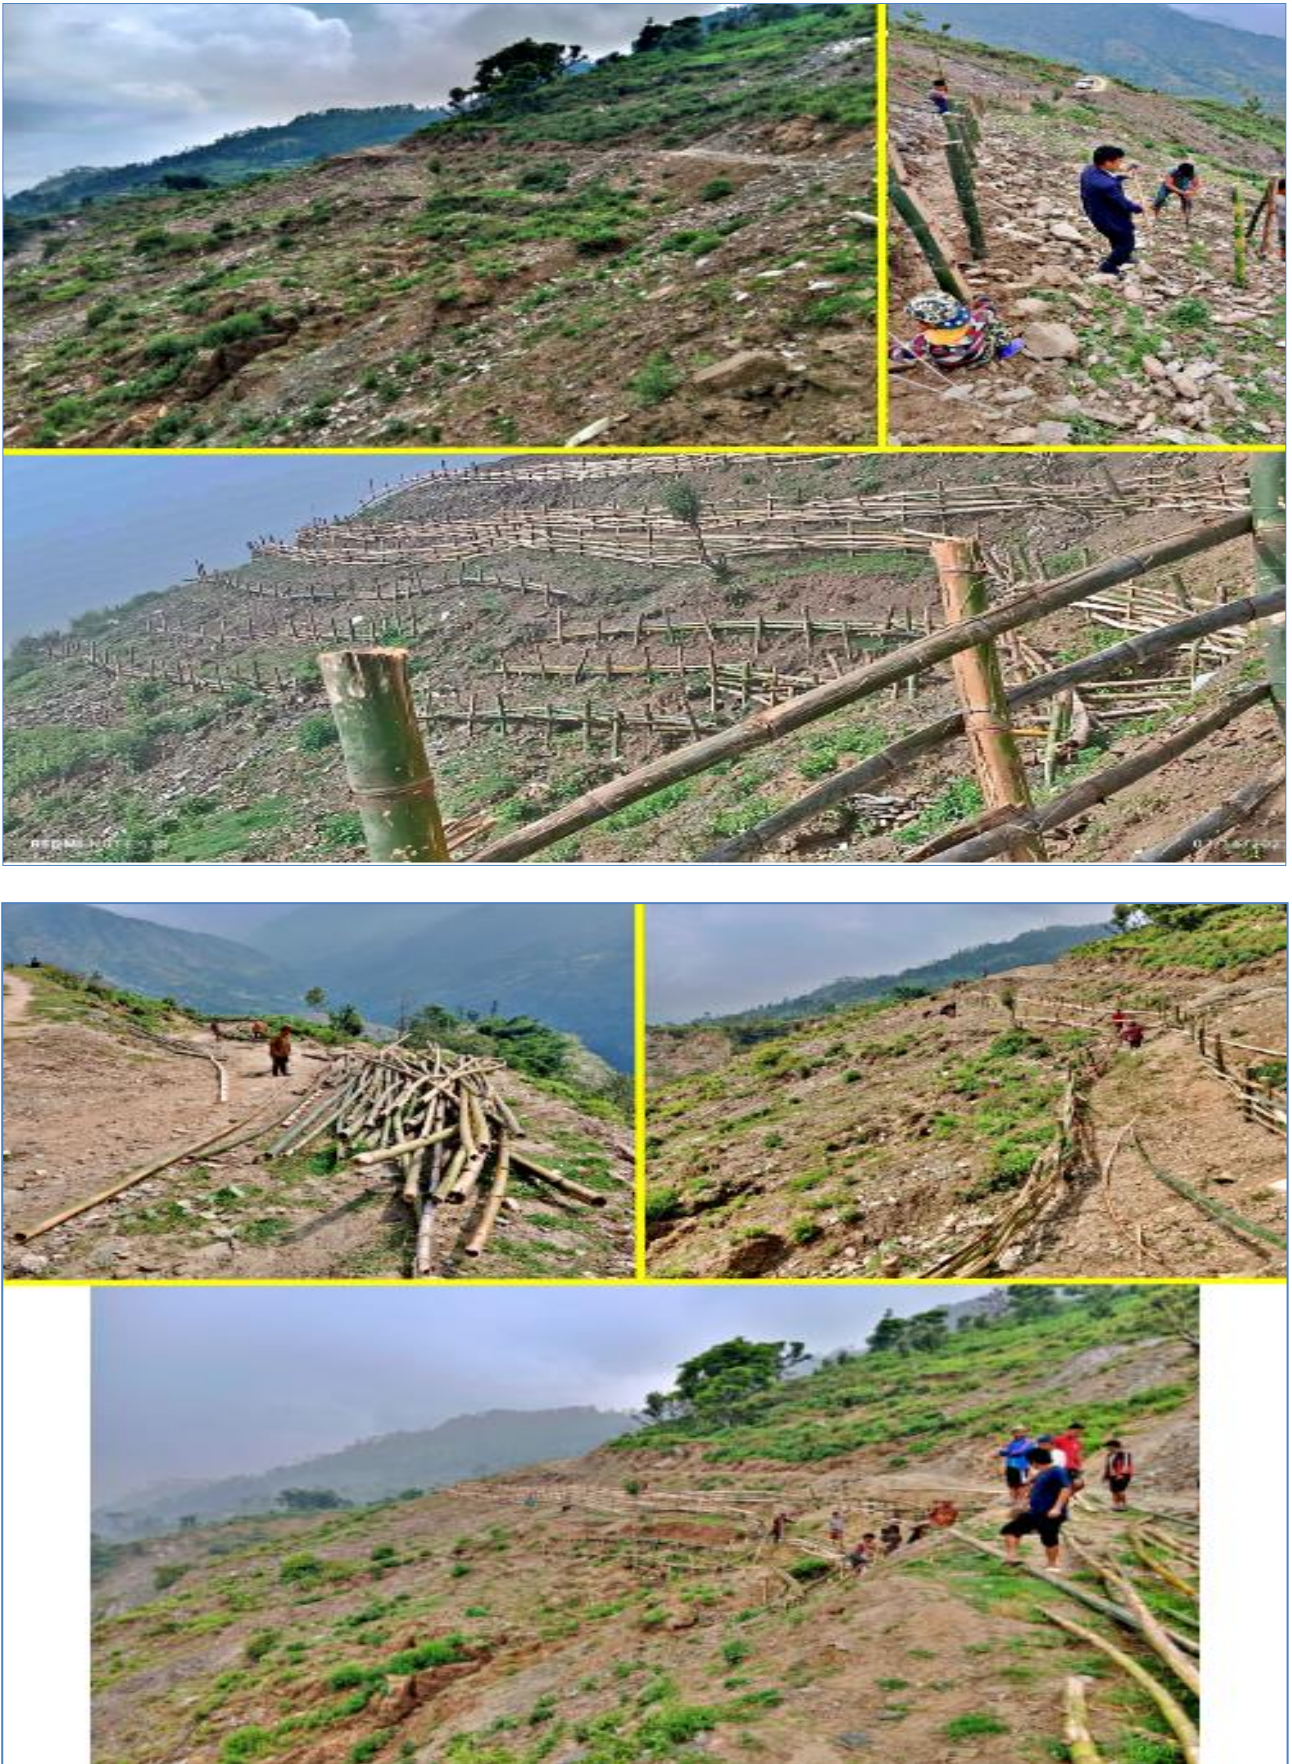
Figure 20: Fagam Landslide Treatment

1	Program: Gully, Landslide and Torrent Control				
2	Location: District/Rural Municipality: Rolpa /Sunchhahari	Ward No: 6	Place: Fagaam	F/Y: 079/80	
	Co-ordinates:	Latitude: 28.311727		Longitude: 82.738566	
3	Existing Site Problem: The gully formation possess a risk of damage to the settlement, rural road and agricultural land				
4	Cost:				
a	Estimated	Total: 1113450.40	Office: 999996.98	Users: 113453.42	Others:
b	Actual Expenditure	Total: 1104732.97	Office: 992486.50	Users: 112246.51	Others:
5	Objectives:	a) to reduce soil erosion and mass movement b) to reduce devastating effects on the downstream and surrounding area			
6	Technique Applied:	a) Structural: Gabion Chek-dam Construction (Gabion Box 48 Nos; Box size 2m*1m*1m=11 Nos., 1.5m*1m*1m=61 Nos., 1.5m*1m*0.50m=21 Nos.; were used to construct 2 nos. of Gabion Check-dam)			
7	Implementation Process:	Co-ordination with Local Representatives, User Groups and other concerned authorities; Field Visits; Survey, Design & Cost Estimation; Provide funds for the purchase of Gabion Boxes, Skilled Labour, Hoarding Board from Program cost; Unskilled Labour cost was contributed jointly through program cost and people participation; Monitoring & Evaluation

8	Employment:	352 md			
9	Gender/Social Consideration:	Both men and women were equally involved; More emphasis was given to the genuine participation of disadvantaged groups			
10	Effect/Impact:	To some extent, erosion and mass movement has been reduced; Reduce the risk of damage to the settlement, rural road and agricultural land; Approximately 0.5 ha of barren land has been conserved			
11	Benefitted HH:	Total: 100	Dalit: 12	Janajati: 65	Others: 23
12	Problem/Obstacles Faced:	Local people didn't believe that these types of low cost soil conservation techniques can control landslide			
13	Maintenance/Sustainability:	5% amount of total payable amount has been deducted for the maintenance work, if some damage occurs.			
14	Lesson Learned:	If real needs of the community are to be addressed, villagers readily participate throughout the activity implementation process, thus greater achievements are possible even with small external support.

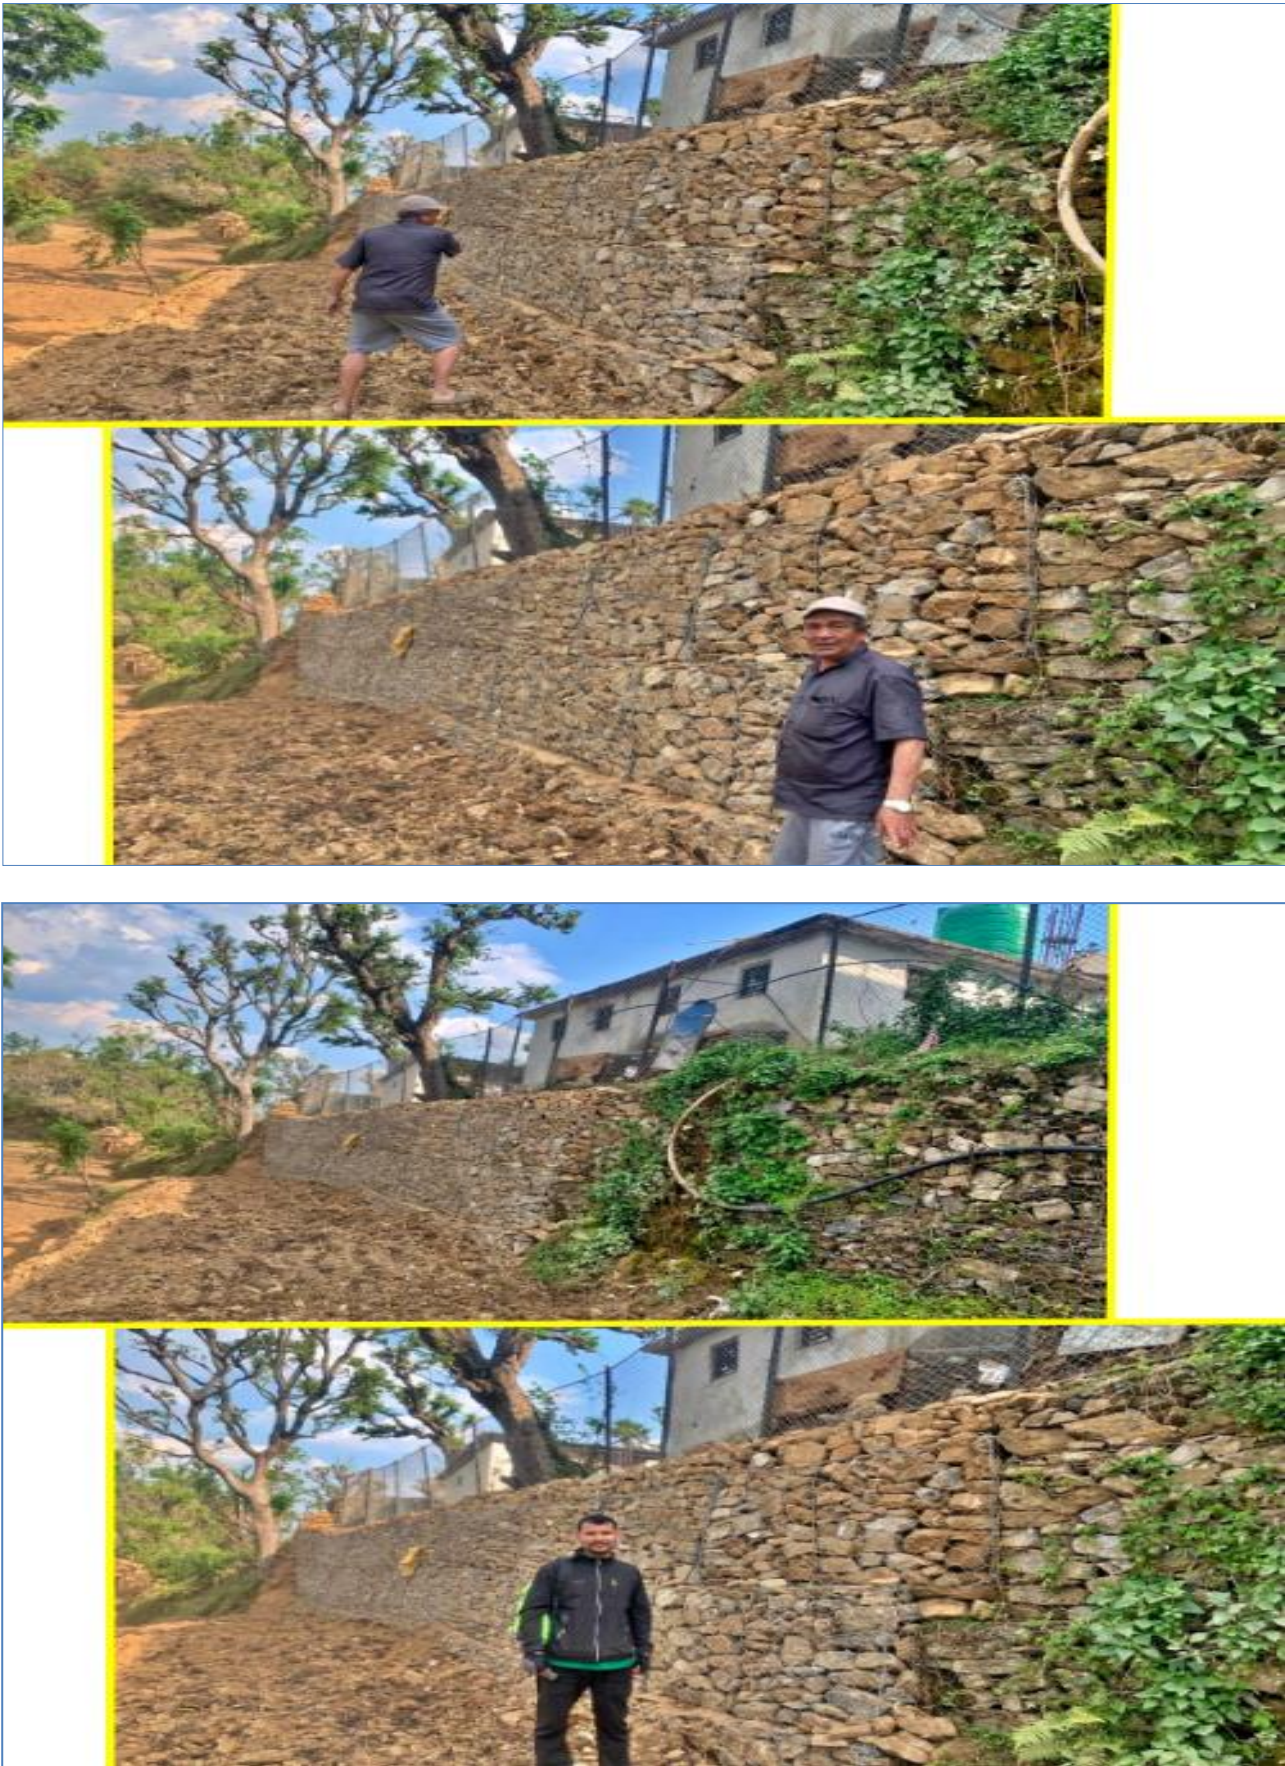
Figure 21: Gajul Landslide Treatment

1	Program: Gully, Landslide and Torrent Control				
2	Location: District/Rural Municipality: Rolpa /Sunilsmriti	Ward No: 6	Place: Gajul	F/Y: 079/80	
	Co-ordinates:	Latitude: 28.292277		Longitude: 82.713124	
3	Existing Site Problem: The Landslide in front of the School possess a risk of damage to the School building & rural road				
4	Cost:				
a	Estimated	Total: 168414.36	Office: 149926.65	Users: 18470.87	Others:
b	Actual Expenditure	Total: 168414.36	Office: 149926.65	Users: 18470.87	Others:
5	Objectives:	a) to reduce soil erosion and mass movement b) to reduce devastating effects on the downstream and surrounding area			
6	Technique Applied:	a) Structural: Gabion Retaining Wall Construction (Gabion Box 24 Nos; Box size 2m*1m*1m=16 Nos. 1.5m*1m*1m=8 Nos.; provided by Office were used to construct 8m long & 4m high Gabion Retaining Wall)			
7	Implementation Process:	Co-ordination with Local Representatives, User Groups and other concerned authorities; Field Visits; Survey, Design & Cost Estimation; Provide funds for the purchase of Gabion Boxes, Skilled Labour, Hoarding Board from Program cost; Unskilled Labour cost was contributed jointly through program cost and people participation; Monitoring & Evaluation

8	Employment:	104 md			
9	Gender/Social Consideration:	Both men and women were equally involved; More emphasis was given to the genuine participation of disadvantaged groups			
10	Effect/Impact:	To some extent, erosion and mass movement has been reduced; Reduce the risk of damage to the school & rural road Approximately 0.25 ha of school area has been conserved			
11	Benefitted HH:	Total: 90	Dalit: 20	Janajati: 30	Others: 40
12	Problem/Obstacles Faced:	No			
13	Maintenance/Sustainability:	5% amount of total payable amount has been deducted for the maintenance work, if some damage occurs.			
14	Lesson Learned:	If real needs of the community are to be addressed, villagers readily participate throughout the activity implementation process, thus greater achievements are possible even with small external support. The physical structures constructed should be accompanied by bio-engineering techniques to sustain the structures.
