ACTIVITY PROFILE

079/80

SOIL AND WATERSHED
MANAGEMENT OFFICE,
ROLPA

LUMBINI STATE GOVERNMENT
MINISTRY OF FORESTS AND ENVIRONMENT
SOIL AND WATERSHED MANAGEMENT OFFICE
MULPANI, ROLPA

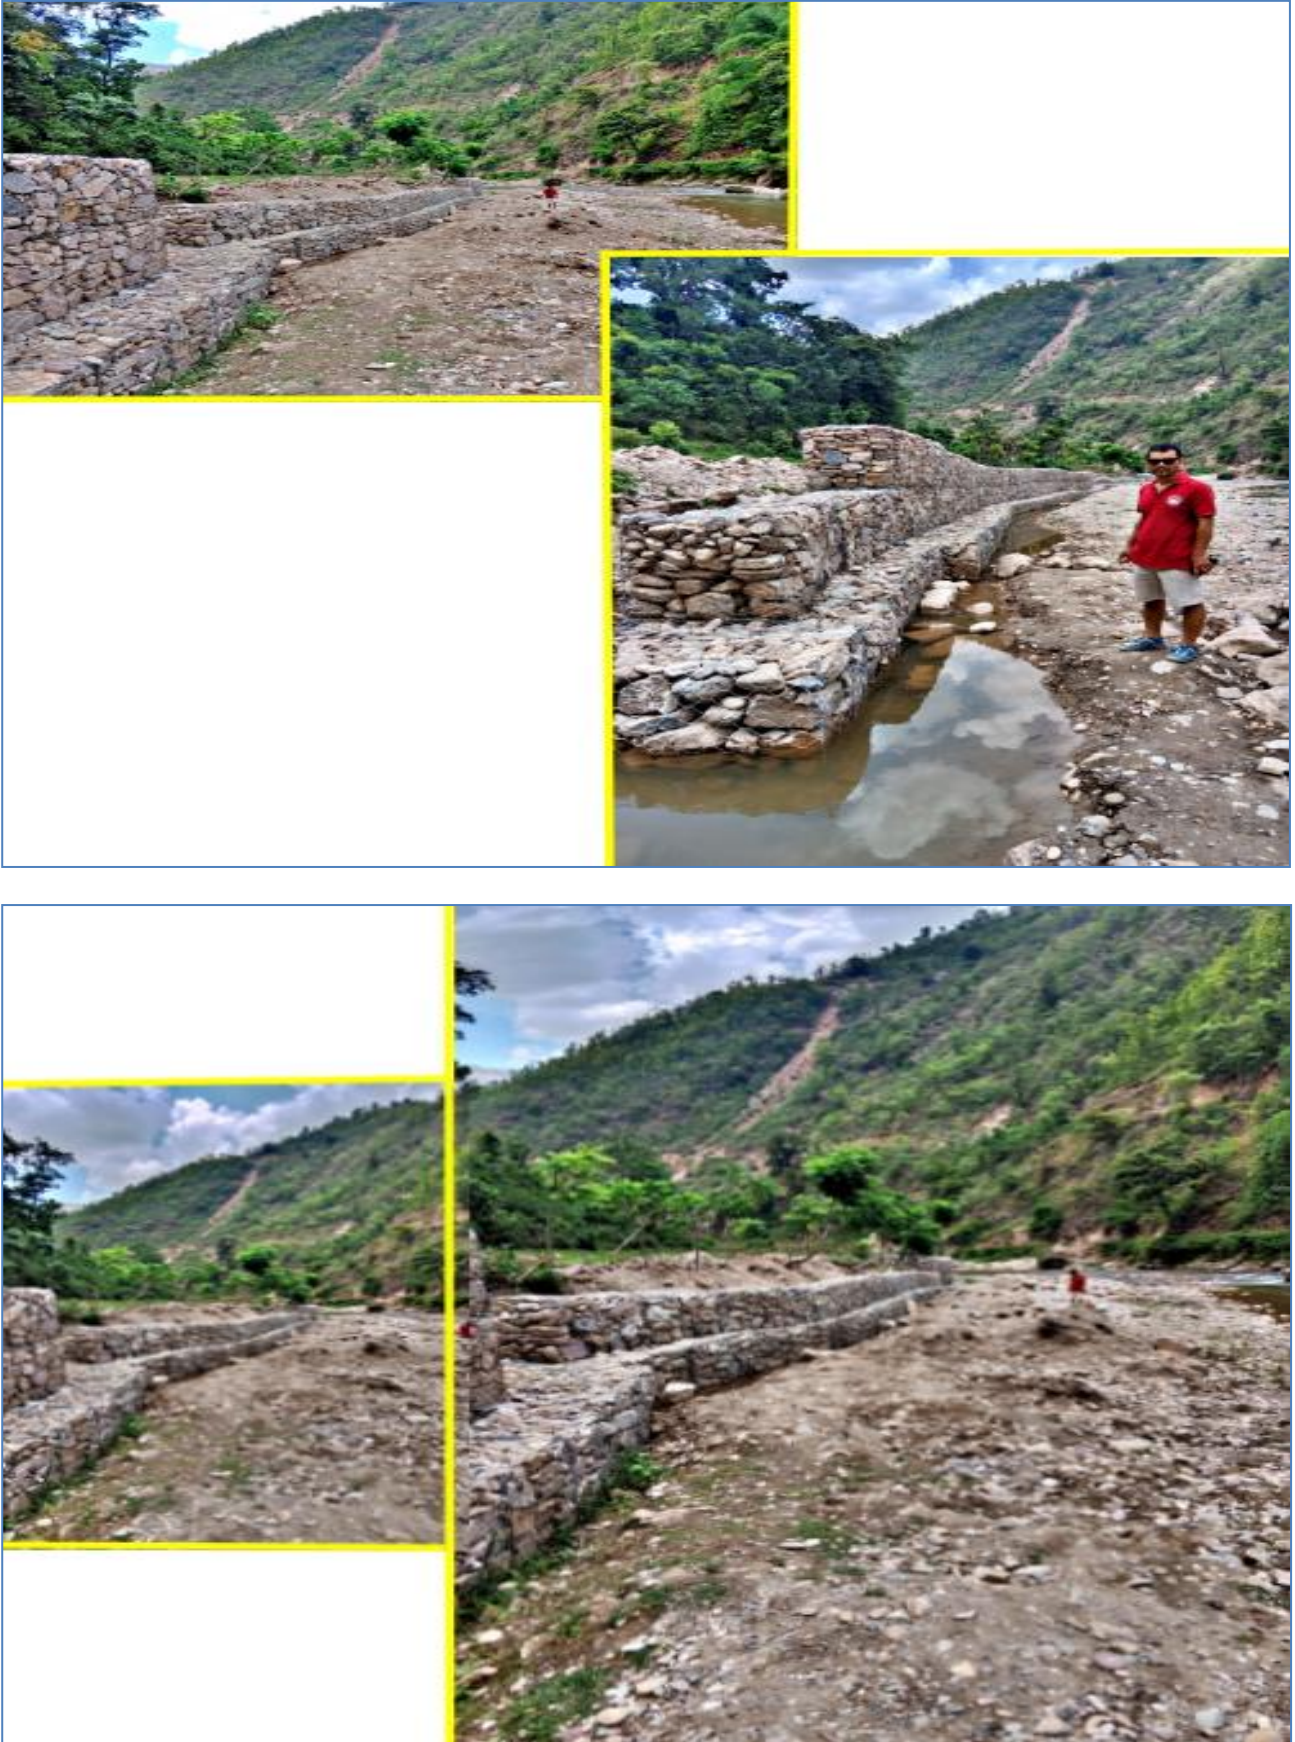
Figure 22: Sulibagar Madikhola Landslide Treatment

1	Program: Emergency Landslide Protection				
2	Location: District/Municipality: Rolpa /Rolpa	Ward No: 5	Place: Bajhawang	F/Y: 079/80	
	Co-ordinates:	Latitude: 28.250831		Longitude: 82.611527	
3	Existing Site Problem: The Landslide caused by river bank cutting possess a risk of damage to the agricultural land				
4	Cost:				
a	Estimated	Total: 795879.48	Office: 699960.37	Users: 95919.11	Others:
b	Actual Expenditure	Total: 793166.90	Office: 697689.82	Users: 95477.08	Others:
5	Objectives:	a) to <i>reduce soil erosion and mass movement</i> b) to <i>reduce devastating effects on the downstream and surrounding area</i>			
6	Technique Applied:	a) Structural: Gabion Retaining Wall Construction (Gabion Box 60 Nos; Box size 2m*1m*1m=20 Nos.; ; Box size 1.5m*1m*1m=40 Nos.; were used to construct 40m long Gabion Retaining Wall)			
7	Implementation Process:	Co-ordination with Local Representatives, User Groups and other concerned authorities; Field Visits; Survey, Design & Cost Estimation; Provide funds for the purchase of Gabion Boxes, Skilled Labour, Hoarding Board from Program cost; Unskilled Labour cost was contributed jointly through program cost and people participation; Monitoring & Evaluation

8	Employment:	485 md			
9	Gender/Social Consideration:	Both men and women were equally involved; More emphasis was given to the genuine participation of disadvantaged groups			
10	Effect/Impact:	To some extent, erosion and mass movement has been reduced; Reduce the risk of damage to the agricultural land; Approximately 0.5 ha of agricultural land has been conserved			
11	Benefitted HH:	Total: 40	Dalit: 20	Janajati: 15	Others: 5
12	Problem/Obstacles Faced:	No			
13	Maintenance/Sustainability:	5% amount of total payable amount has been deducted for the maintenance work, if some damage occurs.			
14	Lesson Learned:	If real needs of the community are to be addressed, villagers readily participate throughout the activity implementation process, thus greater achievements are possible even with small external support. The physical structures constructed should be accompanied by bio-engineering techniques to sustain the structures.

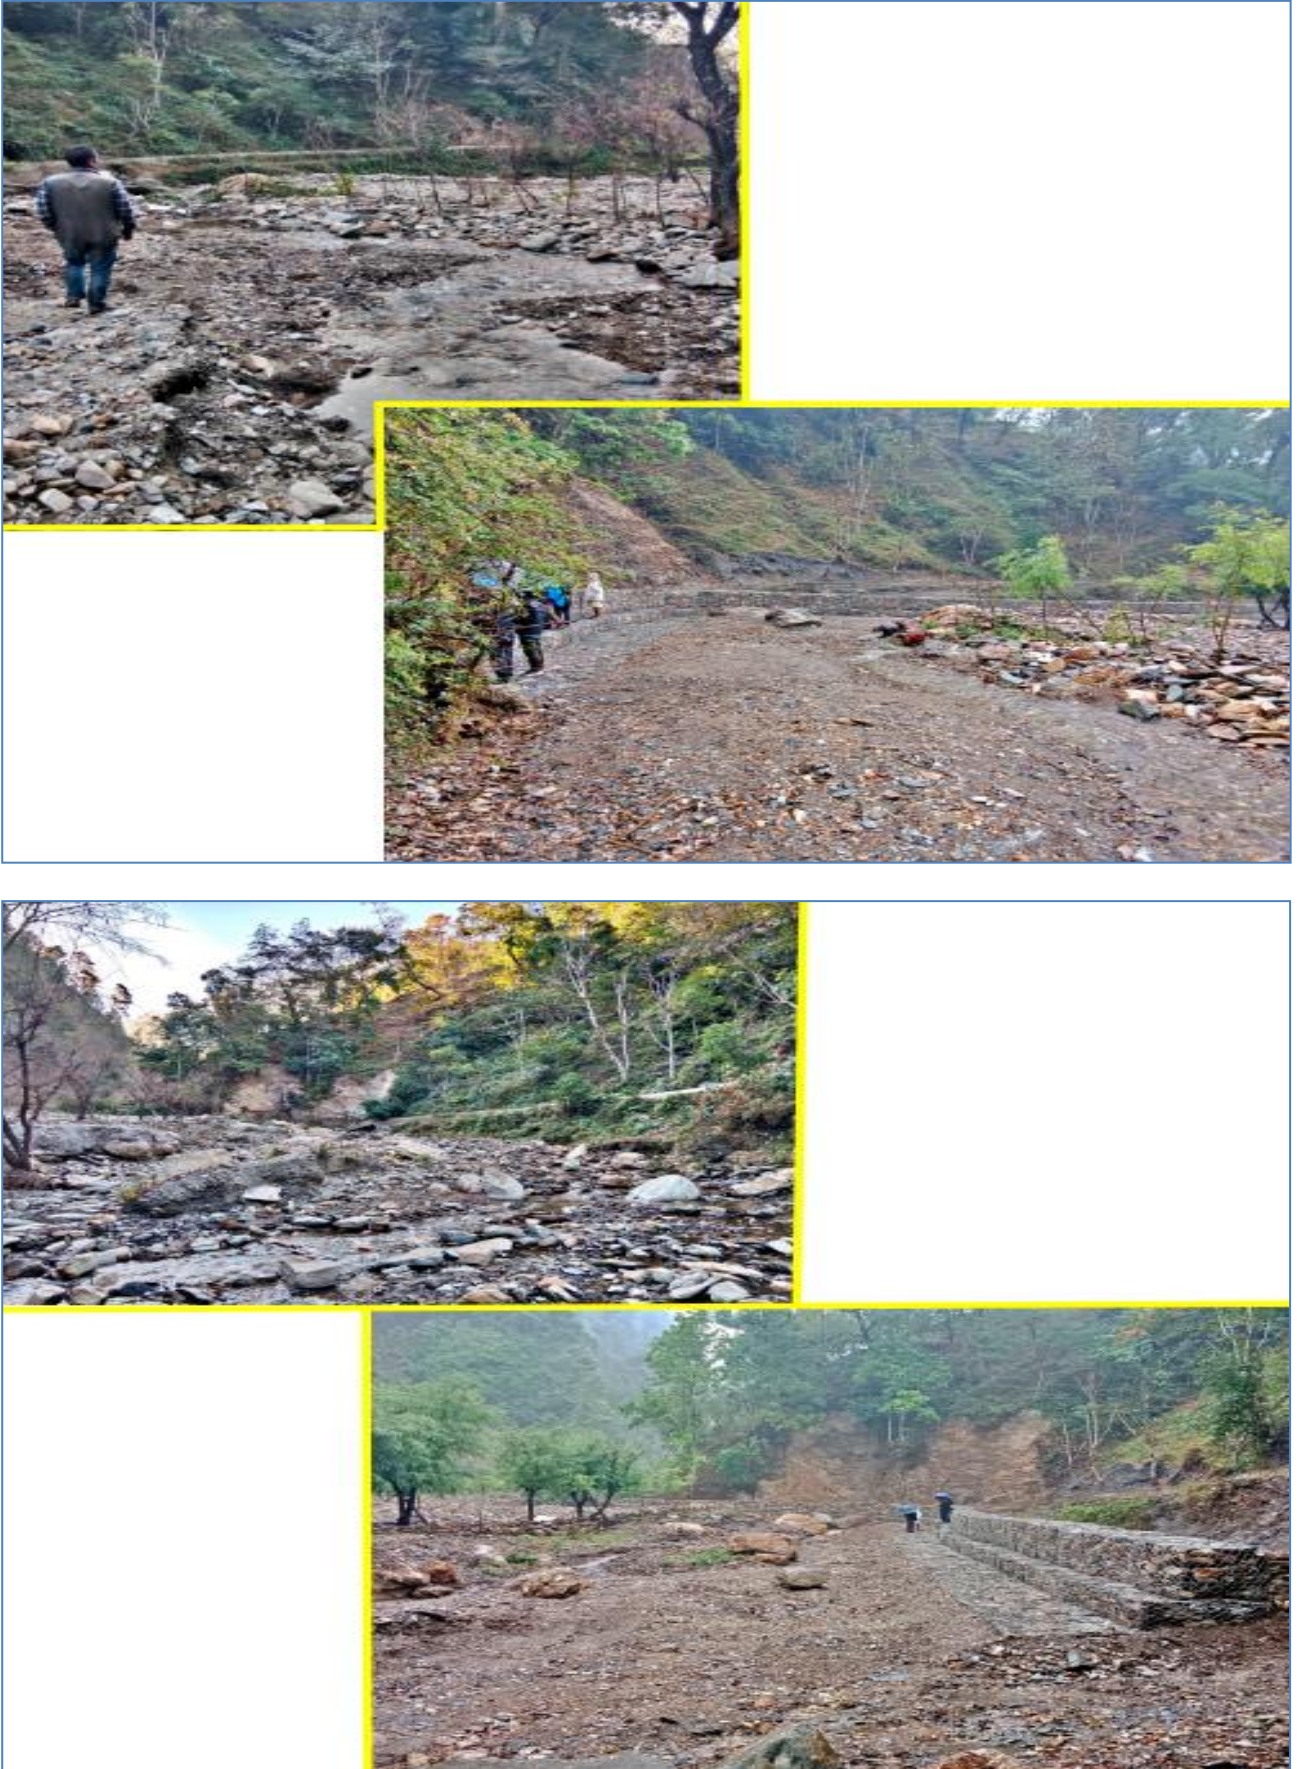
Figure 24: Jutung Khola Stream Bank Protection

1	Program: River/Stream Bank Protection				
2	Location: District/Rural Municipality: Rolpa /Lungri	Ward No: 3	Place: Jutung Khola, Chiurafed	F/Y: 079/80	
	Co-ordinates:	Latitude: 28.217681	Longitude: 82.810925		
3	Existing Site Problem: The irrigation canal has been damaged & agricultural land has been in degraded form by Jutung khola bank cutting				
4	Cost:				
a	Estimated	Total: 1122013.29	Office: 999999.07	Users: 122014.22	Others:
b	Actual Expenditure	Total: 1118996.31	Office: 996982.09	Users: 122014.22	Others:
5	Objectives:	a) to prevent stream bank cutting b) to protect the irrigation canal & conserve agricultural land			
6	Technique Applied:	a) Structural: Gabion Embankment Construction (Gabion Box 150 Nos; Box size 1.5m*1m*0.5m=60 Nos.; Box size 2m*1m*1m=30 Nos.; Box size 1.5m*1m*1m=60 Nos.; were used to construct 60m long Gabion Embankment)			
7	Implementation Process:	Co-ordination with Local Representatives, User Groups and other concerned authorities; Field Visits; Survey, Design & Cost Estimation; Provide funds for the purchase of Gabion Boxes, Skilled Labour, Hoarding Board from Program cost; Unskilled Labour cost was contributed jointly through program cost and people participation; Monitoring & Evaluation

8	Employment:	693 md			
9	Gender/Social Consideration:	Both men and women were equally involved; More emphasis was given to the genuine participation of disadvantaged groups			
10	Effect/Impact:	To some extent, stream bank cutting and erosion has been controlled; Reduce the risk of damage to the irrigation canal and agricultural land; Approximately 0.6 ha of agricultural land has been conserved			
11	Benefitted HH:	Total: 17	Dalit:	Janajati: 13	Others: 4
12	Problem/Obstacles Faced:	No			
13	Maintenance/Sustainability:	5% amount of total payable amount has been deducted for the maintenance work, if some damage occurs.			
14	Lesson Learned:	If real needs of the community are to be addressed, villagers readily participate throughout the activity implementation process, thus greater achievements are possible even with small external support. The physical structures constructed should be accompanied by bio-engineering techniques to sustain the structures.

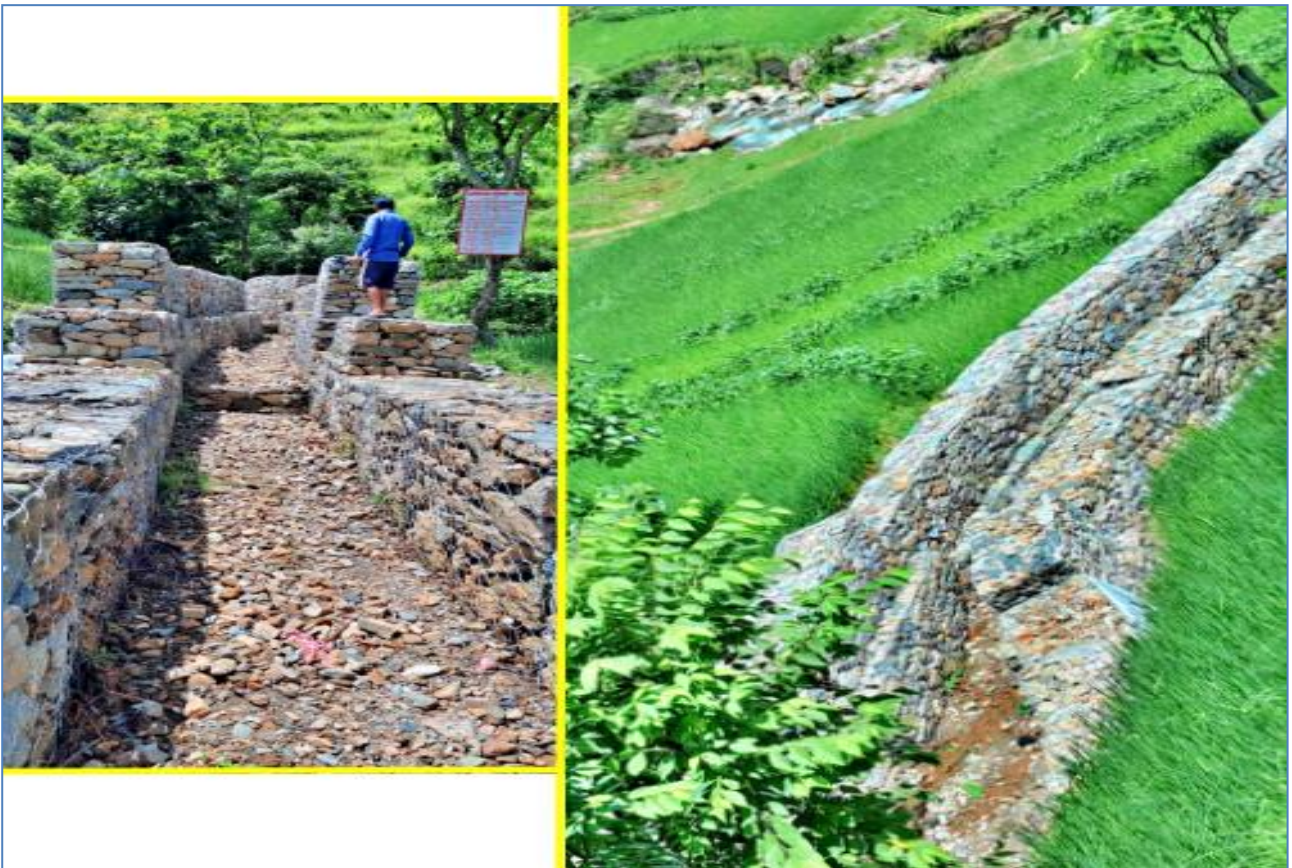
Figure 28: Jutung Khola Stream Bank Protection

1	Program: River/Stream Bank Protection				
2	Location: District/Rural Municipality: Rolpa /Lungri	Ward No: 3	Place: Jutung Khola	F/Y: 079/80	
	Co-ordinates:	Latitude: 28.224324		Longitude: 82.797658	
3	Existing Site Problem: The Jutung khola possess a risk of damage to agricultural land by stream bank cutting				
4	Cost:				
a	Estimated	Total: 902106.15	Office: 799983.62	Users: 102122.53	Others:
b	Actual Expenditure	Total: 898928.26	Office: 797357.08	Users: 101571.18	Others:
5	Objectives:	a) to prevent stream bank cutting b) to conserve agricultural land			
6	Technique Applied:	a) Structural: Gabion Embankment Construction (Gabion Box 97 Nos; Box size 1.5m*1m*0.5m=30 Nos.; Box size 2m*1m*1m=22 Nos.; Box size 1.5m*1m*1m=45 Nos.; were used to construct 45m long Gabion Embankment)			
7	Implementation Process:	Co-ordination with Local Representatives, User Groups and other concerned authorities; Field Visits; Survey, Design & Cost Estimation; Provide funds for the purchase of Gabion Boxes, Skilled Labour, Hoarding Board from Program cost; Unskilled Labour cost was contributed jointly through program cost and people participation; Monitoring & Evaluation

8	Employment:	554 md			
9	Gender/Social Consideration:	Both men and women were equally involved; More emphasis was given to the genuine participation of disadvantaged groups			
10	Effect/Impact:	To some extent, stream bank cutting and erosion has been controlled; Reduce the risk of damage to the agricultural land; Approximately 0.8 ha of agricultural land has been conserved			
11	Benefitted HH:	Total: 39	Dalit: 6	Janajati: 23	Others: 10
12	Problem/Obstacles Faced:	No			
13	Maintenance/Sustainability:	5% amount of total payable amount has been deducted for the maintenance work, if some damage occurs.			
14	Lesson Learned:	If real needs of the community are to be addressed, villagers readily participate throughout the activity implementation process, thus greater achievements are possible even with small external support. The physical structures constructed should be accompanied by bio-engineering techniques to sustain the structures.

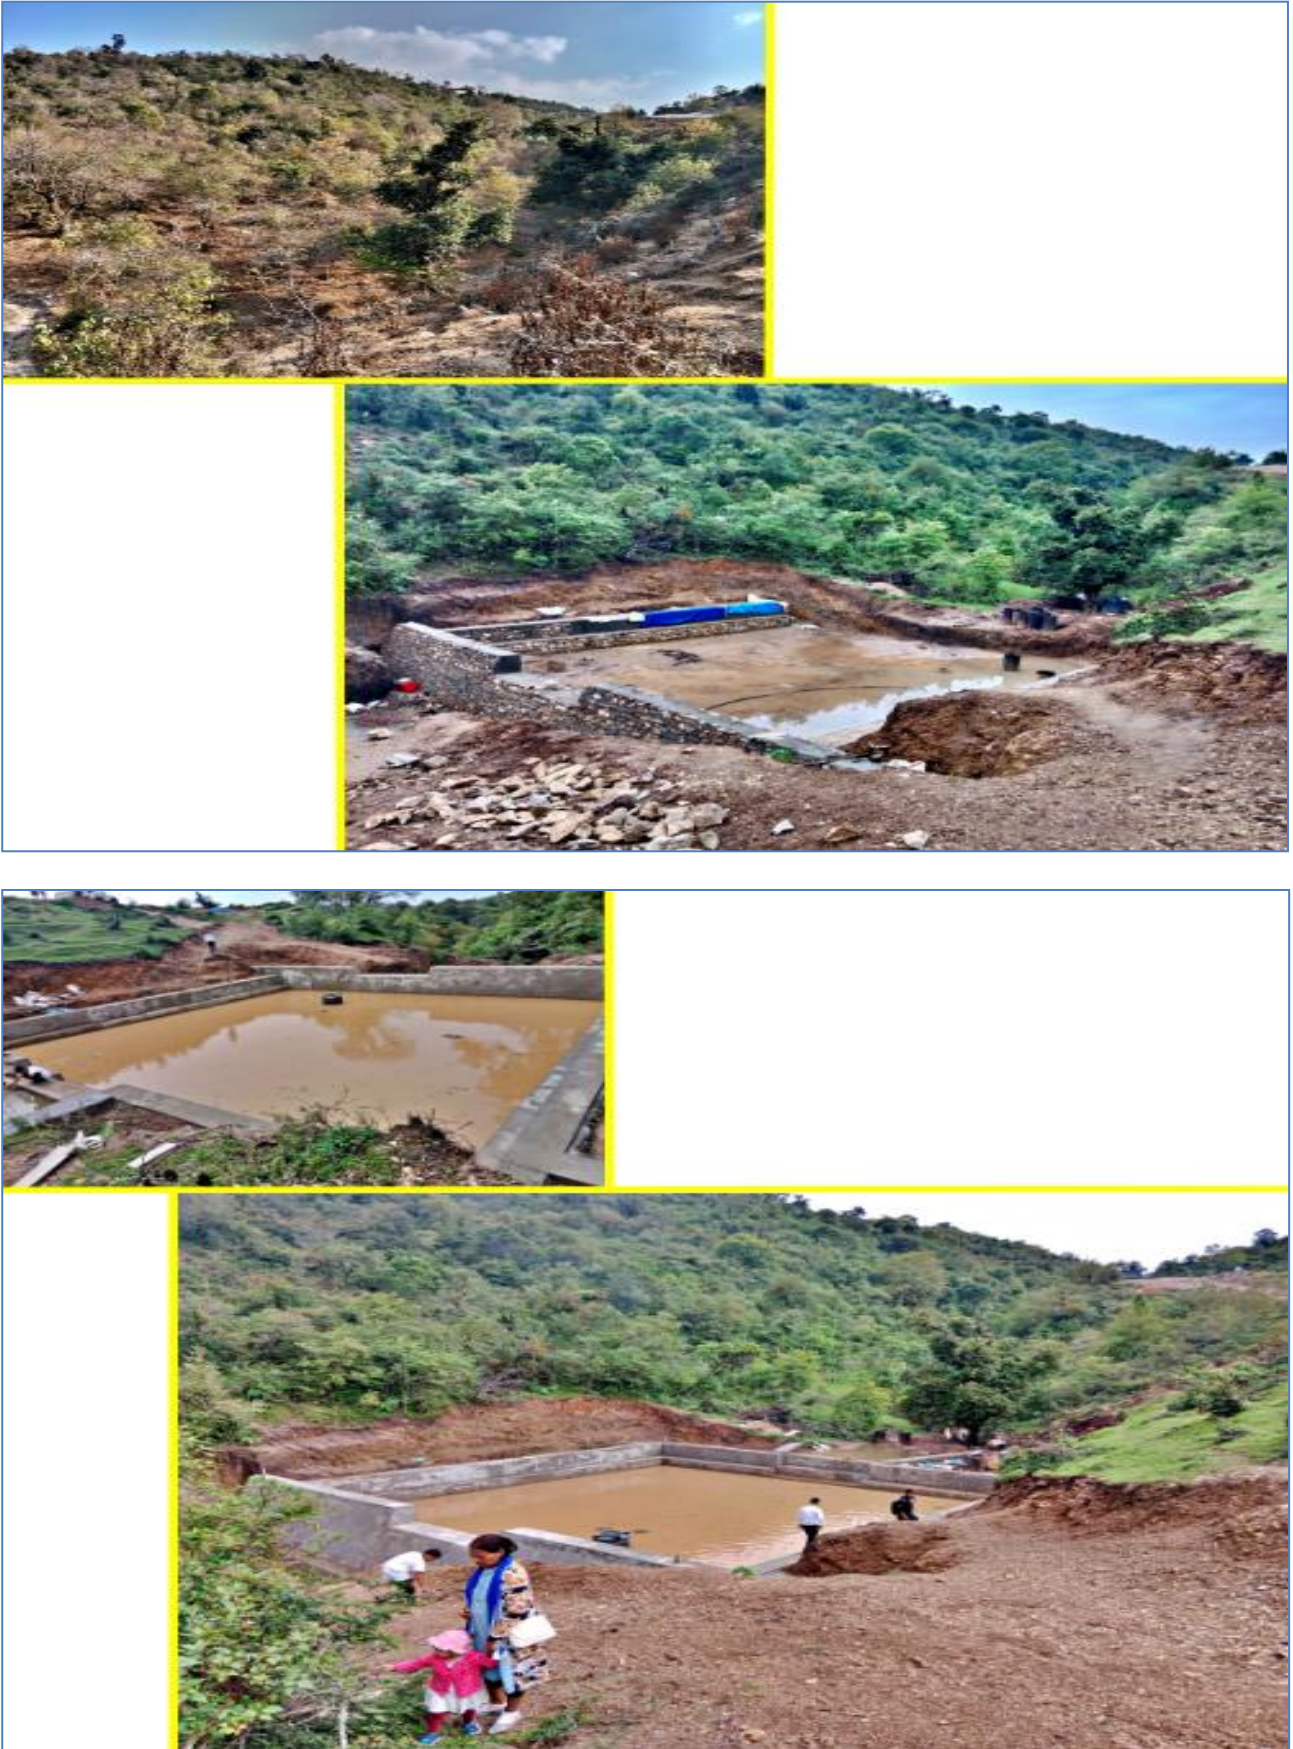
Figure 29: Satdobato Recharge Pond

1	Program: Water Source Protection/Conservation Pond				
2	Location: District/Municipality: Rolpa /Rolpa	Ward No: 3	Place: Satdobato	F/Y: 079/80	
	Co-ordinates:	Latitude: 28.271607		Longitude: 82.666552	
3	Existing Site Problem: The excess runoff water flowing through its own natural channel caused erosion and landslide in the downstream area; Lack of water for irrigation, livestock and other domestic purposes				
4	Cost:				
a	Estimated	Total: 1155108.88	Office: 999989.87	Users: 155119.01	Others:
b	Actual Expenditure	Total: 1165620.29	Office: 999186.32	Users: 166433.97	Others:
5	Objectives:	a) to harvest the runoff water b) to control erosion and landslides on downstream area c) to use the harvested runoff water for irrigation, livestock and other domestic purposes			
6	Technique Applied:	a) Structural: Dam (19.28m*0.85m*2m) & Recharge Pond Construction (Pond wall 4 nos,=15.4m & 15.1m, Wall Height=1.5m; Water Holding Capacity=348.80m3)

7	Implementation Process:	Co-ordination with Local Representatives, User Groups and other concerned authorities; Field Visits; Survey, Design & Cost Estimation; Provide funds for the purchase of Construction Materials, Skilled Labour, Hoarding Board from Program cost; Unskilled Labour cost was contributed jointly through program cost and people participation; Monitoring & Evaluation			
8	Employment:	795 md			
9	Gender/Social Consideration:	Both men and women were equally involved; More emphasis was given to the genuine participation of disadvantaged groups			
10	Effect/Impact:	Properly harvest the runoff water; Reduce the risk of damage in downstream area Support irrigation facilities for approximately 3 ha of agricultural land			
11	Benefitted HH:	Total: 16	Dalit: 1	Janajati: 5	Others: 10
12	Problem/Obstacles Faced:	No			
13	Maintenance/Sustainability:	5% amount of total payable amount has been deducted for the maintenance work, if some damage occurs.

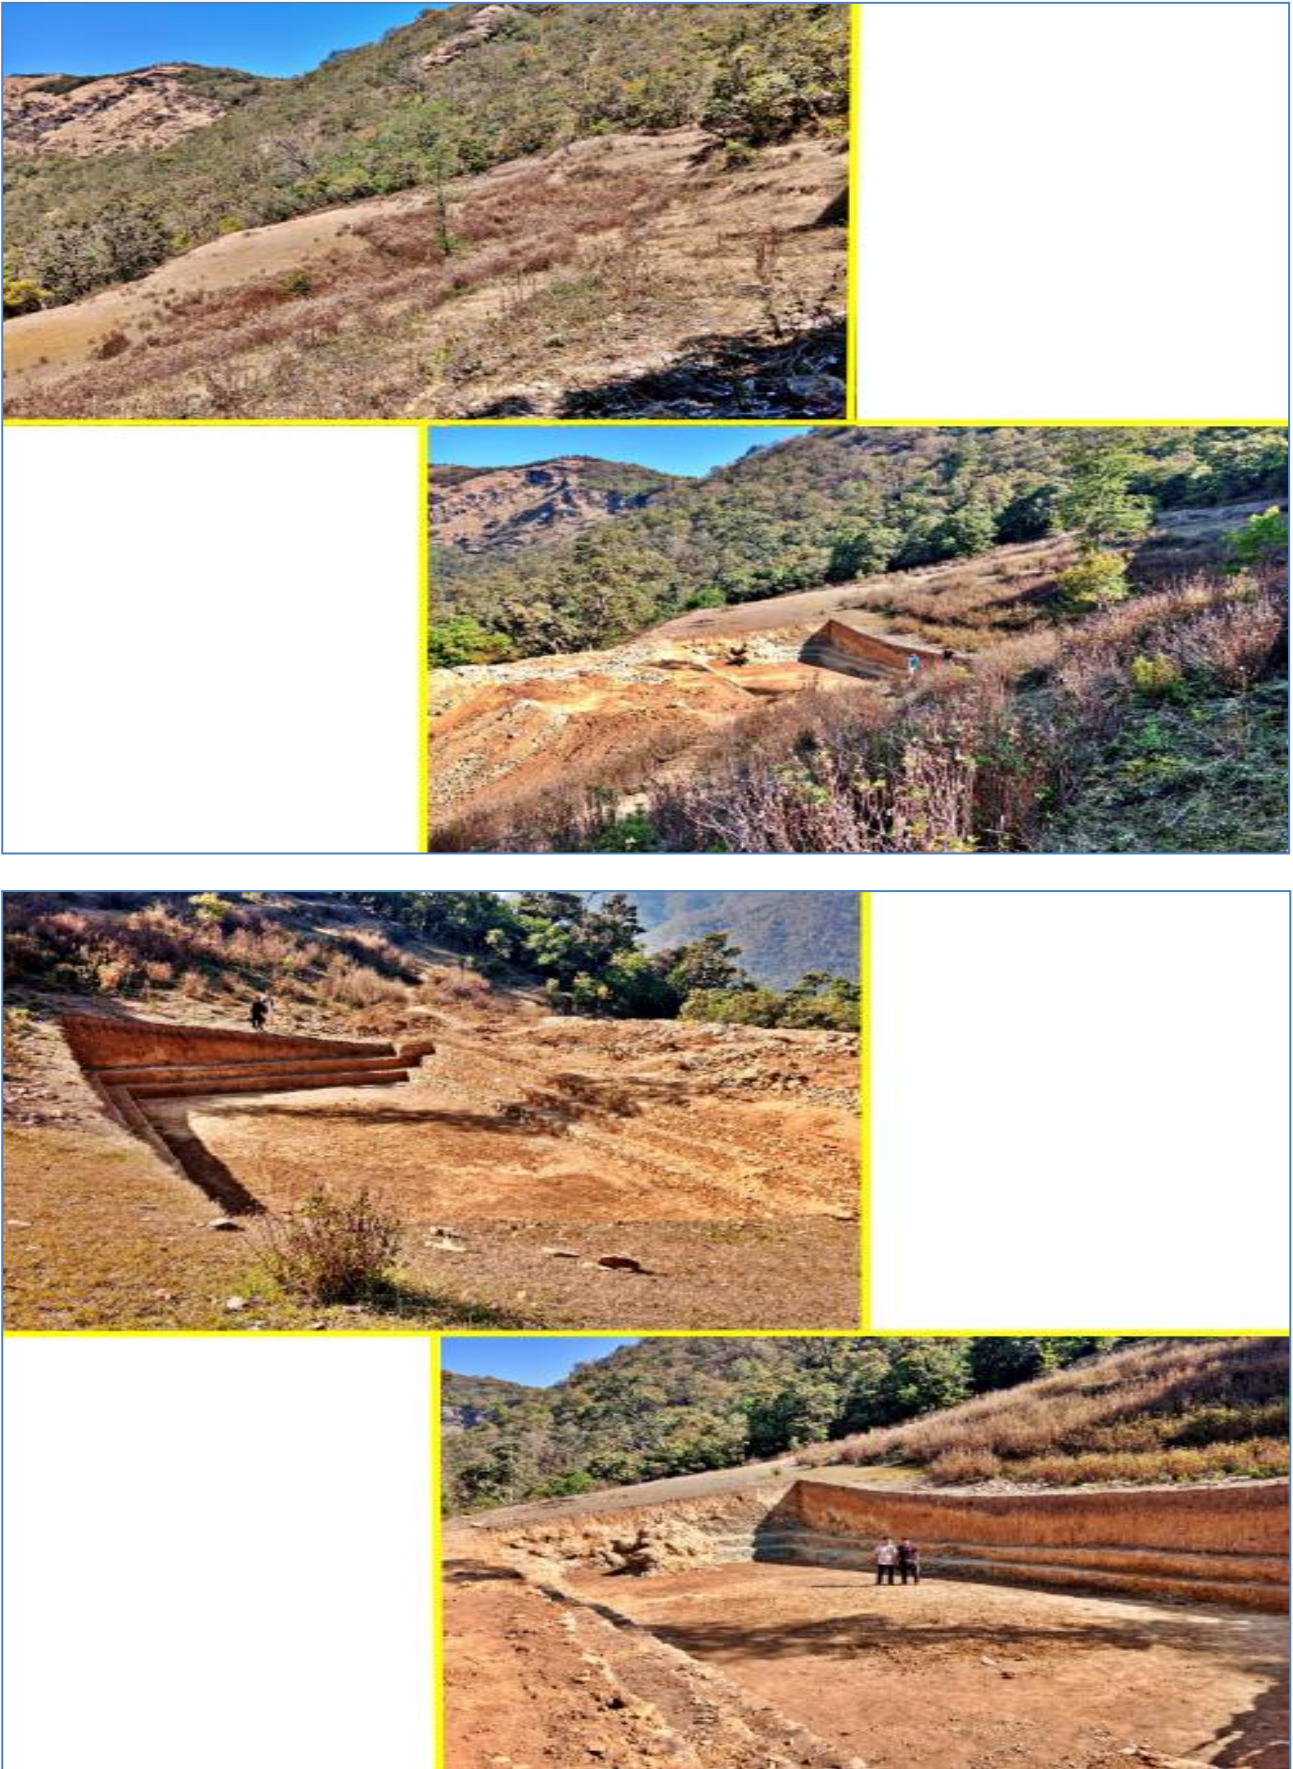
Figure 30: Baghthala Recharge Pond

1	Program: Water Source Protection/Conservation Pond				
2	Location: District/Municipality: Rolpa /Rolpa	Ward No: 6	Place: Bagthala, Darbot	F/Y: 079/80	
	Co-ordinates:	Latitude: 28.336338		Longitude: 82.539503	
3	Existing Site Problem: The excess runoff water flowing through its own natural channel caused erosion and landslide in the downstream area; Lack of water for irrigation, livestock and other domestic purposes				
4	Cost:				
a	Estimated	Total: 1111772.99	Office: 999960.00	Users: 111812.99	Others:
b	Actual Expenditure	Total: 1079100.35	Office: 969259.33	Users: 109841.02	Others:
5	Objectives:	a) to harvest the runoff water b) to control erosion and landslides on downstream area c) to use the harvested runoff water for irrigation, livestock and other domestic purposes			
6	Technique Applied:	a) Structural: Recharge Pond Construction (L= 24m, B= 11m, H= 1.5m; Water Holding Capacity= 396 m3)

7	Implementation Process:	Co-ordination with Local Representatives, User Groups and other concerned authorities; Field Visits; Survey, Design & Cost Estimation; Provide funds for the purchase of Construction Materials, Skilled Labour, Hoarding Board Placing from Program cost; Unskilled Labour cost was contributed jointly through program cost and people participation; Monitoring & Evaluation			
8	Employment:	898 md			
9	Gender/Social Consideration:	Both men and women were equally involved; More emphasis was given to the genuine participation of disadvantaged groups			
10	Effect/Impact:	Properly harvest the runoff water; Reduce the risk of damage in downstream area Support irrigation facilities for approximately 3 ha of agricultural land			
11	Benefitted HH:	Total: 60	Dalit: 10	Janajati: 30	Others: 20
12	Problem/Obstacles Faced:	No			
13	Maintenance/Sustainability:	5% amount of total payable amount has been deducted for the maintenance work, if some damage occurs.

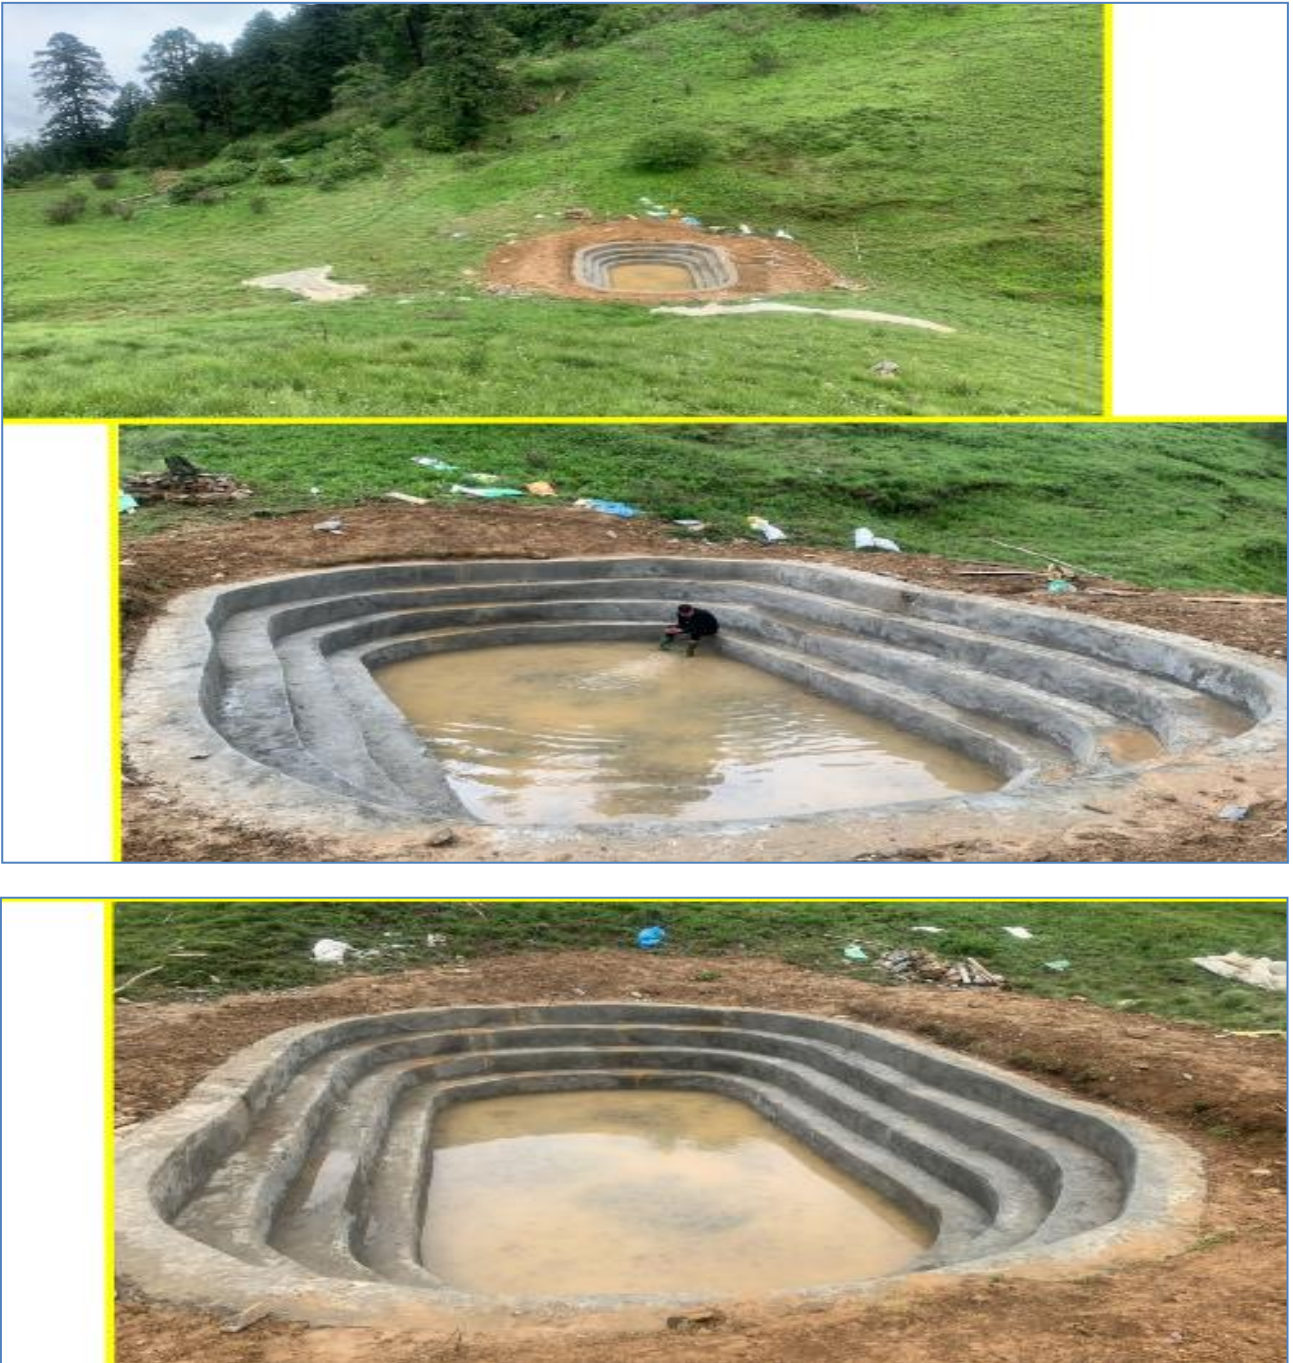
Figure 31: Jaljala Recharge Pond

1	Program: Water Source Protection/Conservation Pond				
2	Location: District/Rural Municipality: Rolpa /Thawang	Ward No: 1	Place: Jaljala	F/Y: 079/80	
	Co-ordinates:	Latitude: 28.444811		Longitude: 82.724672	
3	Existing Site Problem: The excess runoff water flowing through its own natural channel caused erosion and landslide in the downstream area				
4	Cost:				
a	Estimated	Total: 999619.45	Office: 999619.45	Users:	Others:
b	Actual Expenditure	Total: 958404.65	Office: 958404.65	Users:	Others:
5	Objectives:	a) to harvest the runoff water b) to control erosion and landslides on downstream area			
6	Technique Applied:	a) Structural: Recharge Pond Construction (9.9m*6m*1.35m; Water Holding Capacity= 88.20m3)			
7	Implementation Process:	Co-ordination with Local Representatives and other concerned authorities; Field Visits; Survey, Design & Cost Estimation; Provide funds for the construction of recharge pond by quotation; Monitoring & Evaluation

8	Employment:	666 md			
9	Gender/Social Consideration:	Both men and women were equally involved; More emphasis was given to the genuine participation of disadvantaged groups			
10	Effect/Impact:	Properly harvest the runoff water; Reduce the risk of damage in downstream area			
11	Benefitted HH:	Total: 100	Dalit: 26	Janajati: 64	Others: 10
12	Problem/Obstacles Faced:	No			
13	Maintenance/Sustainability:	5% amount of total payable amount has been deducted for the maintenance work, if some damage occurs.			
14	Lesson Learned:	If real needs of the community are to be addressed, villagers readily participate throughout the activity implementation process, thus greater achievements are possible even with small external support. The physical structures constructed should be accompanied by plantation of different fruit tree species which supports for income generation.			
15	Others; Name of:	Firm name: Tribeni Construction & Transportation Pvt. Ltd.

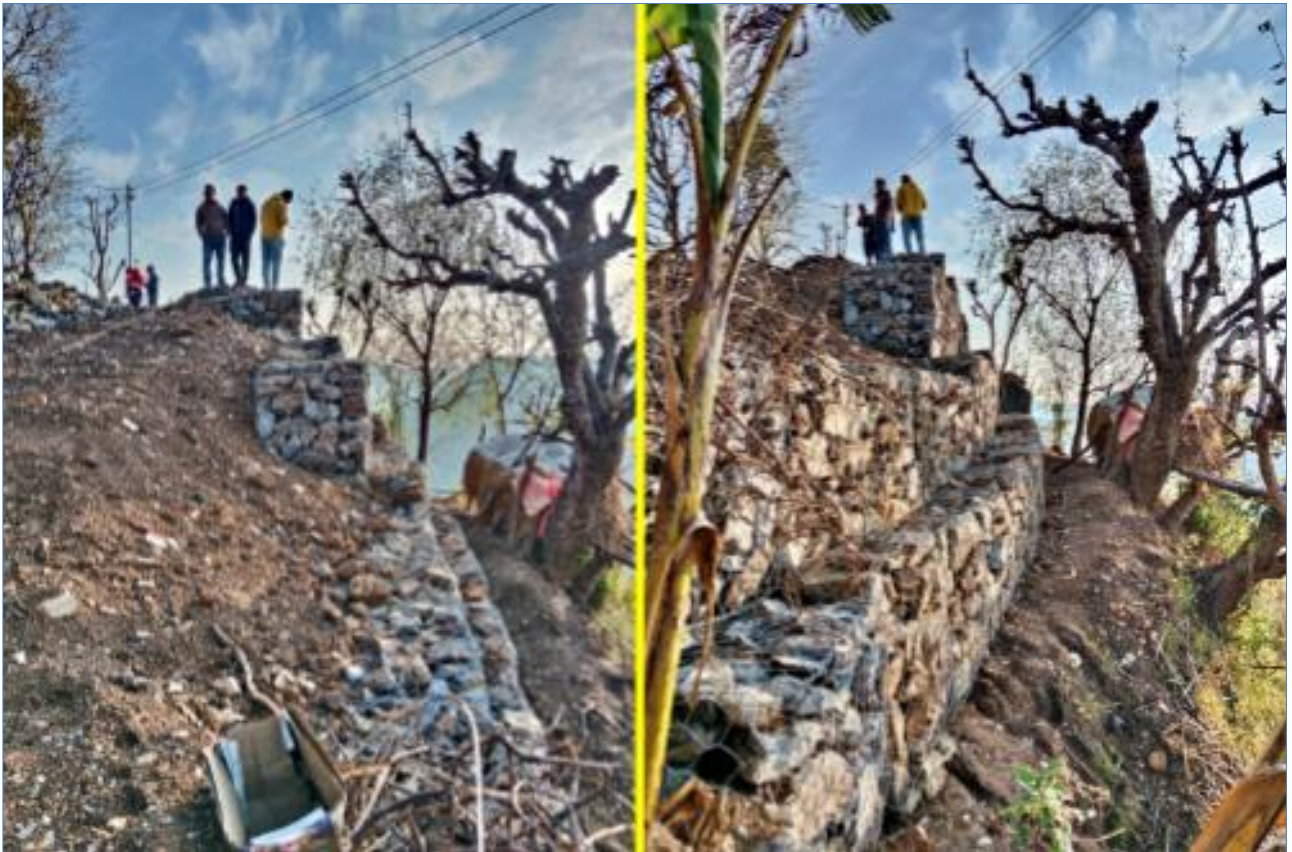
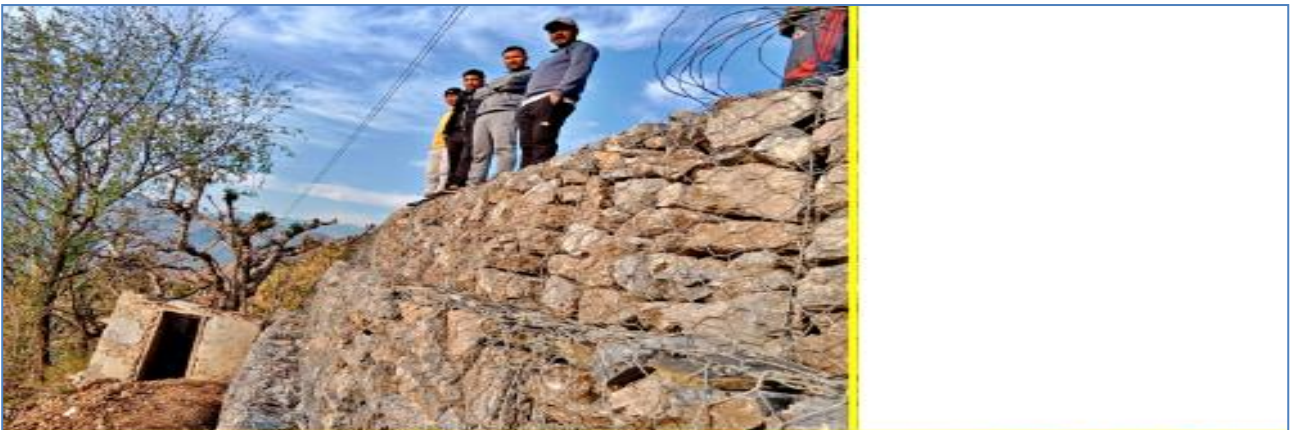
Figure 34: Salwang Rural Road Conservation

1	Program: Soil Conservation Work Along Rural Road				
2	Location: District/Municipality: Rolpa/Rolpa	Ward No: 2	Place: Salwang	F/Y: 079/80	
	Coordinate:	Latitude: 28.306625		Longitude: 82.591885	
3	Existing Site Problem: The soil erosion & landslide possess a risk of damage to the rural road and agricultural land				
4	Cost:				
a	Estimated	Total: 889481.39	Office: 799991.96	Users: 89489.44	Others:
b	Actual Expenditure	Total: 889481.39	Office: 799991.96	Users: 89489.44	Others:
5	Objectives:	a) to reduce soil erosion and mass movement from landslide b) to reduce devastating effects on the downstream and surrounding area c) to improve the road condition			
6	Technique Applied:	a) Structural: Gabion Retaining Wall Construction (Gabion Box 50 Nos; Box size 2m*1m*1m=25Nos., 1.5m*1m*1m=25Nos. were used to construct 20m long Retaining Wall)			
7	Implementation Process:	Co-ordination with Local Representatives, User Groups and other concerned authorities; Field Visits; Survey, Design & Cost Estimation; Provide funds for the purchase of Gabion Boxes, Skilled Labour, Hoarding Board from Program cost; unskilled Labour cost was contributed jointly through program cost and people participation; Monitoring & Evaluation

8	Employment:	556 md			
9	Gender/Social Consideration:	Both men and women were equally involved; More emphasis was given to the genuine participation of disadvantaged groups			
10	Effect/Impact:	To some extent, erosion and mass movement has been reduced; Reduce the risk of damage to the rural road; Approximately 0.04 km of rural road & 0.1ha of agricultural land has been conserved			
11	Benefitted HH:	Total: 50	Dalit: 10	Janajati: 10	Others: 30
12	Problem/Obstacles Faced:	No			
13	Maintenance/Sustainability:	5% amount of total payable amount has been deducted for the maintenance work, if some damage occurs.			
14	Lesson Learned:	If real needs of the community are to be addressed, villagers readily participate throughout the activity implementation process, thus greater achievements are possible even with small external support. The physical structures constructed should be accompanied by bio-engineering techniques to sustain the structures.

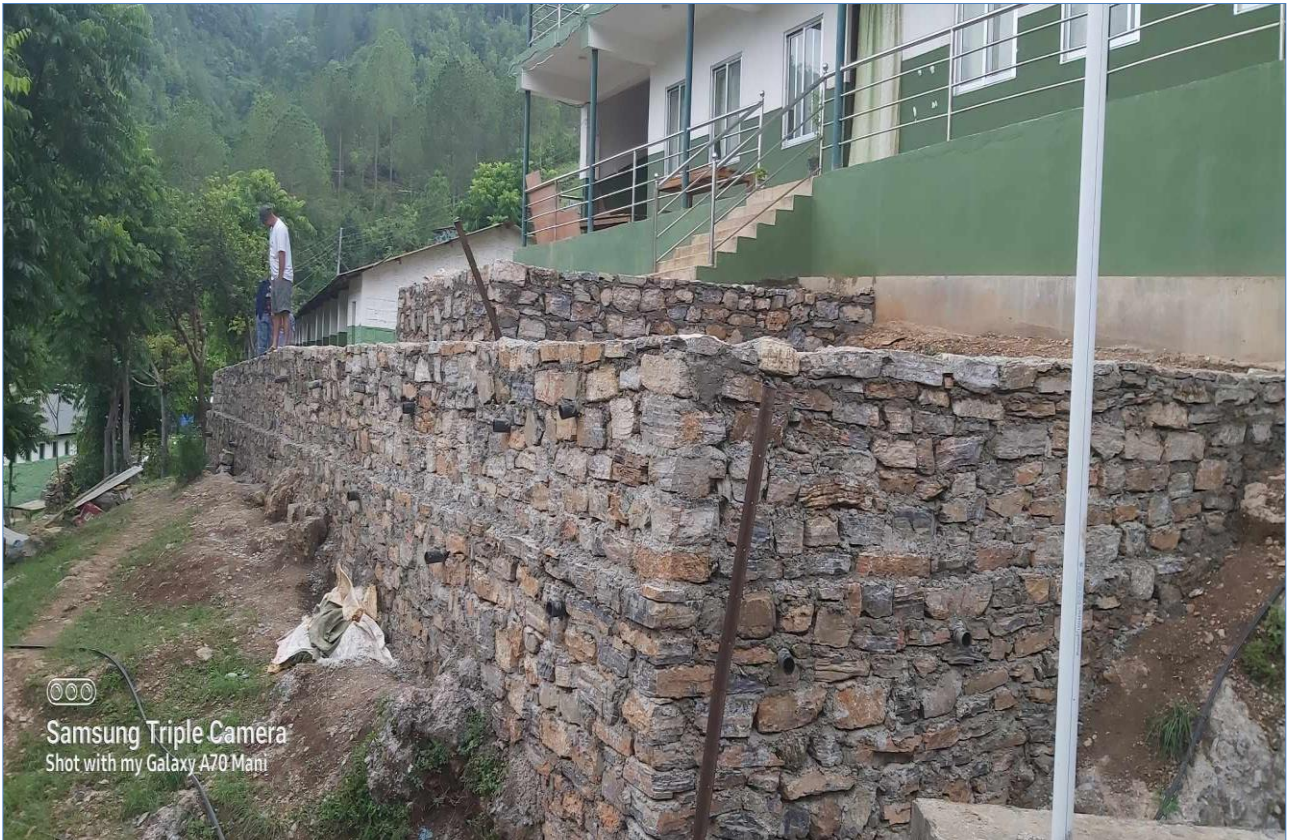
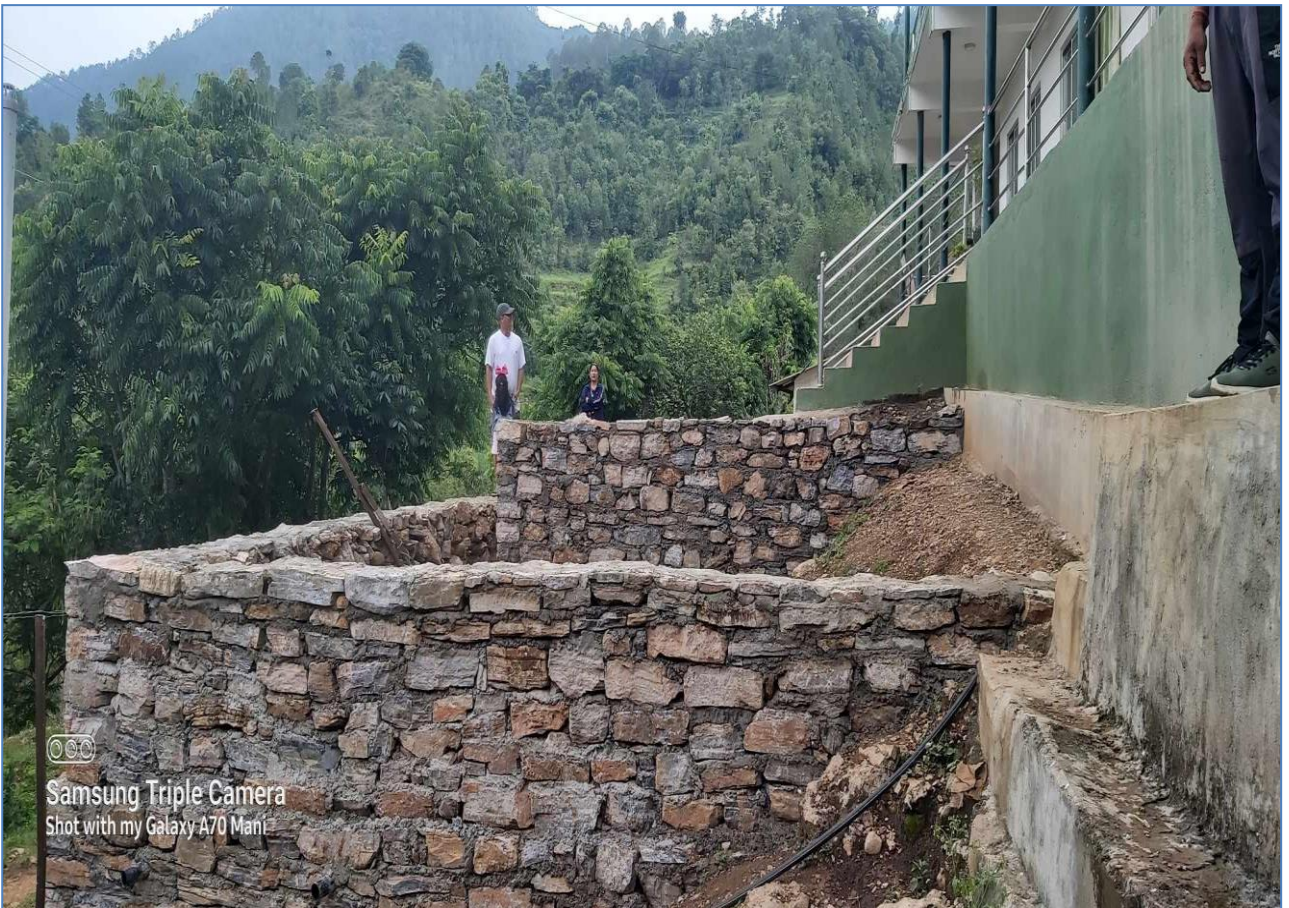
Figure 35: Barreck Landslide Treatment

1	Program: Soil Conservation Work Along Rural Road				
2	Location: District/Municipality: Rolpa/Rolpa	Ward No: 4	Place: Barreck	F/Y: 079/80	
	Coordinate:	Latitude: 28.298414		Longitude: 82.636739	
3	Existing Site Problem: The Landslide possess a risk of damage to the rural road, Army Staff Building and agricultural land				
4	Cost:				
a	Estimated	Total: 199803.64	Office: 199803.64	Users:	Others:
b	Actual Expenditure	Total: 199803.64	Office: 199803.64	Users:	Others:
5	Objectives:	a) to reduce soil erosion and mass movement from landslide b) to reduce devastating effects on the downstream and surrounding area			
6	Technique Applied:	a) Structural: Stone Masonary Retaining Wall Construction (9m*0.7m*1.95m)			
7	Implementation Process:	Co-ordination with Local Representatives and other concerned authorities; Field Visits; Survey, Design & Cost Estimation; Provide funds for the construction of Retaining Wall through quotation; Monitoring & Evaluation

8	Employment:	120 md			
9	Gender/Social Consideration:	Both men and women were equally involved; More emphasis was given to the genuine participation of disadvantaged groups			
10	Effect/Impact:	To some extent, erosion and mass movement has been reduced; Reduce the risk of damage to the rural road; Approximately 0.02 km of rural road & 0.06 ha of agricultural land has been conserved			
11	Benefitted HH:	Total: 20	Dalit: 8	Janajati: 8	Others: 4
12	Problem/Obstacles Faced:	No			
13	Maintenance/Sustainability:	5% amount of total payable amount has been deducted for the maintenance work, if some damage occurs.			
14	Lesson Learned:	If real needs of the community are to be addressed, villagers readily participate throughout the activity implementation process, thus greater achievements are possible even with small external support. The physical structures constructed should be accompanied by bio-engineering techniques to sustain the structures.
