ACTIVITY PROFILE

079/80

SOIL AND WATERSHED
MANAGEMENT OFFICE,
ROLPA

LUMBINI STATE GOVERNMENT
MINISTRY OF FORESTS AND ENVIRONMENT
SOIL AND WATERSHED MANAGEMENT OFFICE
MULPANI, ROLPA

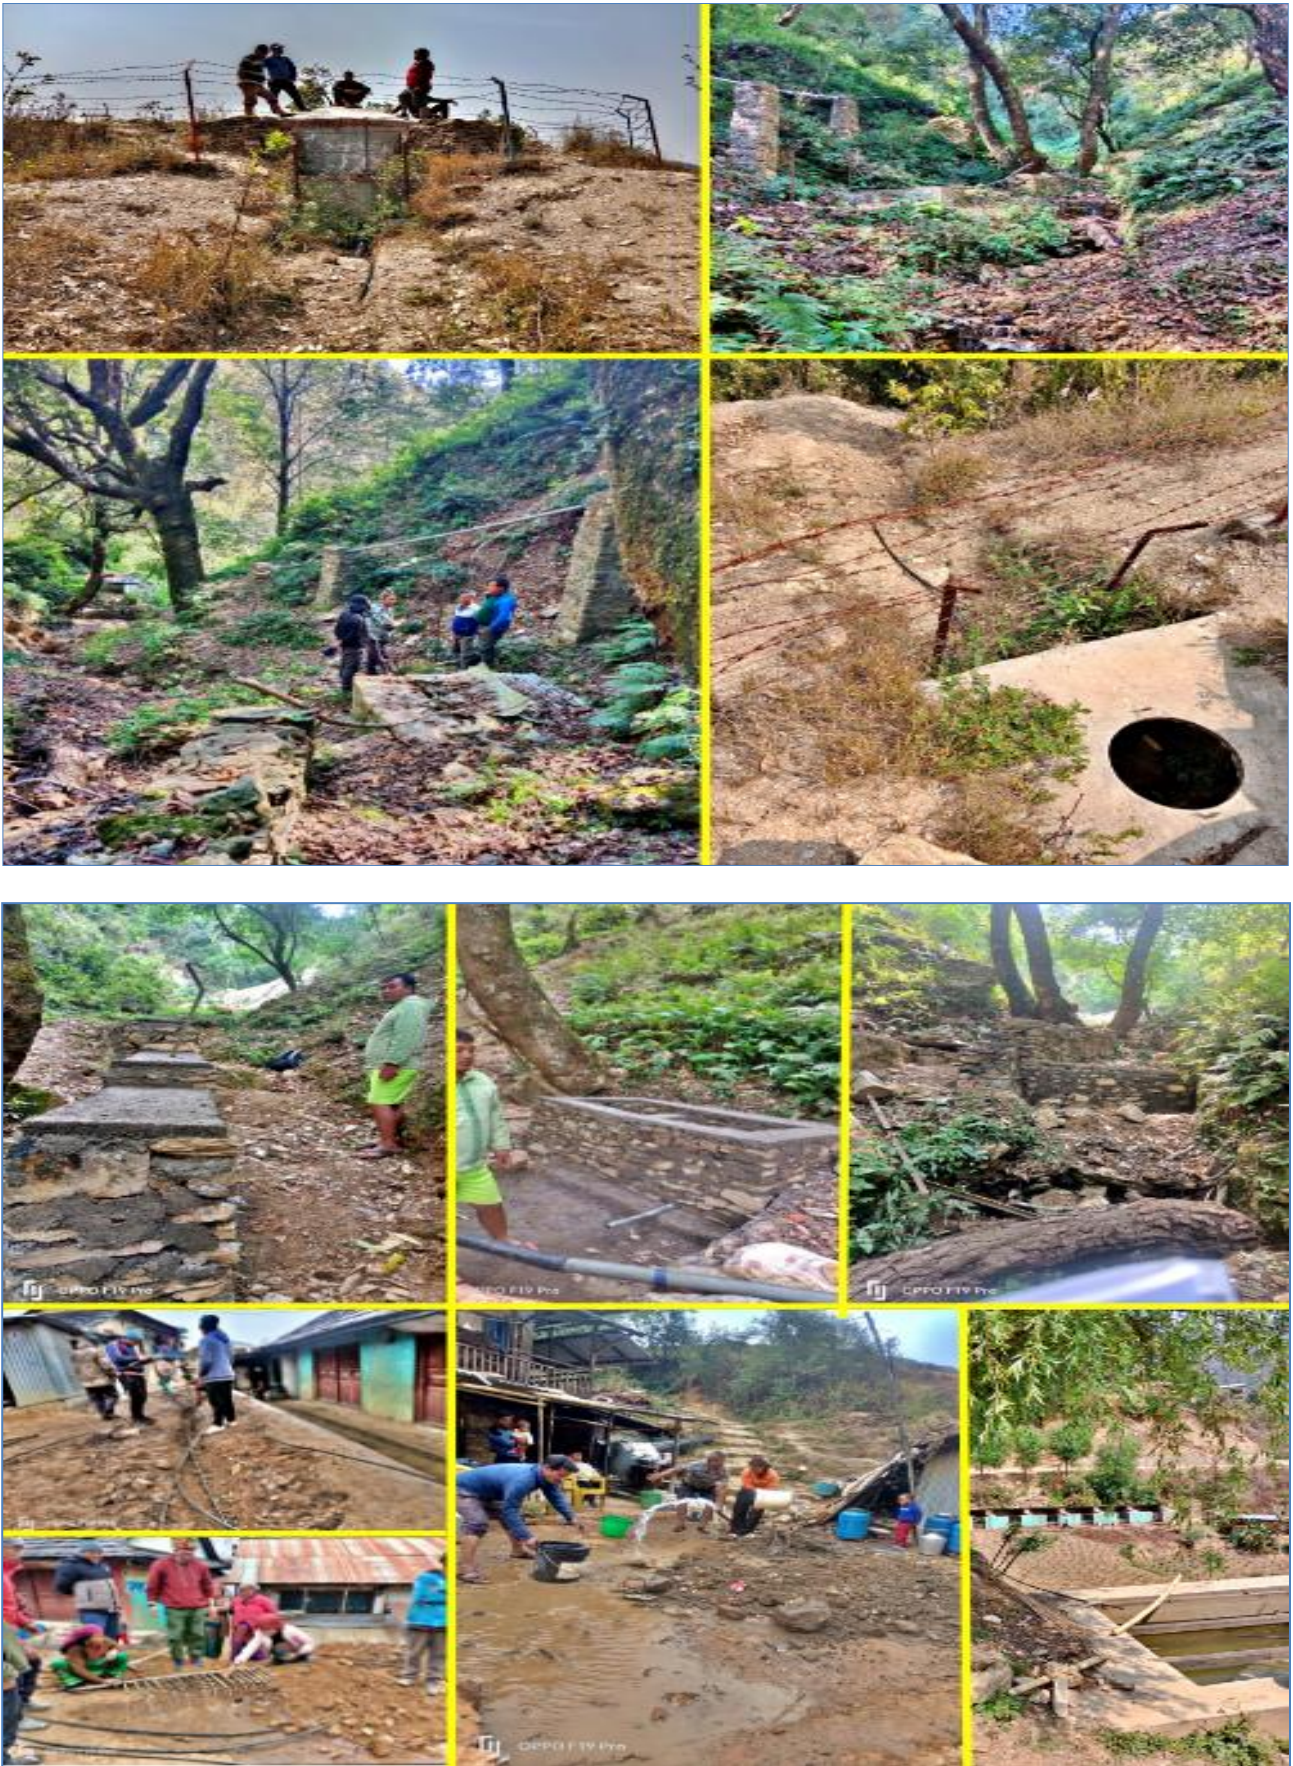
Figure 36: Darbot Water Source Protection

1	Program: Sensitive Watershed Area Protection				
2	Location: District/Municipality: Rolpa /Rolpa	Ward No: 6	Place: Darbot	F/Y: 079/80	
	Coordinate:	Latitude: 28.327471	Longitude: 82.539079		
3	Existing Site Problem: The water source was unprotected and drinking water facilities was lacking due to old pipeline;				
4	Cost:				
a	Estimated	Total: 1010786.39	Office: 833248.25	Users: 177583.13	Others:
b	Actual Expenditure	Total: 917400.65	Office: 749330.02	Users: 168070.63	Others:
5	Objectives:	a) to protect the water source, improve water quality or its regime b) to support drinking water facilities			
6	Technique Applied:	a) Structural: Intake Construction (L= 2.75m, B= 1.30m, H= 0.80m; Stone Masonry Protection Wall Construction=12.2 m long altogether; Pipeline Construction=1150m)			
7	Implementation Process:	Co-ordination with Local Representatives, User Groups and other concerned authorities; Field Visits; Survey, Design & Cost Estimation; Provide funds for the purchase of Construction Materials, Skilled Labour, Hoarding Board from Program cost; Unskilled Labour cost was contributed jointly through program cost and people participation; Monitoring & Evaluation

8	Employment:	521 md			
9	Gender/Social Consideration:	Both men and women were equally involved; More emphasis was given to the genuine participation of disadvantaged groups			
10	Effect/Impact:	Protect the water source; improved water quality Support drinking facilities for 80 households			
11	Benefitted HH:	Total: 80	Dalit: 15	Janajati: 35	Others: 30
12	Problem/Obstacles Faced:	No			
13	Maintenance/Sustainability:	5% amount of total payable amount has been deducted for the maintenance work, if some damage occurs.			
14	Lesson Learned:	If real needs of the community are to be addressed, villagers readily participate throughout the activity implementation process, thus greater achievements are possible even with small external support. The physical structures constructed should be accompanied by plantation of different tree species around thw water source			
15	Others; Name of:	User Group: Saurya Urja Khanepani Upabhokta Samiti

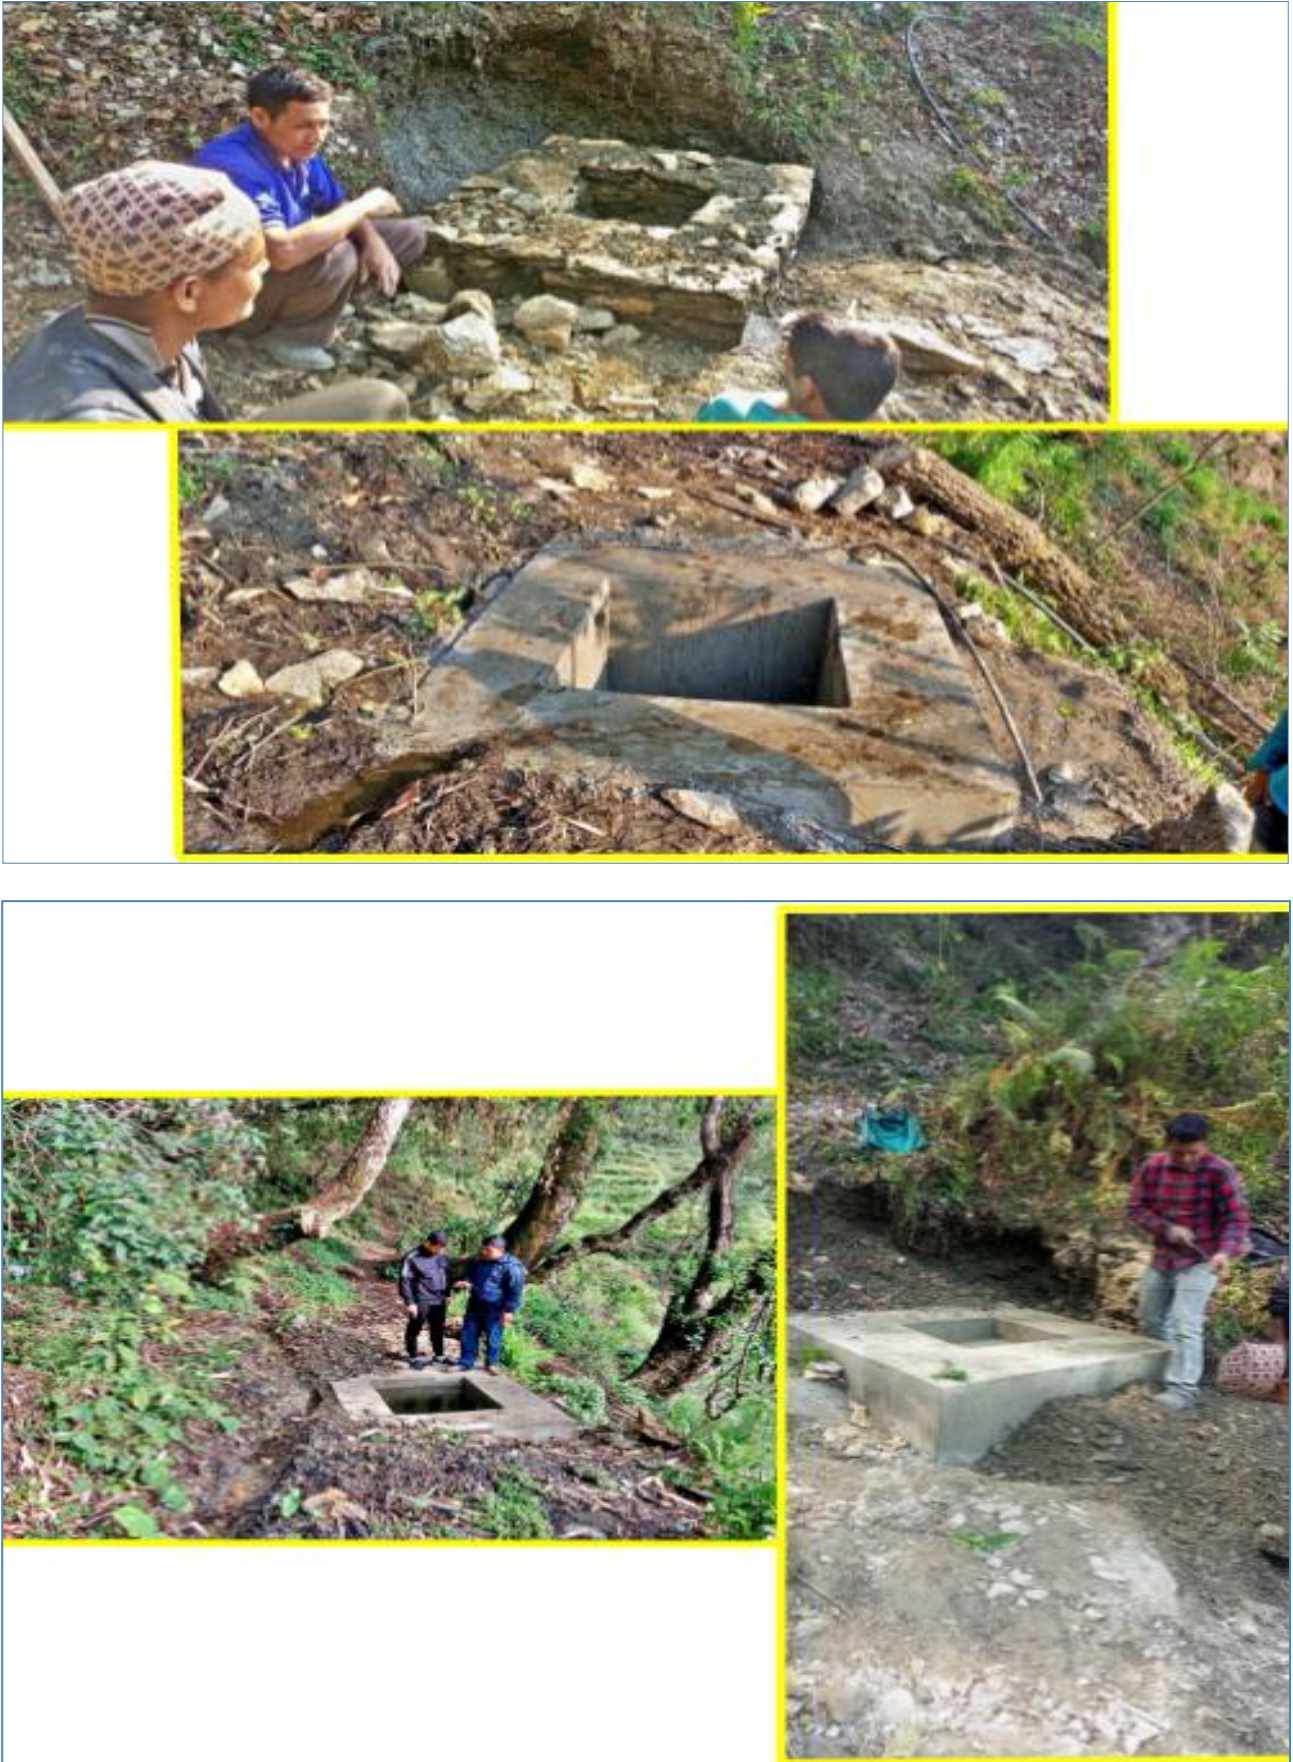
Figure 37: Bhanbhane Water Source Protection

1	Program: Sensitive Watershed Area Protection				
2	Location: District/Municipality: Rolpa /Rolpa	Ward No: 10	Place: Bhanbhane	F/Y: 079/80	
	Coordinate:	Latitude: 28.329528	Longitude: 82.673065		
3	Existing Site Problem: The water source was unprotected and lack of drinking water facilities				
4	Cost:				
a	Estimated	Total: 441525.83	Office: 268532.19	Users: 172993.64	Others:
b	Actual Expenditure	Total: 419625.44	Office: 251618.96	Users: 168006.48	Others:
5	Objectives:	a) to protect the water source, improve water quality or its regime b) to support drinking water facilities			
6	Technique Applied:	a) Structural: Intake Construction 2nos. (L= 1.6m, B= 0.80m, H= 0.95m; Pipeline Construction=2600m)			
7	Implementation Process:	Co-ordination with Local Representatives, User Groups and other concerned authorities; Field Visits; Survey, Design & Cost Estimation; Provide funds for the purchase of Construction Materials, Skilled Labour, Hoarding Board from Program cost; Unskilled Labour cost was contributed jointly through program cost and people participation; Monitoring & Evaluation

8	Employment:	175 md			
9	Gender/Social Consideration:	Both men and women were equally involved; More emphasis was given to the genuine participation of disadvantaged groups			
10	Effect/Impact:	Protect the water source; improved water quality Support drinking facilities for 40 households			
11	Benefitted HH:	Total: 40	Dalit: 2	Janajati: 4	Others: 34
12	Problem/Obstacles Faced:	No			
13	Maintenance/Sustainability:	5% amount of total payable amount has been deducted for the maintenance work, if some damage occurs.			
14	Lesson Learned:	If real needs of the community are to be addressed, villagers readily participate throughout the activity implementation process, thus greater achievements are possible even with small external support. The physical structures constructed should be accompanied by plantation of different tree species around thw water source			
15	Others; Name of:	User Group: Dhawang Khola Sanrakshan Samiti

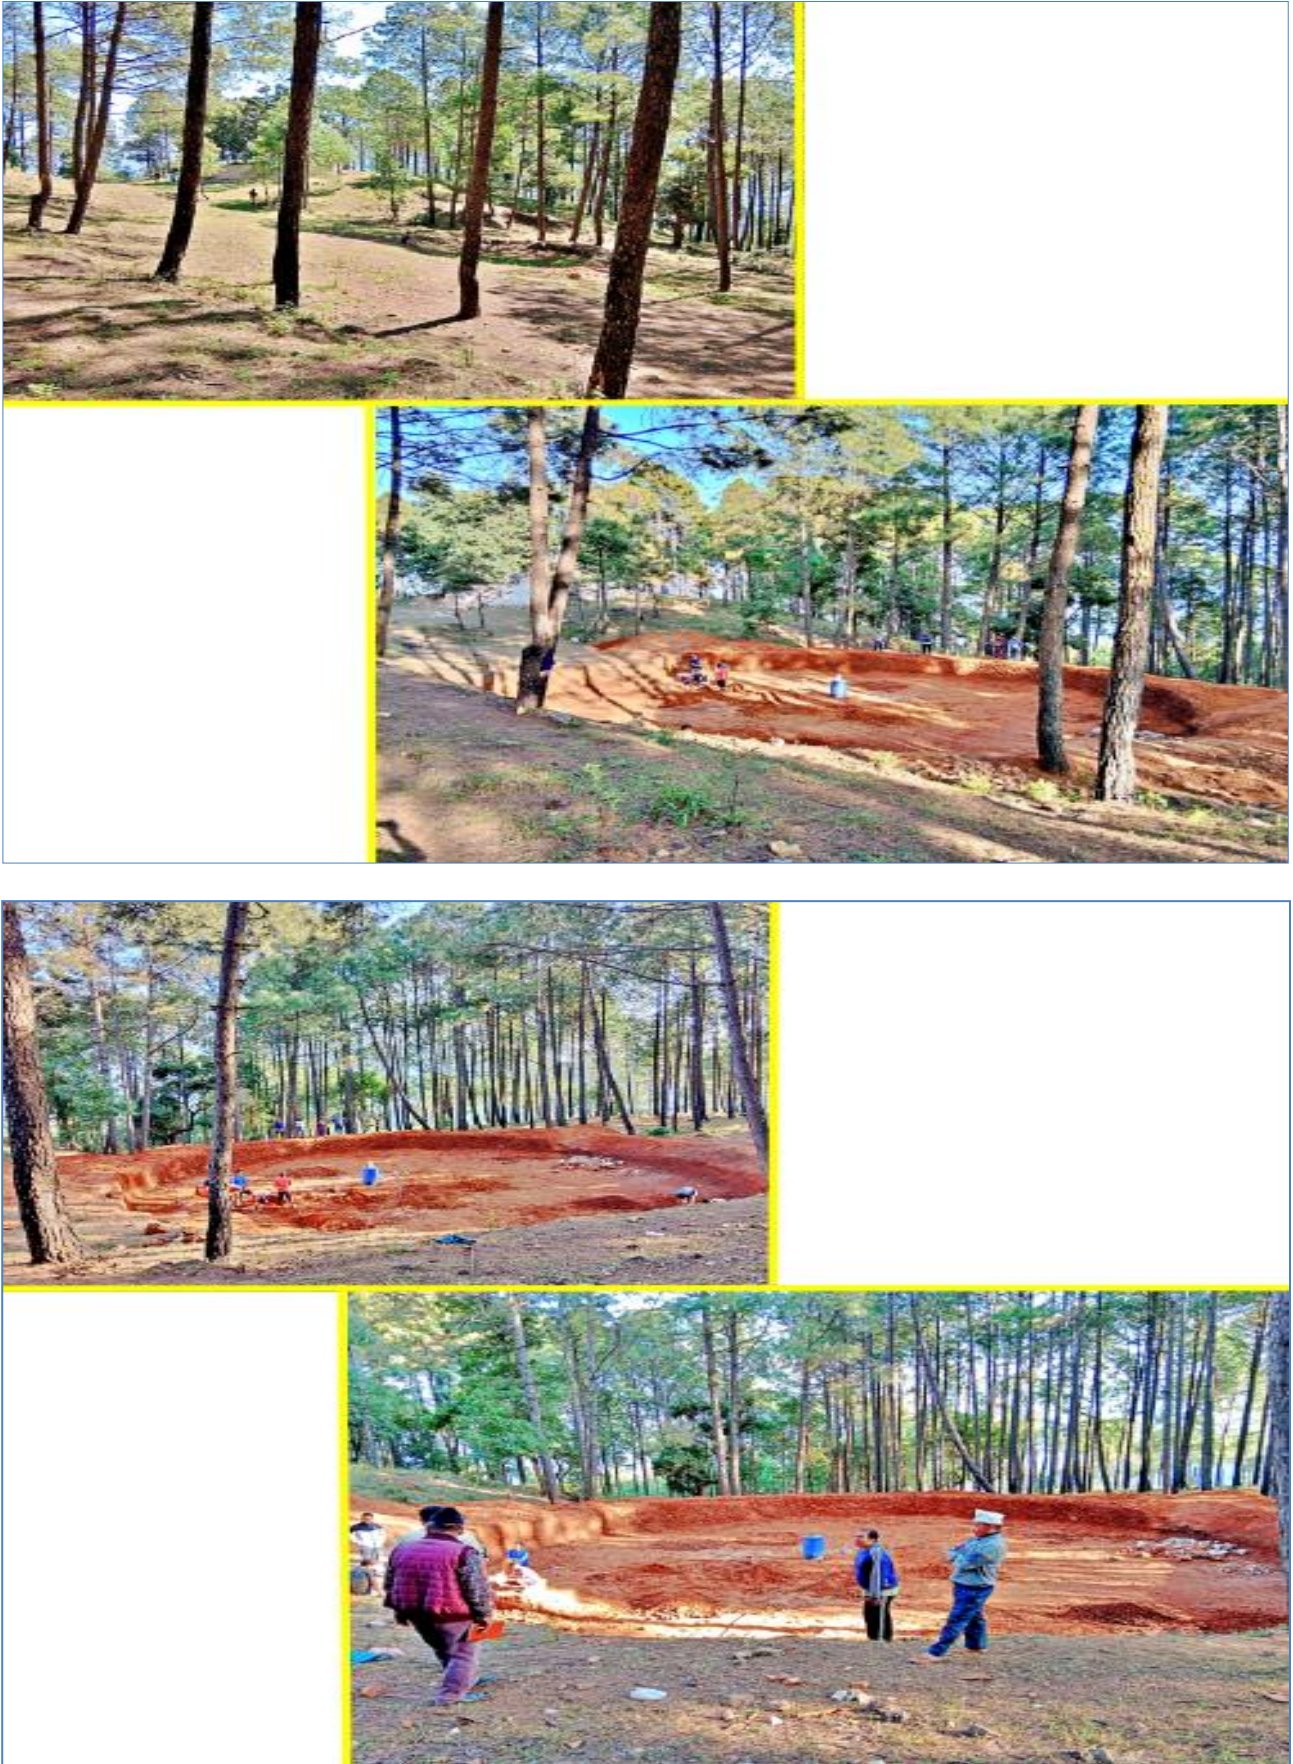
Figure 38: Mijhing Recharge Pond

1	Program: Sensitive Watershed Area Protection				
2	Location: District/Rural Municipality: Rolpa /Sunilsmriti	Ward No: 3	Place: Barhathan, Mijhing	F/Y: 079/80	
	Co-ordinates:	Latitude: 28.255404		Longitude: 82.70713	
3	Existing Site Problem: The excess runoff water flowing through its own natural channel caused erosion and landslide in the downstream area; Lack of water for irrigation, livestock and other domestic purposes				
4	Cost:				
a	Estimated	Total: 231892.69	Office: 199950.88	Users: 31941.82	Others:
b	Actual Expenditure	Total: 230830.65	Office: 198888.83	Users: 31941.82	Others:
5	Objectives:	a) to harvest the runoff water b) to control erosion and landslides on downstream area c) to use the harvested runoff water for irrigation, livestock and other domestic purposes			
6	Technique Applied:	a) Structural: Recharge Pond Construction (Dia=20m H= 1.15m; Water Holding Capacity= 314m ³)			
7	Implementation Process:	Co-ordination with Local Representatives, User Groups and other concerned authorities; Field Visits; Survey, Design & Cost Estimation; Provide funds for the construction of Earthen recharge pond, Skilled Labour, Hoarding Board from Program cost; Unskilled Labour cost was contributed jointly through program cost and people participation; Monitoring & Evaluation

8	Employment:	207 md			
9	Gender/Social Consideration:	Both men and women were equally involved; More emphasis was given to the genuine participation of disadvantaged groups			
10	Effect/Impact:	Properly harvest the runoff water; Reduce the risk of damage in downstream area Support irrigation facilities for approximately 3 ha of agricultural land			
11	Benefitted HH:	Total: 105	Dalit: 35	Janajati: 35	Others: 35
12	Problem/Obstacles Faced:	No			
13	Maintenance/Sustainability:	5% amount of total payable amount has been deducted for the maintenance work, if some damage occurs.			
14	Lesson Learned:	If real needs of the community are to be addressed, villagers readily participate throughout the activity implementation process, thus greater achievements are possible even with small external support. The physical structures constructed should be accompanied by plantation of different fruit tree species which supports for income generation.

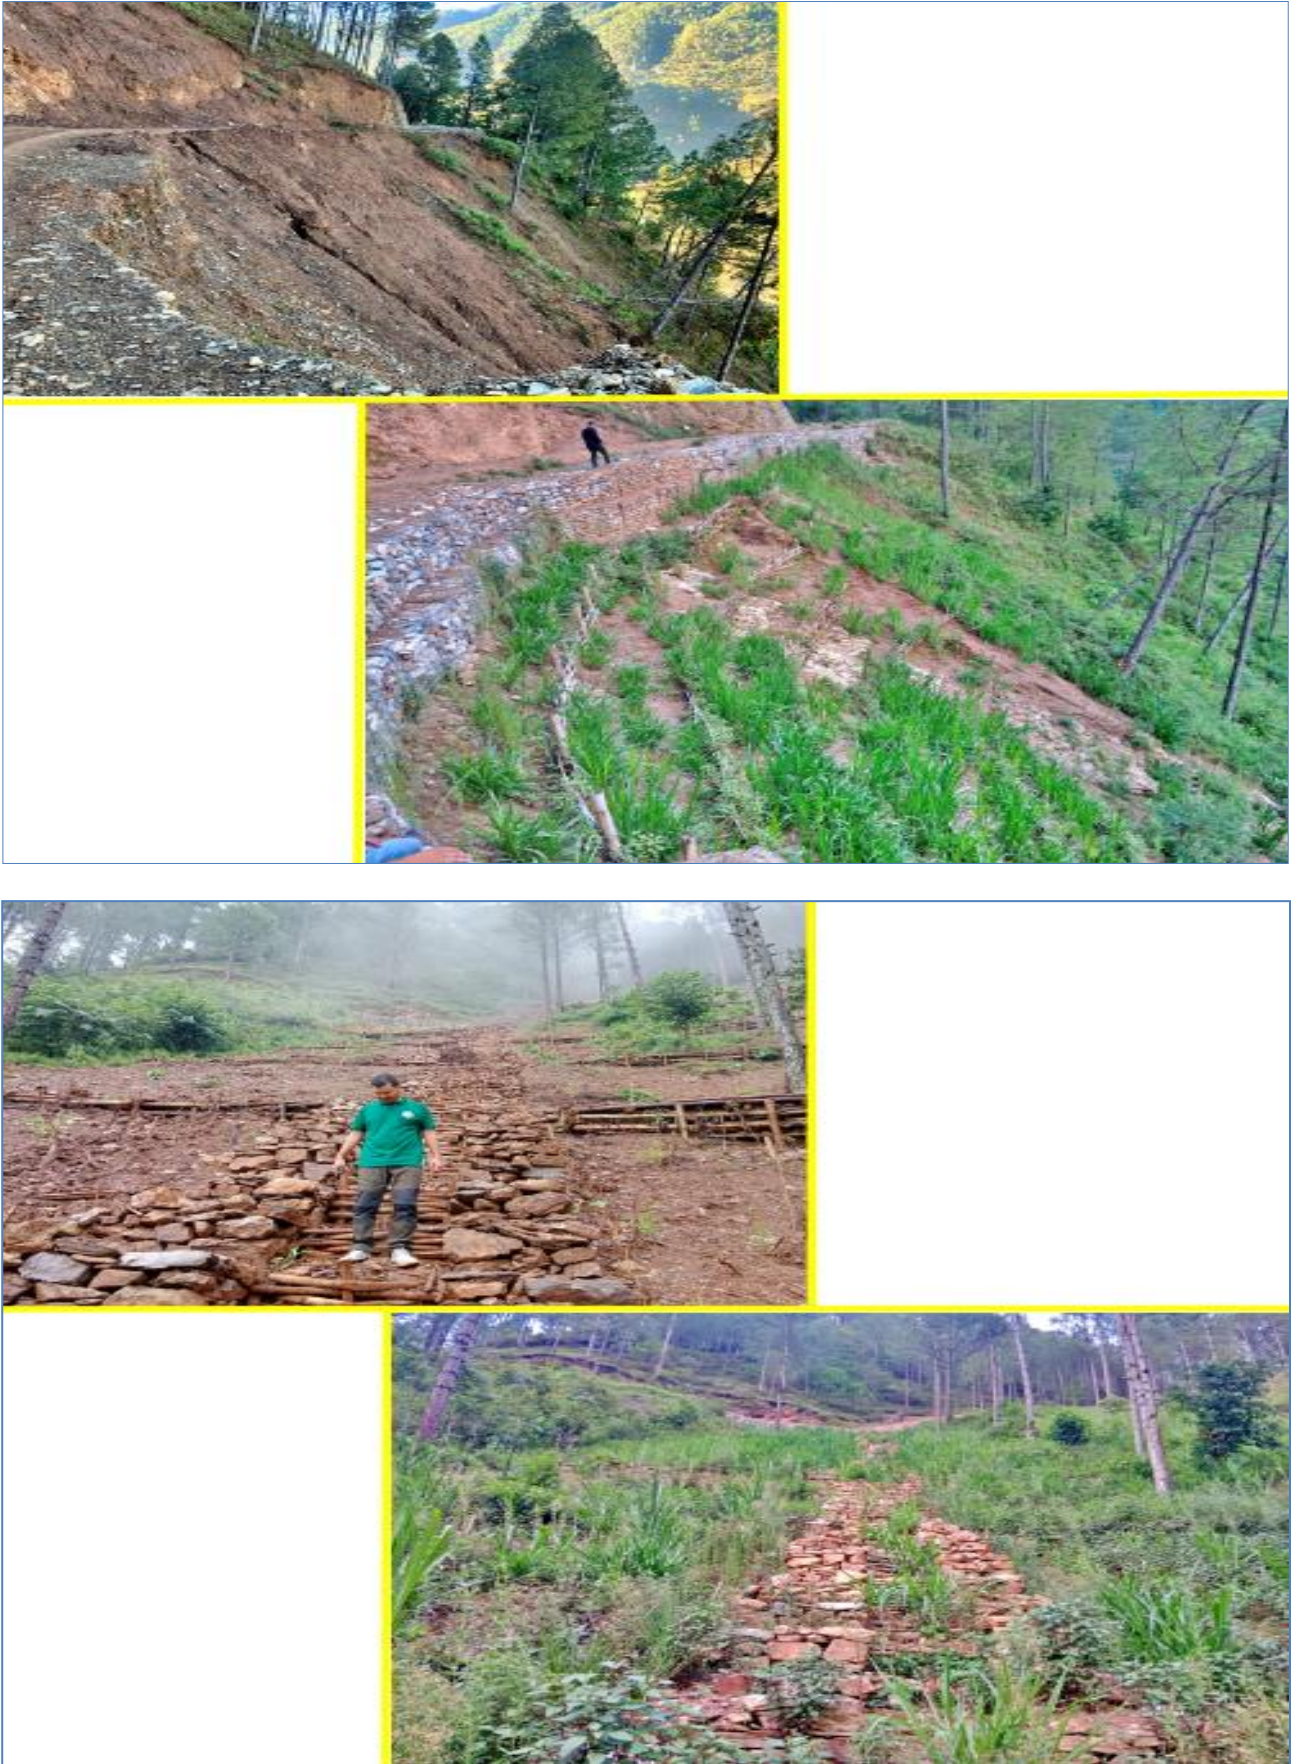
Figure 39: Bamboo Crib Wall, Fascine, Wattling Construction

1	Program: Bamboo Crib Wall Construction , Brush Layering, Fascine & Palisade Construction				
2	Location: District/Municipality: Rolpa /Rolpa	Ward No: 1,4	Place: Chhapdhunga, Runtawang	F/Y: 079/80	
	Co-ordinates:	Latitude: 28.296937, 28.297079		Longitude: 82.64675, 82.647013	
3	Existing Site Problem: The landslide possess a risk of damage to the settlement, rural road, irrigation canal and agricultural land				
4	Cost:				
a	Estimated	Total: 1338972.33	Office: 1172999.05	Users: 165973.29	Others:
b	Actual Expenditure	Total: 1141410.74	Office: 999024.08	Users: 142386.66	Others:
5	Objectives:	a) to <i>reduce soil erosion, mass movement & river bank cutting</i> b) to <i>reduce devastating effects on the downstream and surrounding area</i>			
6	Technique Applied:	a) Structural: Bamboo Crib Wall, Bamboo Wattling, Jute Netting, Brush Layering, PalisadeConstruction Amriso, Smart Napier, Vetiver, Bamboo & Nigalo Plantation

7	Implementation Process:	Co-ordination with Local Representatives, User Groups and other concerned authorities; Field Visits; Survey, Design & Cost Estimation; Provide funds for the purchase of Bamboo Poles, various seedings, Skilled Labour, Hoarding Board from Program cost; Unskilled Labour cost was contributed jointly through program cost and people participation; Monitoring & Evaluation			
8	Employment:	613 md			
9	Gender/Social Consideration:	Both men and women were equally involved; More emphasis was given to the genuine participation of disadvantaged groups			
10	Effect/Impact:	To some extent, erosion and mass movement has been reduced; Reduce the risk of damage to the settlement, rural road & irrigation canal; Approximately 0.7 ha of agricultural land has been conserved			
11	Benefitted HH:	Total: 40	Dalit: 12	Janajati: 20	Others: 8
12	Problem/Obstacles Faced:	No			
13	Maintenance/Sustainability:	5% amount of total payable amount has been deducted for the maintenance work, if some damage occurs.

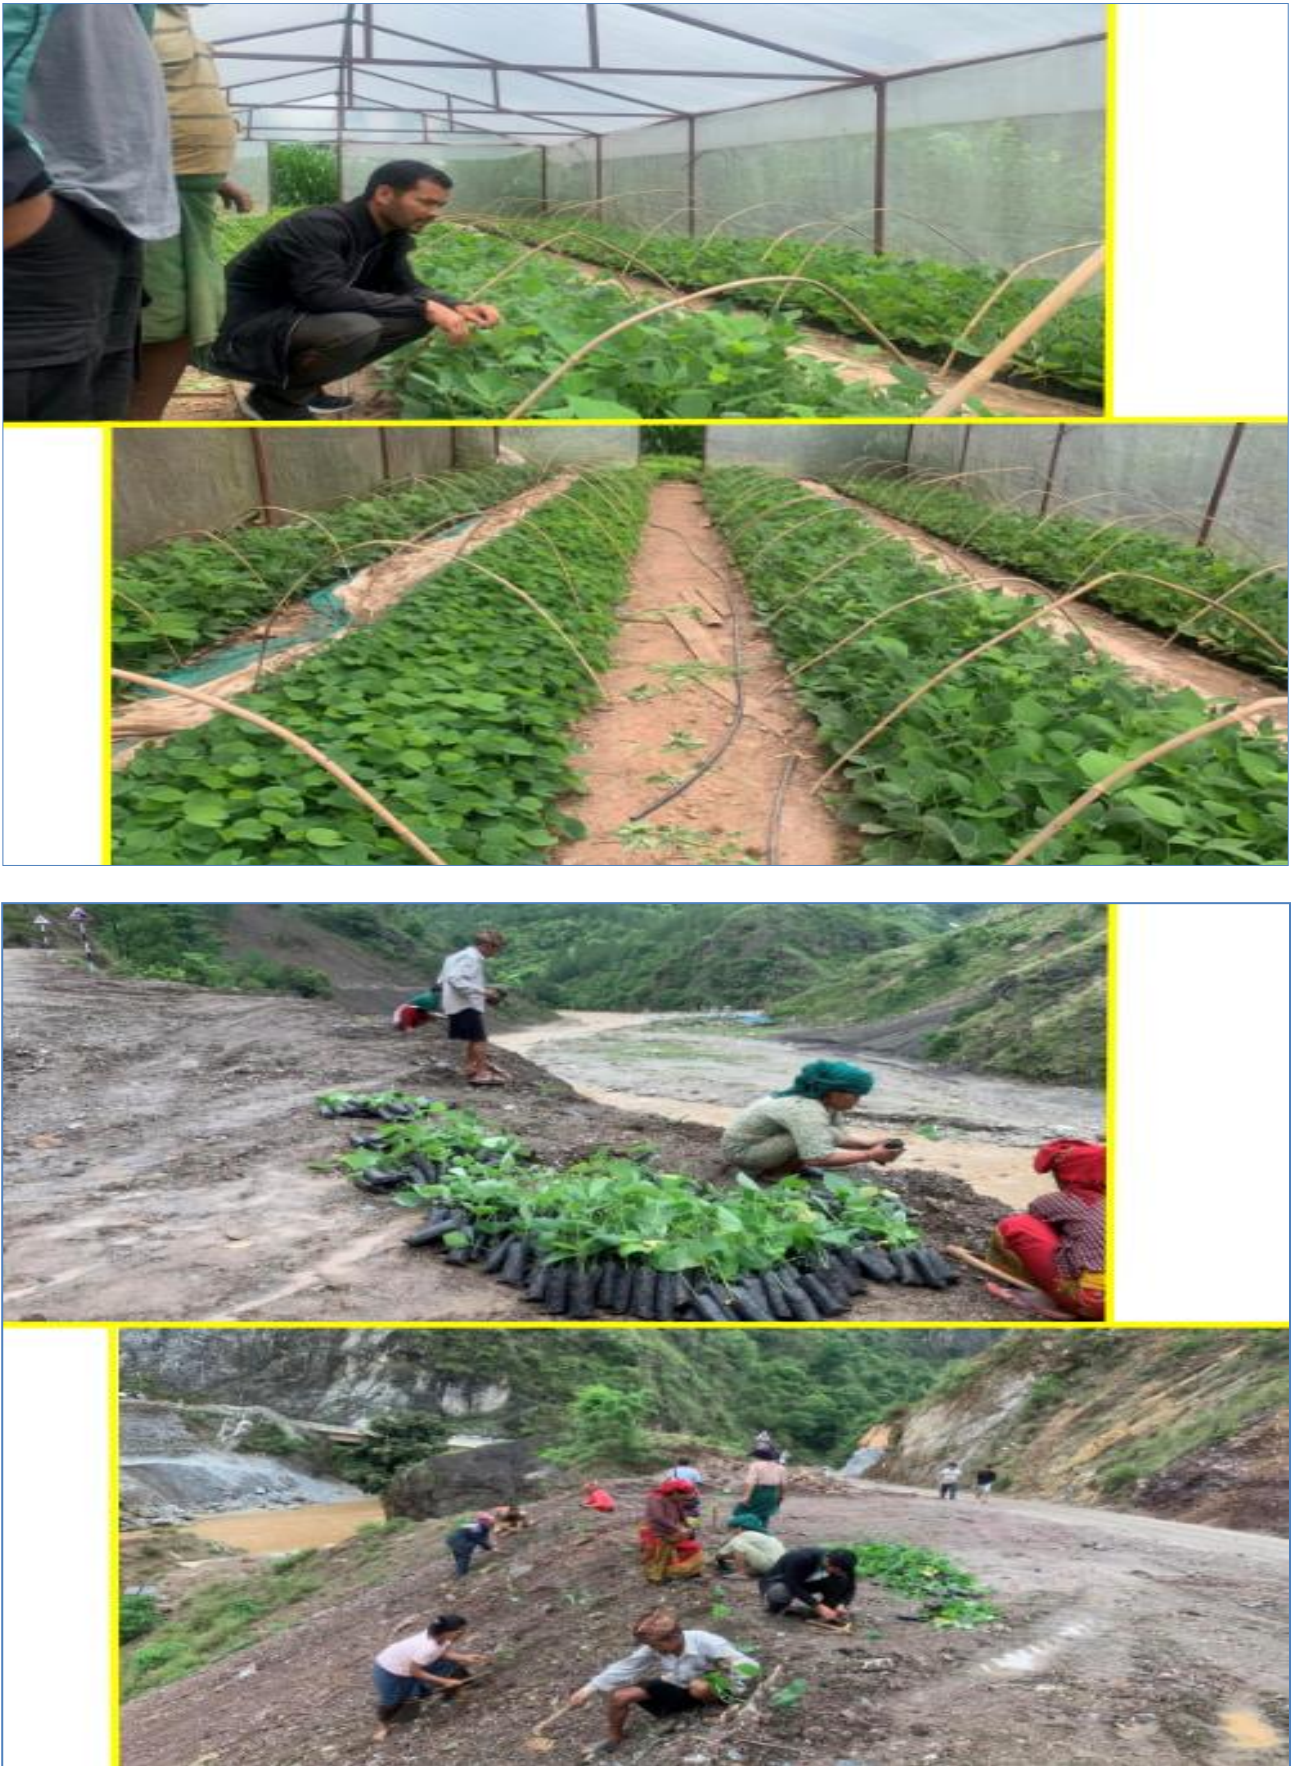
Figure 40: Seedling Production

1	Program: Seedling Production (Fodder/Bioengineering Species)				
2	Location: District/Municipality: Rolpa /Rolpa	Ward No: 1	Place: Mewang	F/Y: 079/80	
	Co-ordinates:	Latitude: 28.294506		Longitude: 82.643422	
3	Existing Site Problem: There is a need for the production of different bio-engineering tree, shrub or grass species to treat the various natural hazards prevalent in the working area of SWM, Rolpa; Also there was a demand for the fodder tree species				
4	Cost:				
a	Estimated	Total: 302772.44	Office: 302772.44	Users:	Others:
b	Actual Expenditure	Total: 296490.00	Office: 296490.00	Users:	Others:
5	Objectives:	a) to produce different types of bio-engineering r fodder species b) to distribute the produced species for the treatment of varius natural hazards prevalent in the working area			
6	Technique Applied:	a) Vegetative: Bhujetro seedling production (12550 nos.), Bamboo Culm Cutting Production (150 nos.), Tanki seeding production (4000 nos.)

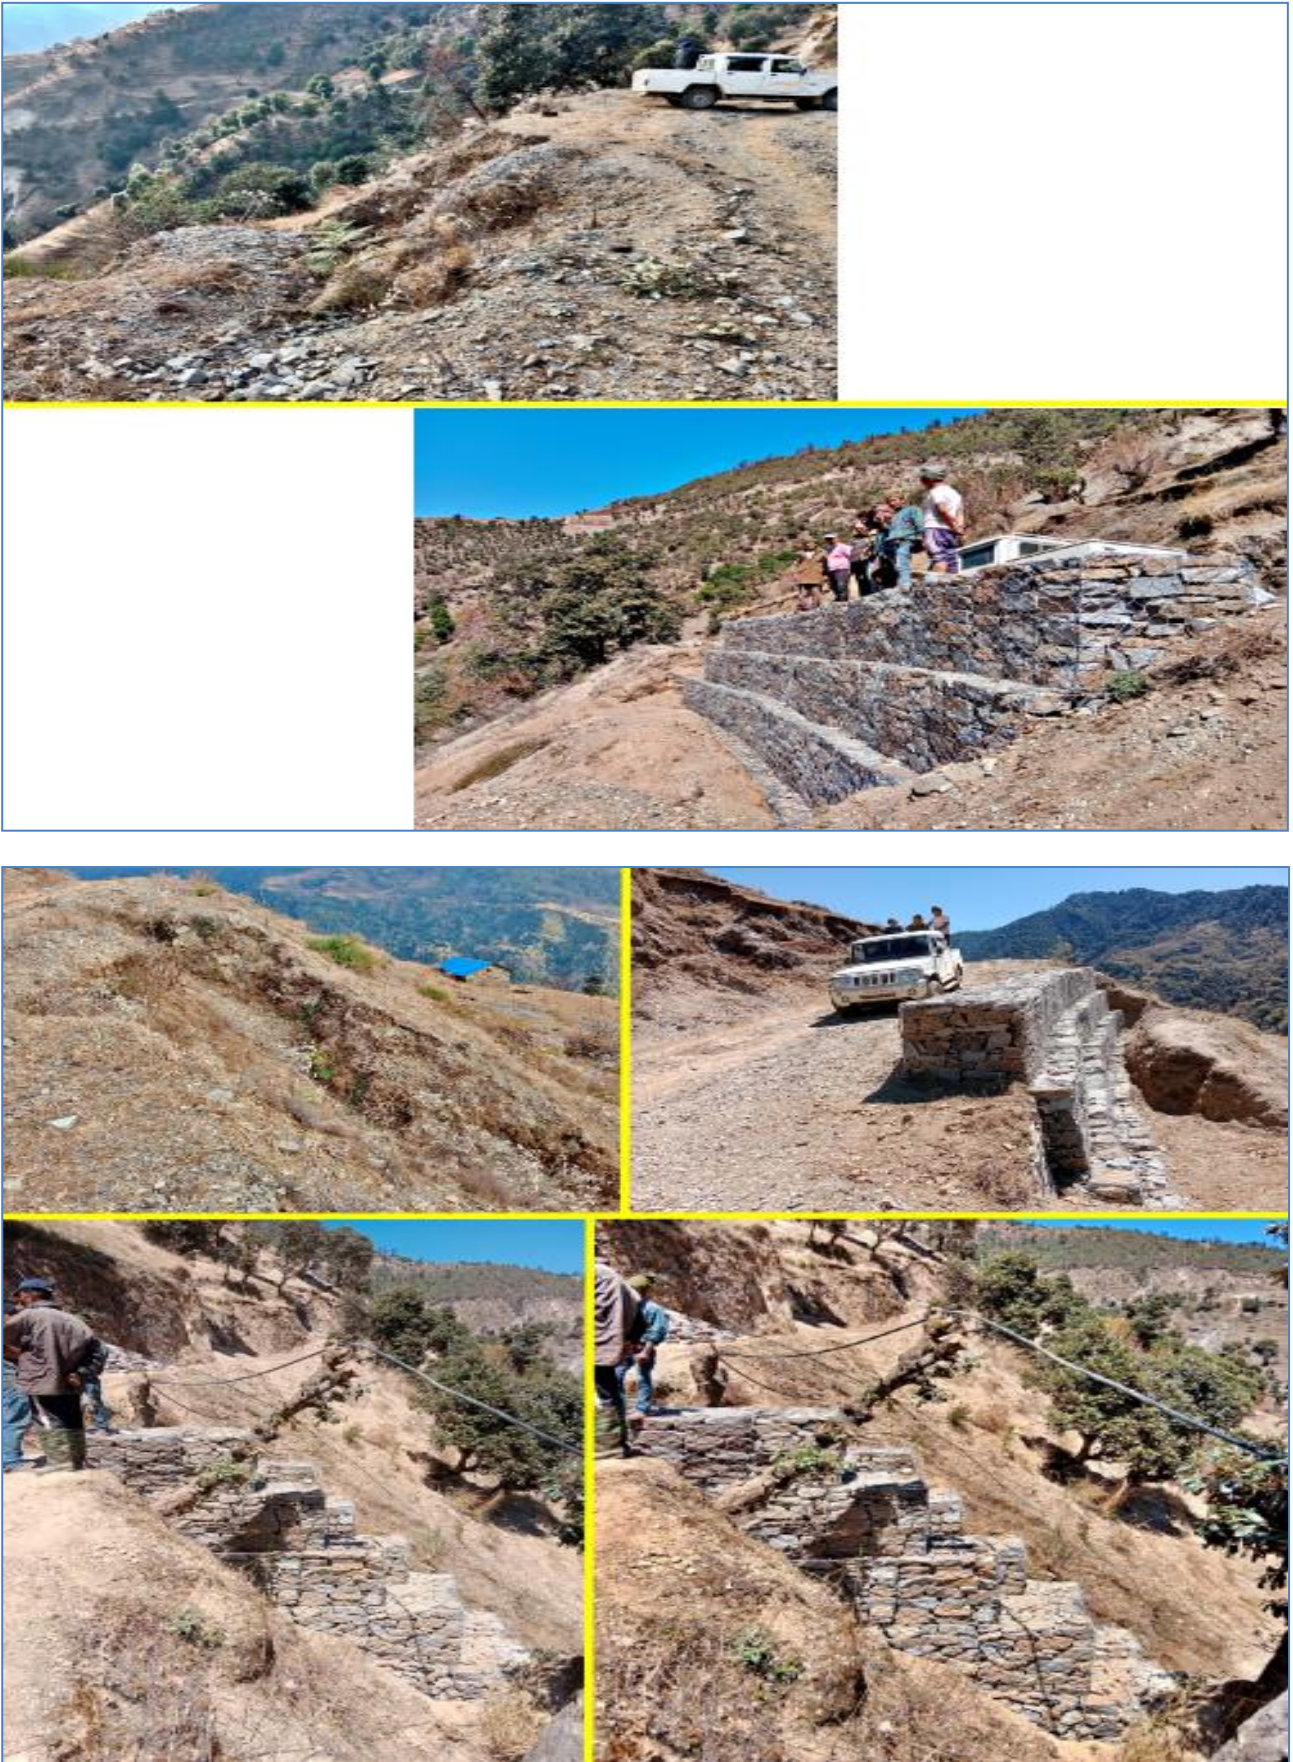
Figure 416: Gunam Gully & Landslide Treatment

1	Program: Gully, Landslide and Torrent Control				
2	Location: District/Rural Municipality: Rukum East/Bhume	Ward No: 7	Place: Gunaam	F/Y: 079/80	
	Coordinate:	Latitude: 28.524993	Longitude: 82.713034		
3	Existing Site Problem: The landslide & gully formation possess a risk of damage to the nearby settlement , rural road and agricultural land				
4	Cost:				
a	Estimated	Total: 889719.45	Office: 799991.75	Users: 89727.70	Others:
b	Actual Expenditure	Total: 889719.45	Office: 799991.75	Users: 89727.70	Others:
5	Objectives:	a) to reduce soil erosion and mass movement from landslide & gully b) to reduce devastating effects on the downstream and surrounding area			
6	Technique Applied:	a) Structural: Gabion Retaining Wall & Check-dam Construction (Gabion Box 66 Nos; Box size 2m*1m*1m=54 Nos., Box size 1.5m*1m*1m=12 Nos. were used to construct 12m long, 3m high Gabion Retaining Wall & 10 nos. of check-dam)

7	Implementation Process:	Co-ordination with Local Representatives, User Groups and other concerned authorities; Field Visits; Survey, Design & Cost Estimation; Provide funds for the purchase of Gabion Boxes, Skilled Labour cost, Hoarding Board from Program cost; Unskilled Labour cost was contributed jointly through program cost and people participation; Monitoring & Evaluation			
8	Employment:	517 md			
9	Gender/Social Consideration:	Both men and women were equally involved; More emphasis was given to the genuine participation of disadvantaged groups			
10	Effect/Impact:	To some extent, erosion and mass movement has been reduced; Reduce the risk of damage to the settlement and rural road; Approximately 0.3 ha of agricultural land has been conserved			
11	Benefitted HH:	Total: 50	Dalit: 5	Janajati: 45	Others:
12	Problem/Obstacles Faced:	No			
13	Maintenance/Sustainability:	5% amount of total payable amount has been deducted for the maintenance work, if some damage occurs.

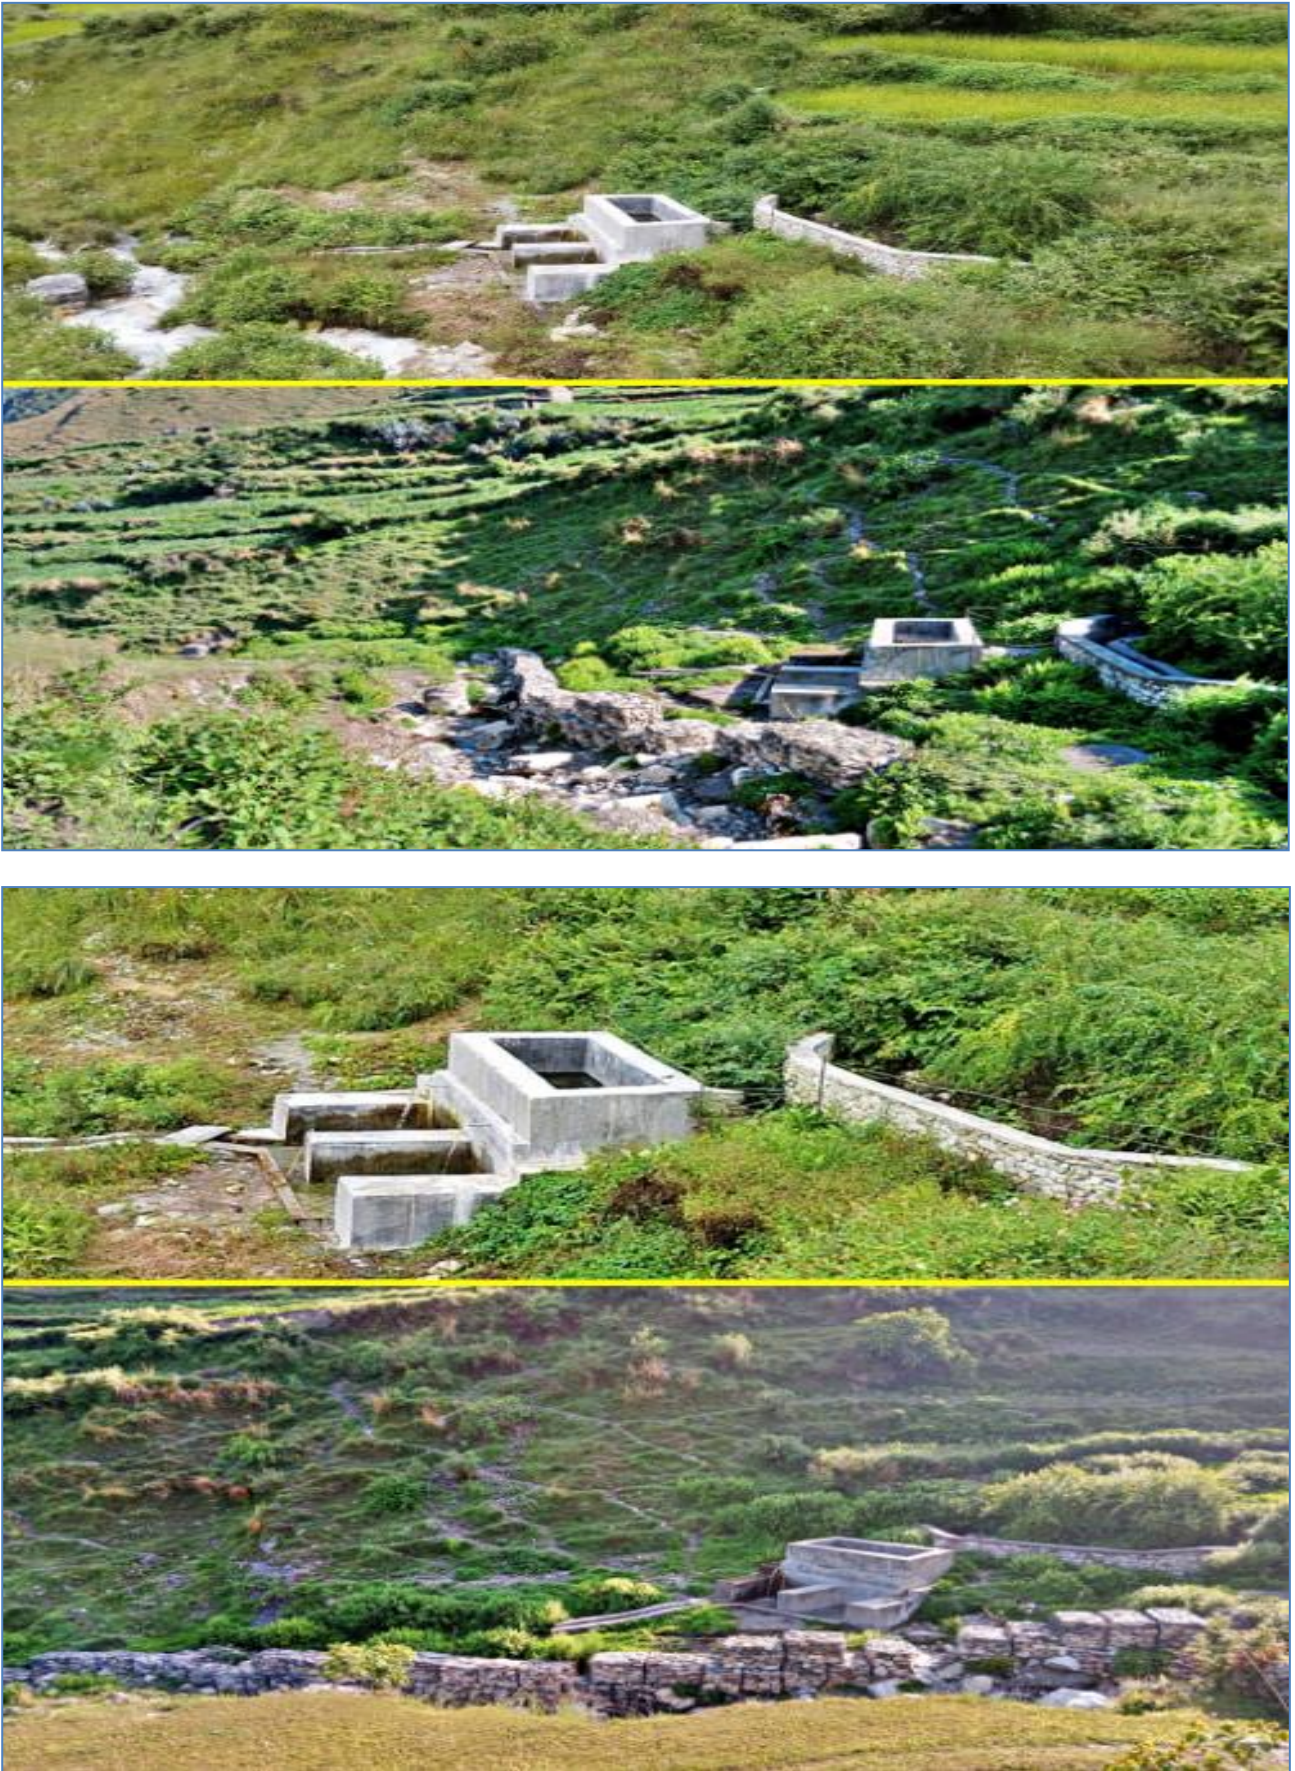
Figure 42: Maikot Torrent Control

1	Program: Gully, Landslide and Torrent Control				
2	Location: District/Rural Municipality: Rukum East/Putha Uttarganga	Ward No: 1	Place: Maikot	F/Y: 079/80	
	Coordinate:	Latitude: 28.6804038	Longitude: 82.8832100		
3	Existing Site Problem: The torrent possess a risk of damage to the water source, water tank-tap and agricultural land				
4	Cost:				
a	Estimated	Total: 910535.77	Office: 799959.68	Users: 110576.09	Others:
b	Actual Expenditure	Total: 897451.72	Office: 788756.15	Users: 108695.96	Others:
5	Objectives:	a) to reduce erosion & torrent bank cutting b) to reduce devastating effects on the downstream and surrounding area			
6	Technique Applied:	a) Structural: Gabion Embankment Construction (Gabion Box 50 Nos; Box size 1.5m*1m*1m=50 Nos.) were used to construct 30m long Embankment)			
7	Implementation Process:	Co-ordination with Local Representatives, User Groups and other concerned authorities; Field Visits; Survey, Design & Cost Estimation; Provide funds for the purchase of Gabion Boxes, Skilled Labour, Hoarding Board from Program cost; Unskilled Labour cost was contributed jointly through program cost and people participation; Monitoring & Evaluation

8	Employment:	408 md			
9	Gender/Social Consideration:	Both men and women were equally involved; More emphasis was given to the genuine participation of disadvantaged groups			
10	Effect/Impact:	To some extent, erosion and torrent bank cutting has been controlled; Reduce the risk of damage to the water source, water tank & tap; Approximately 0.3 ha of agricultural land has been conserved			
11	Benefitted HH:	Total: 70	Dalit: 20	Janajati: 30	Others: 20
12	Problem/Obstacles Faced:	Transportational difficulties; one of the remote area of Lumbini province			
13	Maintenance/Sustainability:	5% amount of total payable amount has been deducted for the maintenance work, if some damage occurs.			
14	Lesson Learned:	If real needs of the community are to be addressed, villagers readily participate throughout the activity implementation process, thus greater achievements are possible even with small external support. The physical structures constructed should be accompanied by bio-engineering techniques to sustain the structures.

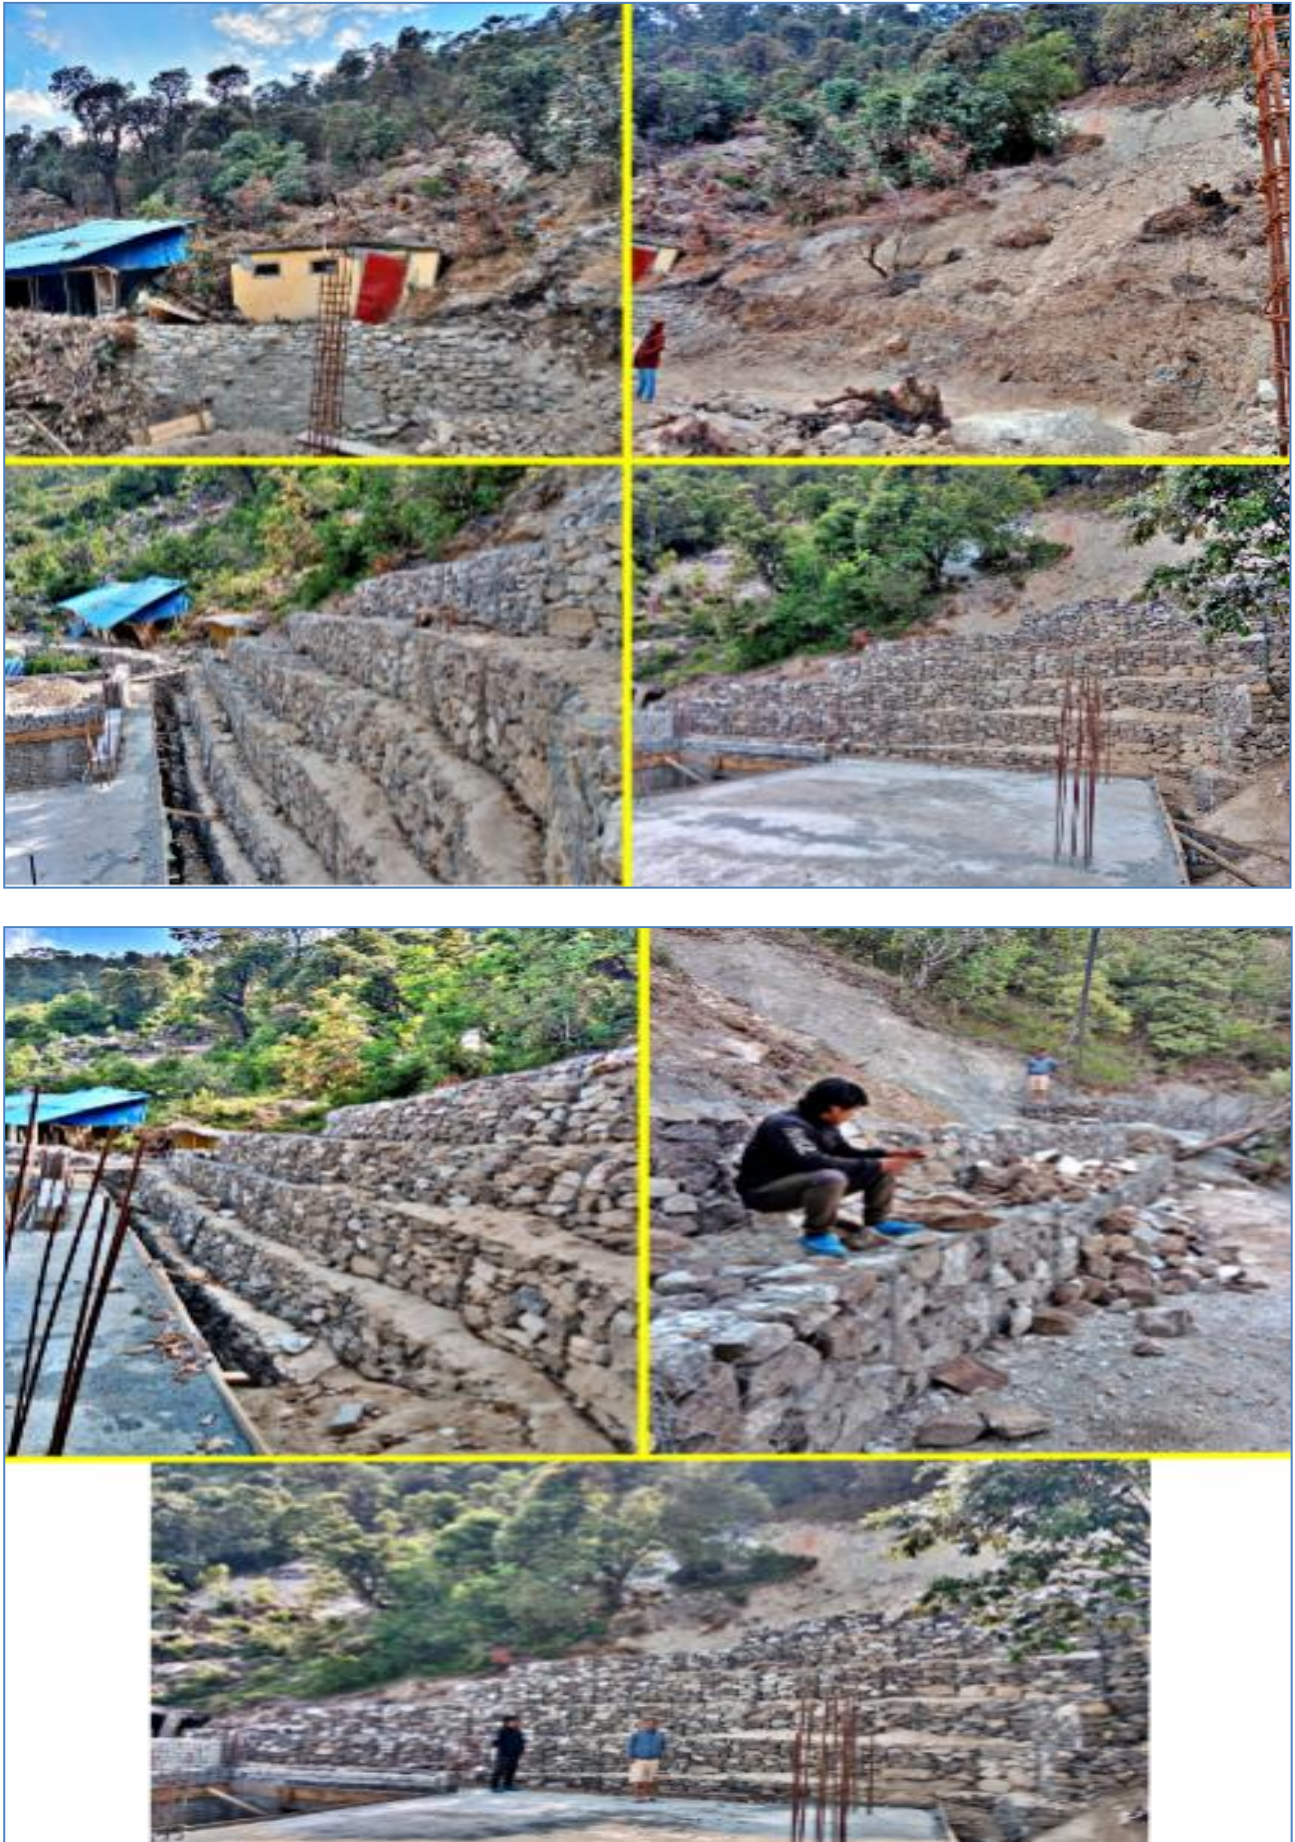
Figure 43: Kharawang Landslide Treatment

1	Program: Emergency Landslide Treatment				
2	Location: District/Rural Municipality: Rukum East/Putha Uttarganga	Ward No: 9	Place: Kharawang	F/Y: 079/80	
	Coordinate:	Latitude: 28.677257	Longitude: 82.791797		
3	Existing Site Problem: The Landslide cause damage to the school building & possess a risk of damage to the settlement and agricultural land				
4	Cost:				
a	Estimated	Total: 2053471.81	Office: 1300092.56	Users: 253379.25	Others: 500000
b	Actual Expenditure	Total: 2023901.89	Office: 1283208.35	Users: 240693.54	Others: 500000
5	Objectives:	a) to prevent erosion and mass movement from landslide b) to reduce devastating effects on the downstream and surrounding area			
6	Technique Applied:	a) Structural: Gabion Wall Construction (Gabion Box 180 Nos; Box size 2m*1m*1m=100 Nos.; Box size 1.5m*1m*1m=80Nos.; were used to construct 24m long * 6m high Gabion wall plus 16m long Gabion wall)			
7	Implementation Process:	Co-ordination with Local Representatives, User Groups and other concerned authorities; Field Visits; Survey, Design & Cost Estimation; Provide funds for the purchase of Gabion Boxes, Skilled Labour cost, Hoarding Board from Program cost; Unskilled Labour cost was contributed jointly through program cost and people participation; Monitoring & Evaluation

8	Employment:	1554 md			
9	Gender/Social Consideration:	Both men and women were equally involved; More emphasis was given to the genuine participation of disadvantaged groups			
10	Effect/Impact:	To some extent, erosion & mass movement has been controlled; Reduce the risk of damage to the school building; Approximately 0.5 ha of school area & 0.8 ha of agricultural land has been conserved			
11	Benefitted HH:	Total: 250	Dalit: 120	Janajati: 110	Others: 20
12	Problem/Obstacles Faced:	Transportational difficulties; one of the remote area of Lumbini province			
13	Maintenance/Sustainability:	5% amount of total payable amount has been deducted for the maintenance work, if some damage occurs.			
14	Lesson Learned:	If real needs of the community are to be addressed, villagers readily participate throughout the activity implementation process, thus greater achievements are possible even with small external support. The physical structures constructed should be accompanied by bio-engineering techniques to sustain the structures.
