ACTIVITY PROFILE

079/80

SOIL AND WATERSHED
MANAGEMENT OFFICE,
ROLPA

LUMBINI STATE GOVERNMENT
MINISTRY OF FORESTS AND ENVIRONMENT
SOIL AND WATERSHED MANAGEMENT OFFICE
MULPANI, ROLPA

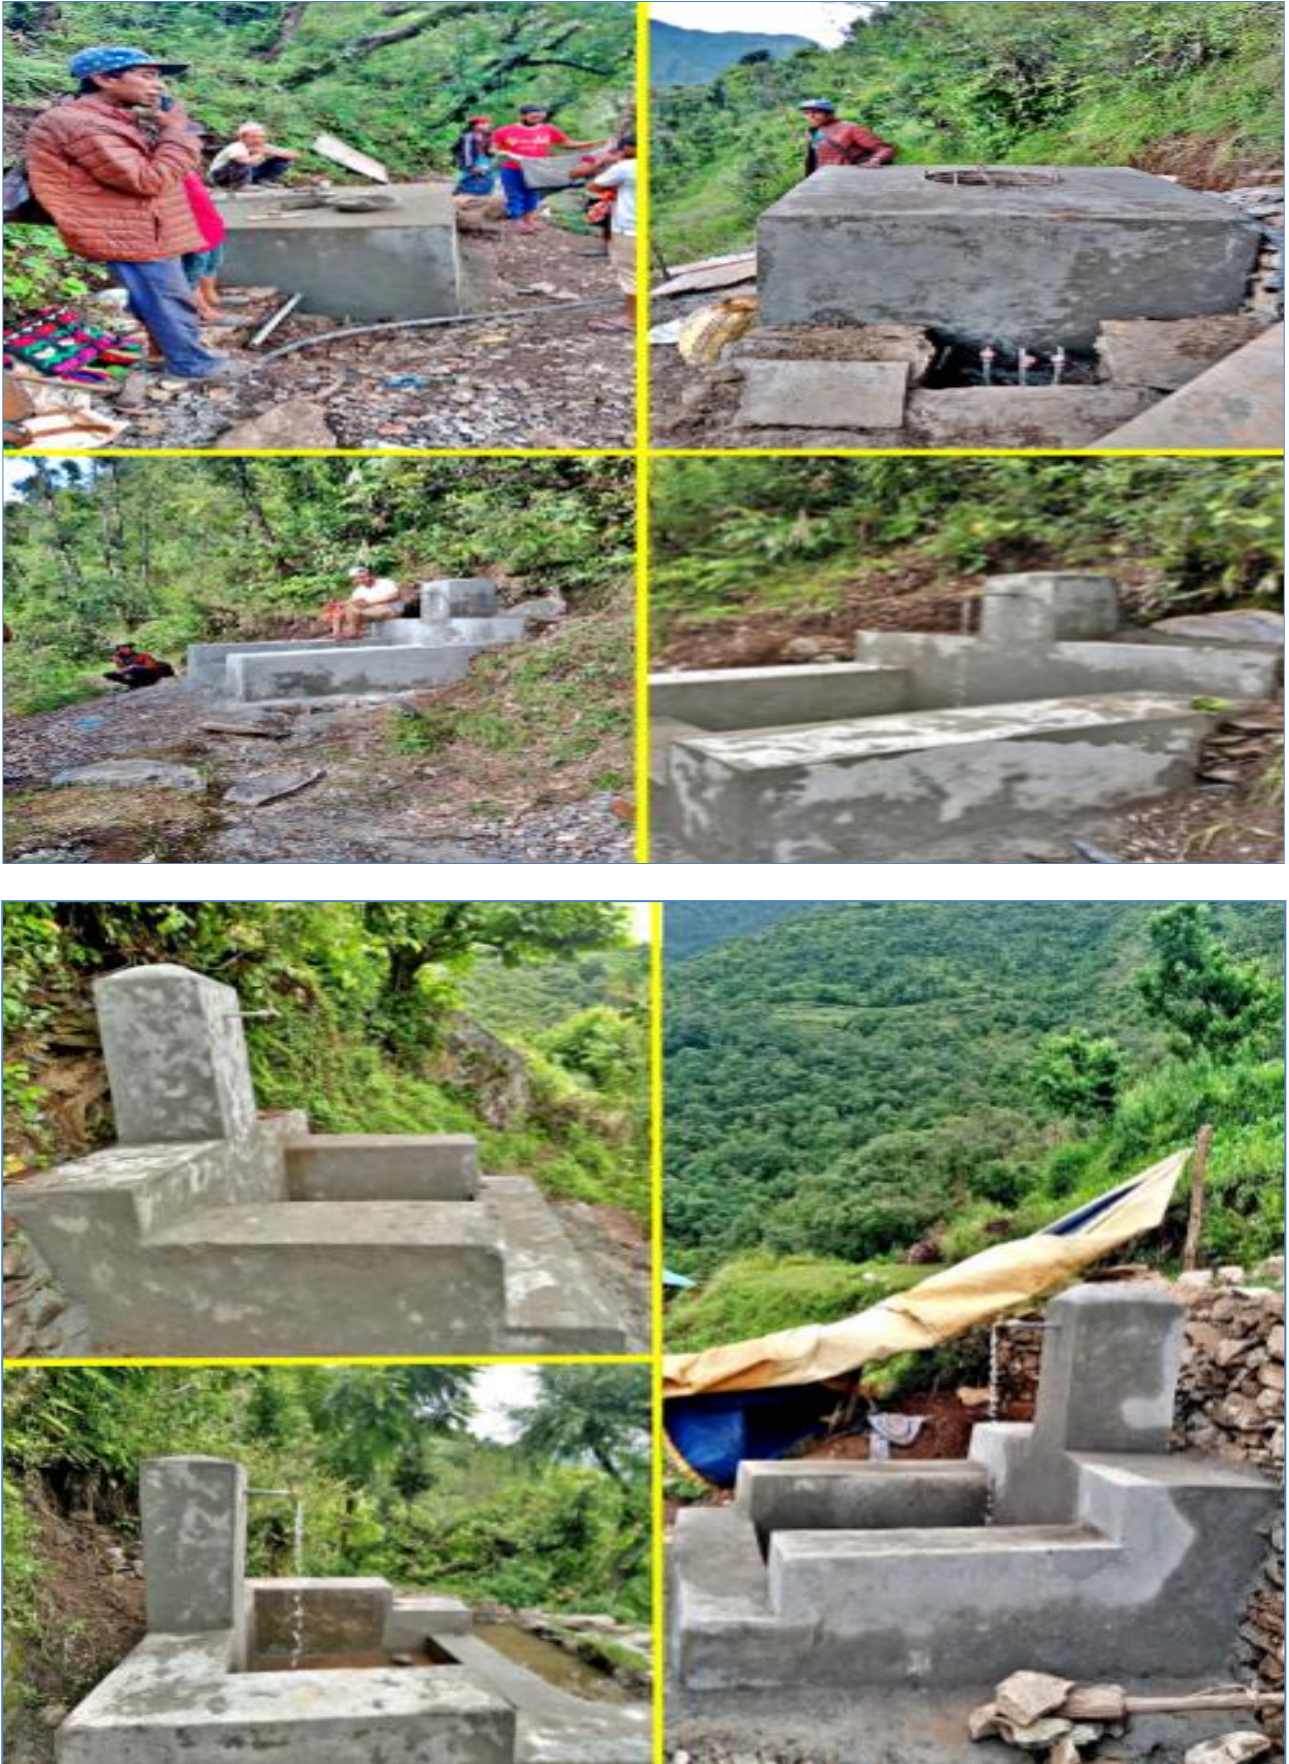
Figure 46: Daliwang Water Source Protection

8	Employment:	323 md			
9	Gender/Social Consideration:	Both men and women were equally involved; More emphasis was given to the genuine participation of disadvantaged groups			
10	Effect/Impact:	Protect the water source; improved water quality Support drinking facilities			
11	Benefitted HH:	Total: 35	Dalit: 25	Janajati: 5	Others: 5
12	Problem/Obstacles Faced:	No			
13	Maintenance/Sustainability:	5% amount of total payable amount has been deducted for the maintenance work, if some damage occurs.			
14	Lesson Learned:	If real needs of the community are to be addressed, villagers readily participate throughout the activity implementation process, thus greater achievements are possible even with small external support. The physical structures constructed should be accompanied by plantation of different tree species around the water source			
15	Others; Name of:	User Group: Daliwang Tallo Okhar Gaira Muhan SanrakshanTatha Tanki Nirman Upabhokta Samiti

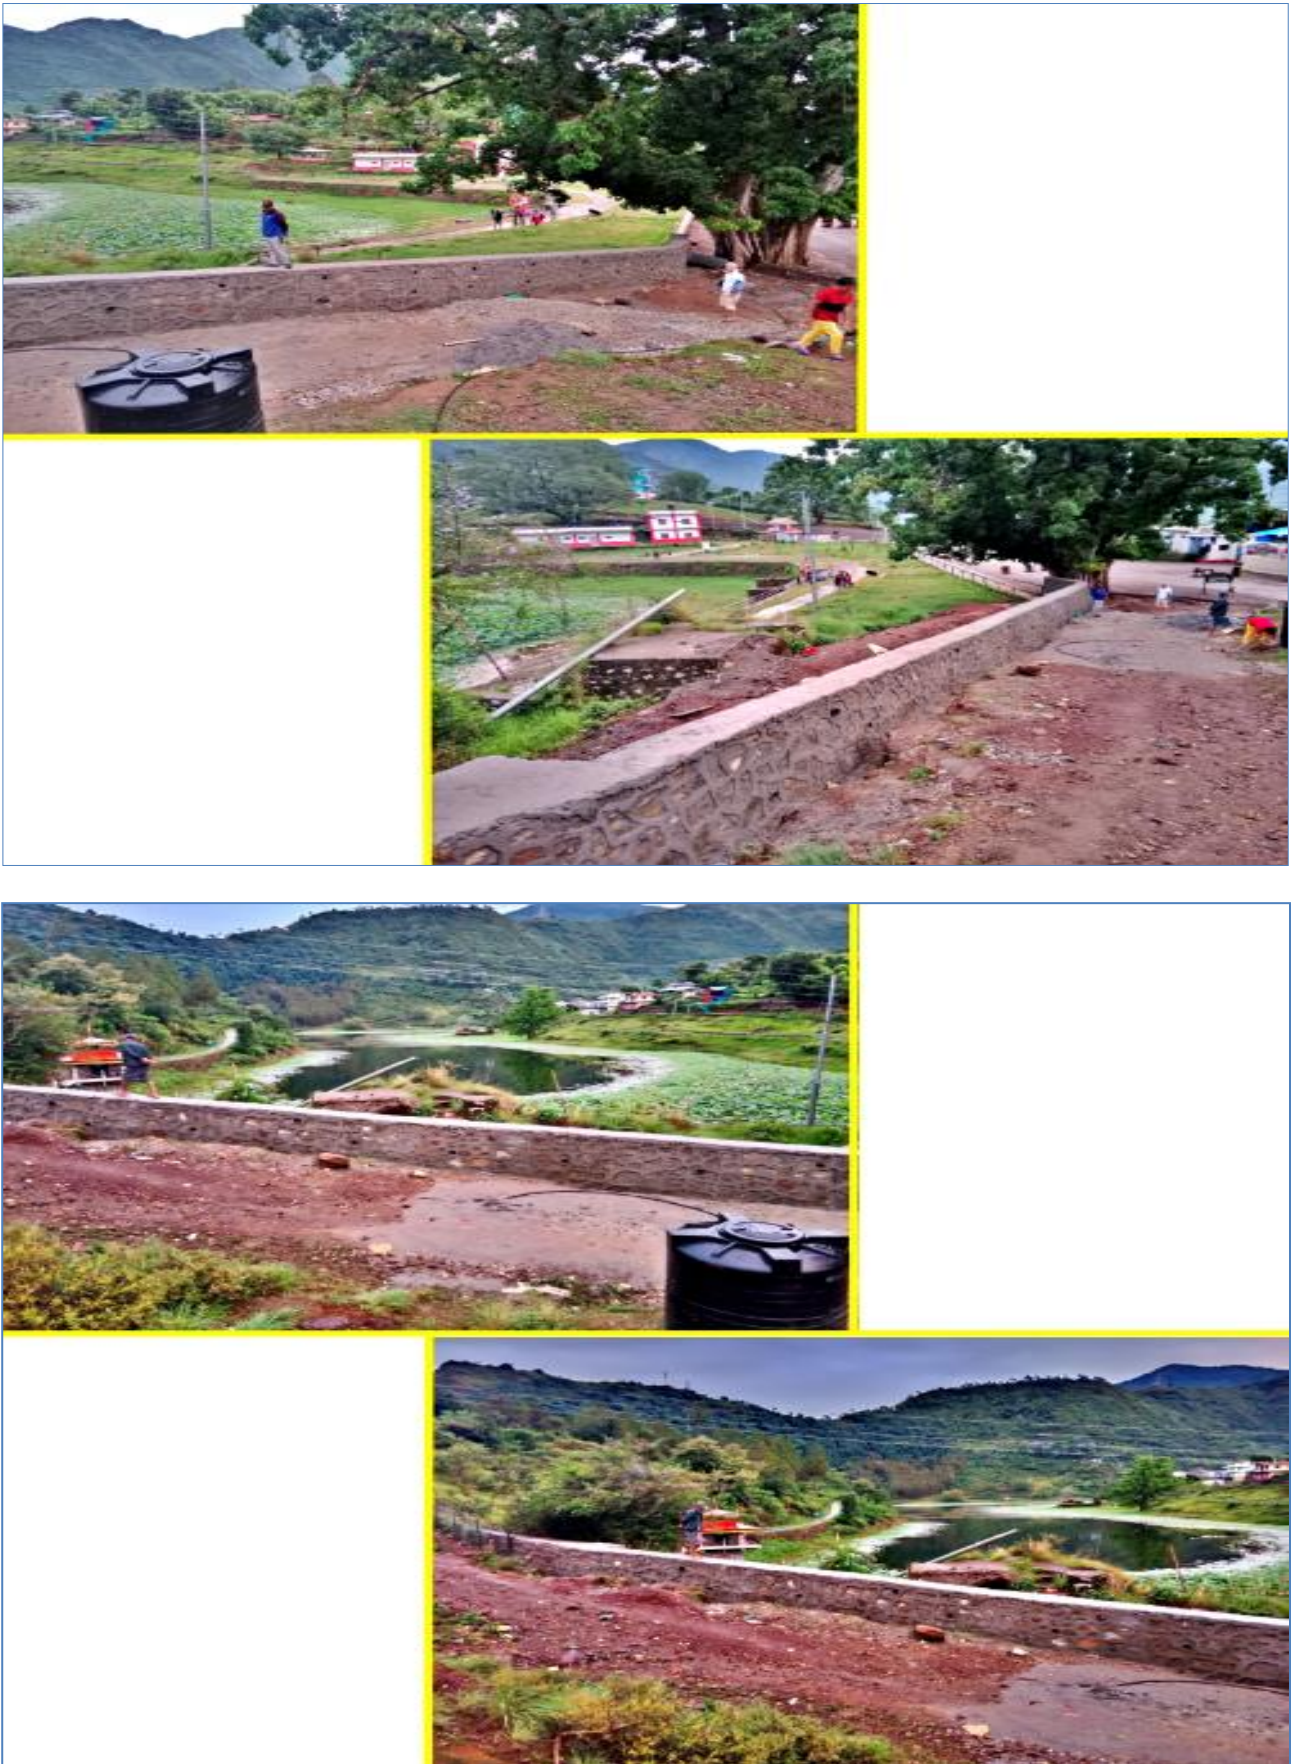
Figure 47: Kamaldaha Protection Work

1	Program: Water Source Protection/Conservation Pond				
2	Location: District/Rural Municipality: Rukum East /Sisne	Ward No: 5	Place: Kamaldaha	F/Y: 079/80	
	Coordinate:	Latitude: 28.610067		Longitude: 82.623953	
3	Existing Site Problem: The kamaldaha pond was affected by erosion & sediment deposition				
4	Cost:				
a	Estimated	Total: 588789.48	Office: 493459.63	Users: 95329.85	Others:
b	Actual Expenditure	Total: 588789.48	Office: 493459.63	Users: 95329.85	Others:
5	Objectives:	a) to reduce the erosion & sedimentation in the pond b) to improve the water regime			
6	Technique Applied:	a) Structural: Stone Masonary Wall Construction (Stone Masonary Wall Construction-33.60m long)			
7	Implementation Process:	Co-ordination with Local Representatives, User Groups and other concerned authorities; Field Visits; Survey, Design & Cost Estimation; Provide funds for the purchase of Construction Materials, Skilled Labour, Hoarding Board from Program cost; Unskilled Labour cost was contributed jointly through program cost and people participation; Monitoring & Evaluation

8	Employment:	323 md			
9	Gender/Social Consideration:	Both men and women were equally involved; More emphasis was given to the genuine participation of disadvantaged groups			
10	Effect/Impact:	Reduce the erosion & sedimentation in the pond Improve the water regime			
11	Benefitted HH:	Total: 100	Dalit: 20	Janajati: 45	Others: 35
12	Problem/Obstacles Faced:	No			
13	Maintenance/Sustainability:	5% amount of total payable amount has been deducted for the maintenance work, if some damage occurs.			
14	Lesson Learned:	If real needs of the community are to be addressed, villagers readily participate throughout the activity implementation process, thus greater achievements are possible even with small external support. The physical structures constructed should be accompanied by plantation of different tree species around the water source			
15	Others; Name of:	User Group: Kamaldaha Dhalko Parkhal Nirman Upabhokta Samiti

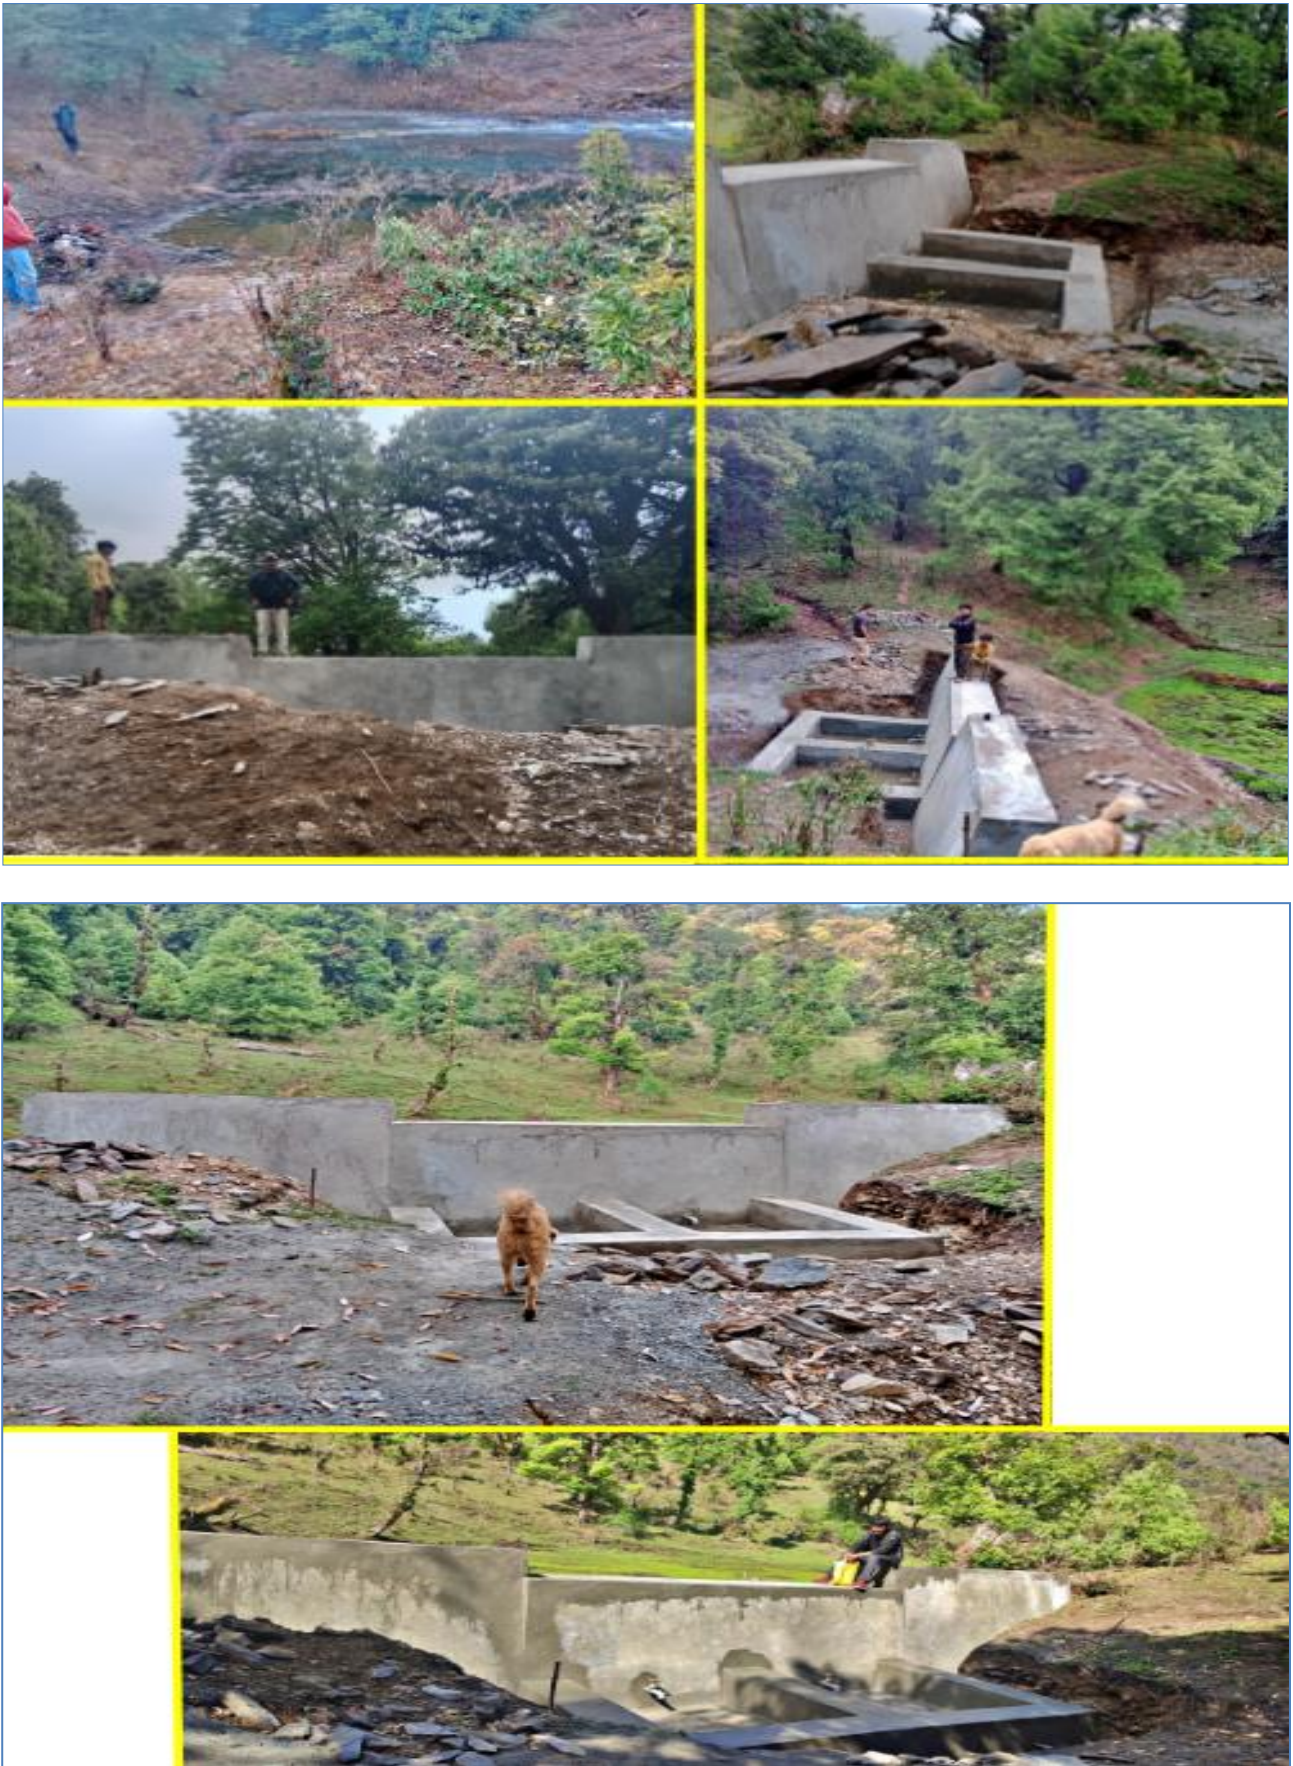
Figure 48: Ratodaha Protection Work

1	Program: Water Source Protection/Conservation Pond				
2	Location: District/Rural Municipality: Rukum East /Putha Uttarganga	Ward No: 9	Place: Lahabang	F/Y: 079/80	
	Coordinate:	Latitude: 28.679142		Longitude: 82.769747	
3	Existing Site Problem: The overflow water from the ratodaha pond possess a risk of damage to the settlement & agricultural and				
4	Cost:				
a	Estimated	Total: 889390.01	Office: 799996.65	Users: 89393.36	Others:
b	Actual Expenditure	Total: 869522.81	Office: 782182.18	Users: 87340.64	Others:
5	Objectives:	a) to manage the overflow water from the pond b) to reduce the devastating effects on the downstream & surrounding area			
6	Technique Applied:	a) Structural: Dam Construction (9.8m*0.75m*1.75m)			
7	Implementation Process:	Co-ordination with Local Representatives, User Groups and other concerned authorities; Field Visits; Survey, Design & Cost Estimation; Provide funds for the purchase of Construction Materials, Skilled Labour, Hoarding Board from Program cost; Unskilled Labour cost was contributed jointly through program cost and people participation; Monitoring & Evaluation

8	Employment:	404 md			
9	Gender/Social Consideration:	Both men and women were equally involved; More emphasis was given to the genuine participation of disadvantaged groups			
10	Effect/Impact:	Manage the overflow water from pond Reduce the risk of damage to the settlement & agricultural land			
11	Benefitted HH:	Total: 20	Dalit: 4	Janajati: 12	Others: 4
12	Problem/Obstacles Faced:	Transportational difficulties; One of the remote area of Lumbini Province			
13	Maintenance/Sustainability:	5% amount of total payable amount has been deducted for the maintenance work, if some damage occurs.			
14	Lesson Learned:	If real needs of the community are to be addressed, villagers readily participate throughout the activity implementation process, thus greater achievements are possible even with small external support. The physical structures constructed should be accompanied by plantation of different tree species around the water source

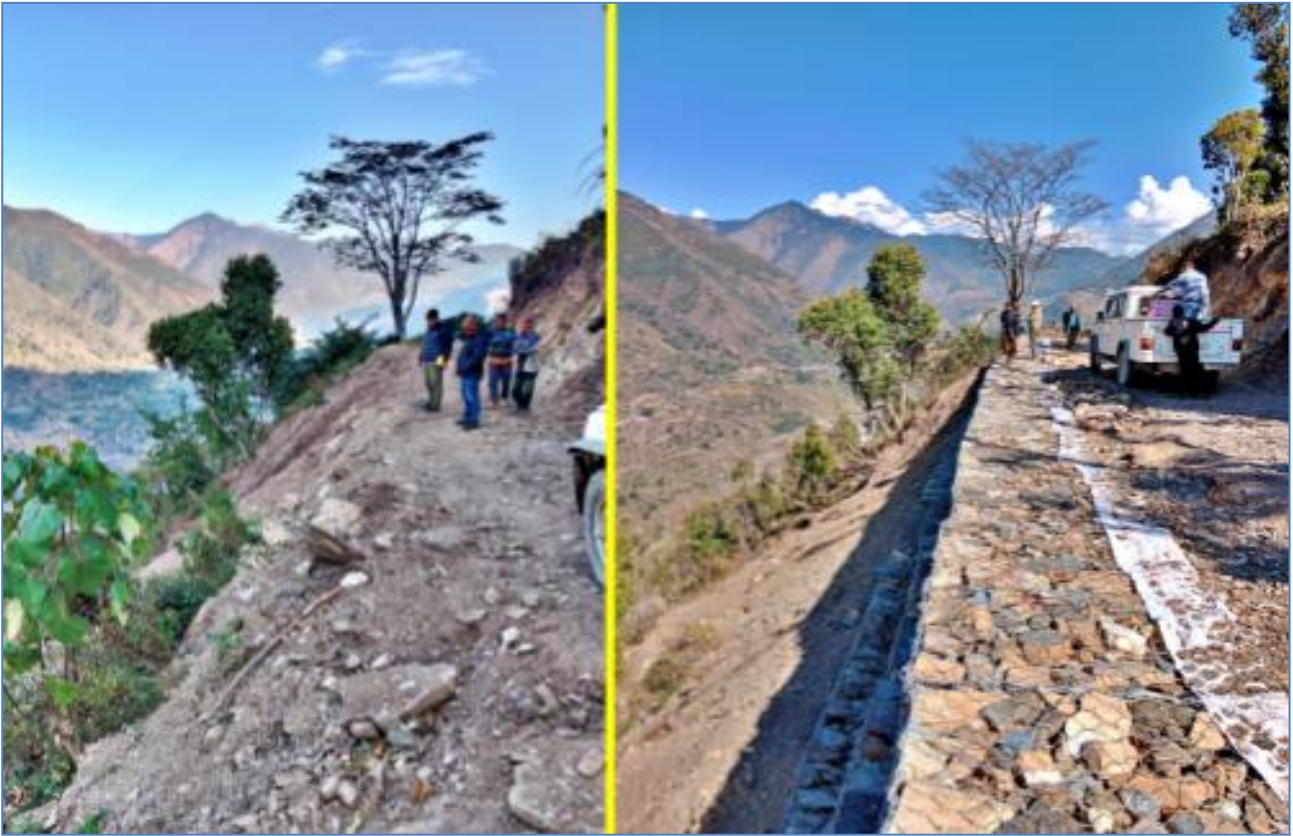
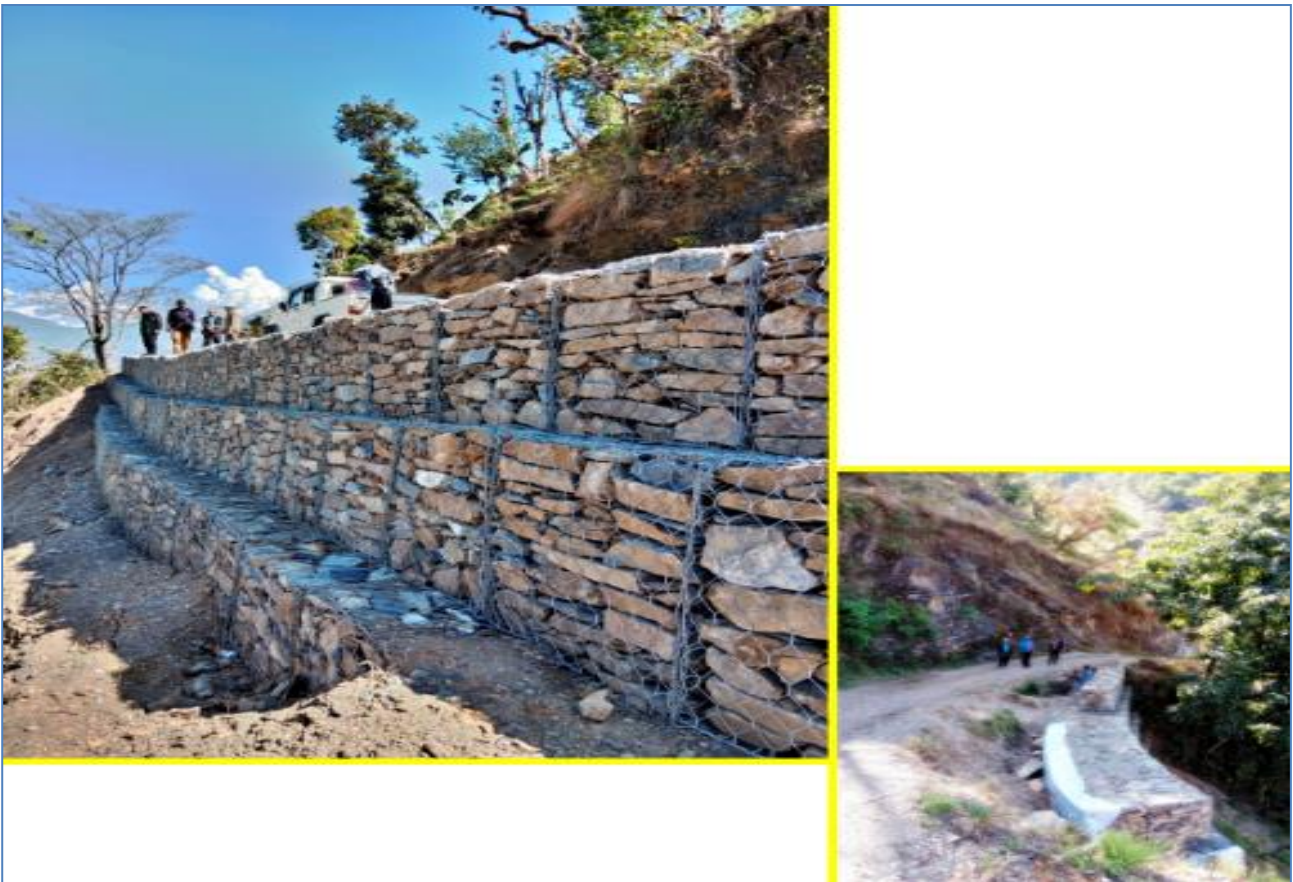
Figure 49: Pakhagaun Rural Road Conservation

1	Program: Soil Conservation Work Along Rural Road				
2	Location: District/Rural Municipality: Rukum East/Sisne	Ward No: 7	Place: Pakhagaun	F/Y: 079/80	
	Coordinate:	Latitude: 28.638428		Longitude: 82.553016	
3	Existing Site Problem: The Landslide possess a risk of damage to the rural road and agricultural land				
4	Cost:				
a	Estimated	Total: 1128309.61	Office: 999990.21	Users: 128319.40	Others:
b	Actual Expenditure	Total: 1128309.61	Office: 999990.21	Users: 128319.40	Others:
5	Objectives:	a) to reduce soil erosion and mass movement from landslide b) to reduce devastating effects on the downstream and surrounding area			
6	Technique Applied:	a) Structural: Gabion Retaining Wall Construction (Gabion Box 98 Nos; Box size 2m*1m*1m=44Nos., Box size 1.5m*1m*1m=54Nos. were used to construct 27m long & 3m high Gabion Retaining Wall)			
7	Implementation Process:	Co-ordination with Local Representatives, User Groups and other concerned authorities; Field Visits; Survey, Design & Cost Estimation; Provide funds for the purchase of Gabion Boxes, Skilled Labour cost, Hoarding Board from Program cost; Unskilled Labour cost was contributed jointly through program cost and people participation; Monitoring & Evaluation

8	Employment:	646 md			
9	Gender/Social Consideration:	Both men and women were equally involved; More emphasis was given to the genuine participation of disadvantaged groups			
10	Effect/Impact:	To some extent, erosion and mass movement has been reduced; Reduce the risk of damage to the rural road; Approximately 0.05 km of rural road & 0.15 ha of agricultural land has been conserved			
11	Benefitted HH:	Total: 40	Dalit: 10	Janajati: 20	Others: 10
12	Problem/Obstacles Faced:	No			
13	Maintenance/Sustainability:	5% amount of total payable amount has been deducted for the maintenance work, if some damage occurs.			
14	Lesson Learned:	If real needs of the community are to be addressed, villagers readily participate throughout the activity implementation process, thus greater achievements are possible even with small external support. The physical structures constructed should be accompanied by bio-engineering techniques to sustain the structures.

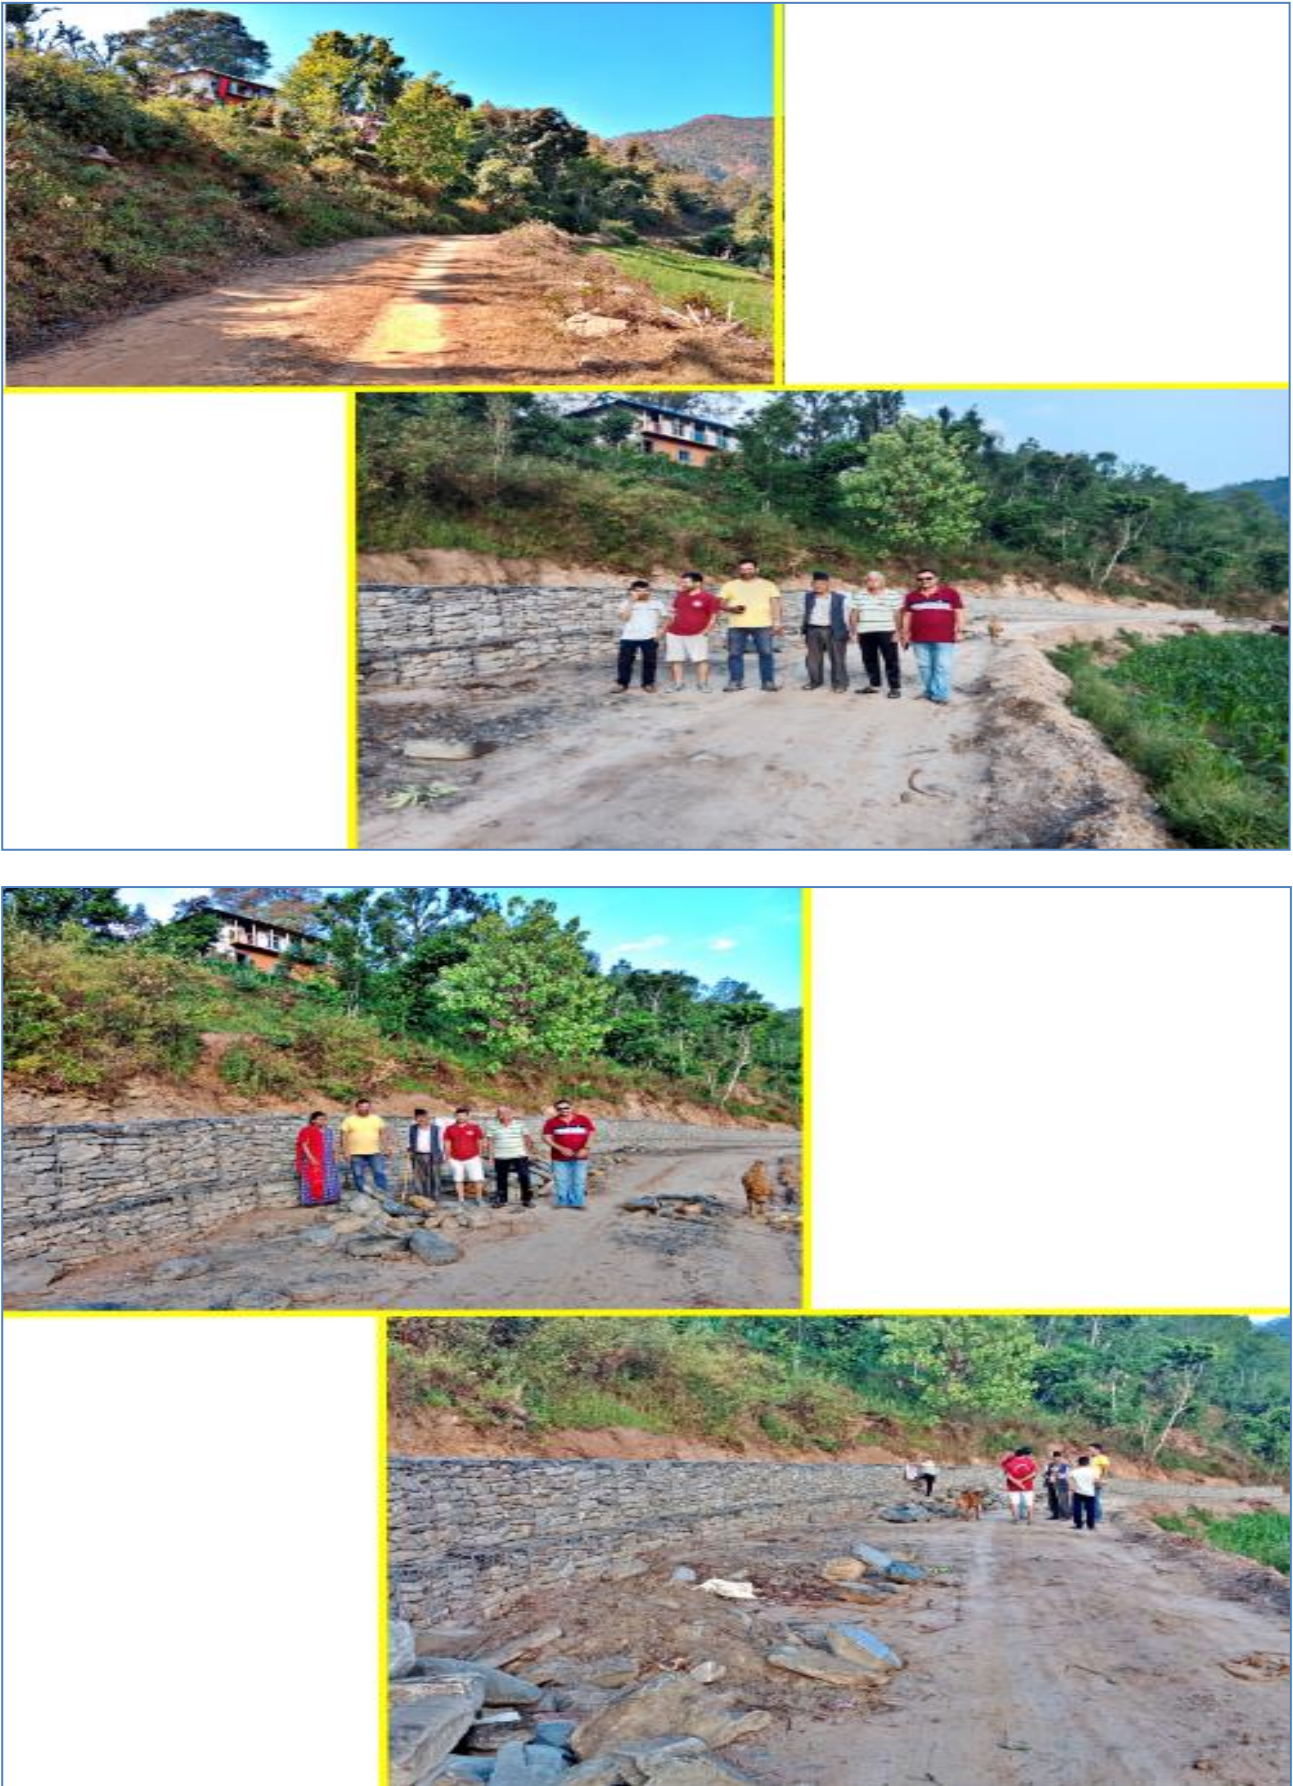
Figure 51: Koladada Landslide Treatment

1	Program: Gully, Landslide and Torrent Control				
2	Location: District/Rural Municipality: Pyuthan/Jhimruk	Ward No: 1	Place: Koladada, Dadakharka	F/Y: 079/80	
	Coordinate:	Latitude: 28.132332	Longitude: 83.032068		
3	Existing Site Problem: The landslide possess a risk of damage to the nearby settlement , rural road and agricultural land				
4	Cost:				
a	Estimated	Total: 1352042.24	Office: 1199967.96	Users: 152074.28	Others:
b	Actual Expenditure	Total: 1347297.58	Office: 1195962.54	Users: 151335.05	Others:
5	Objectives:	a) to reduce soil erosion and mass movement from landslide b) to reduce devastating effects on the downstream and surrounding area			
6	Technique Applied:	a) Structural: Gabion Retaining Wall Construction (Gabion Box 111 Nos; Box size 2m*1m*1m=37 Nos.; Box size 1.5m*1m*1m=74 Nos. were used to construct 74m long Retaining Wall)			
7	Implementation Process:	Co-ordination with Local Representatives, User Groups and other concerned authorities; Field Visits; Survey, Design & Cost Estimation; Provide funds for the purchase of Gabion Boxes, Skilled Labour cost, Hoarding Board from Program cost; Unskilled Labour cost was contributed jointly through program cost and people participation; Monitoring & Evaluation

8	Employment:	777 md			
9	Gender/Social Consideration:	Both men and women were equally involved; More emphasis was given to the genuine participation of disadvantaged groups			
10	Effect/Impact:	To some extent, erosion and mass movement has been reduced; Reduce the risk of damage to the settlement and rural road; Approximately 0.8 ha of agricultural land has been conserved			
11	Benefitted HH:	Total: 100	Dalit: 20	Janajati: 20	Others: 60
12	Problem/Obstacles Faced:	No			
13	Maintenance/Sustainability:	5% amount of total payable amount has been deducted for the maintenance work, if some damage occurs.			
14	Lesson Learned:	If real needs of the community are to be addressed, villagers readily participate throughout the activity implementation process, thus greater achievements are possible even with small external support. The physical structures constructed should be accompanied by bio-engineering techniques to sustain the structures.

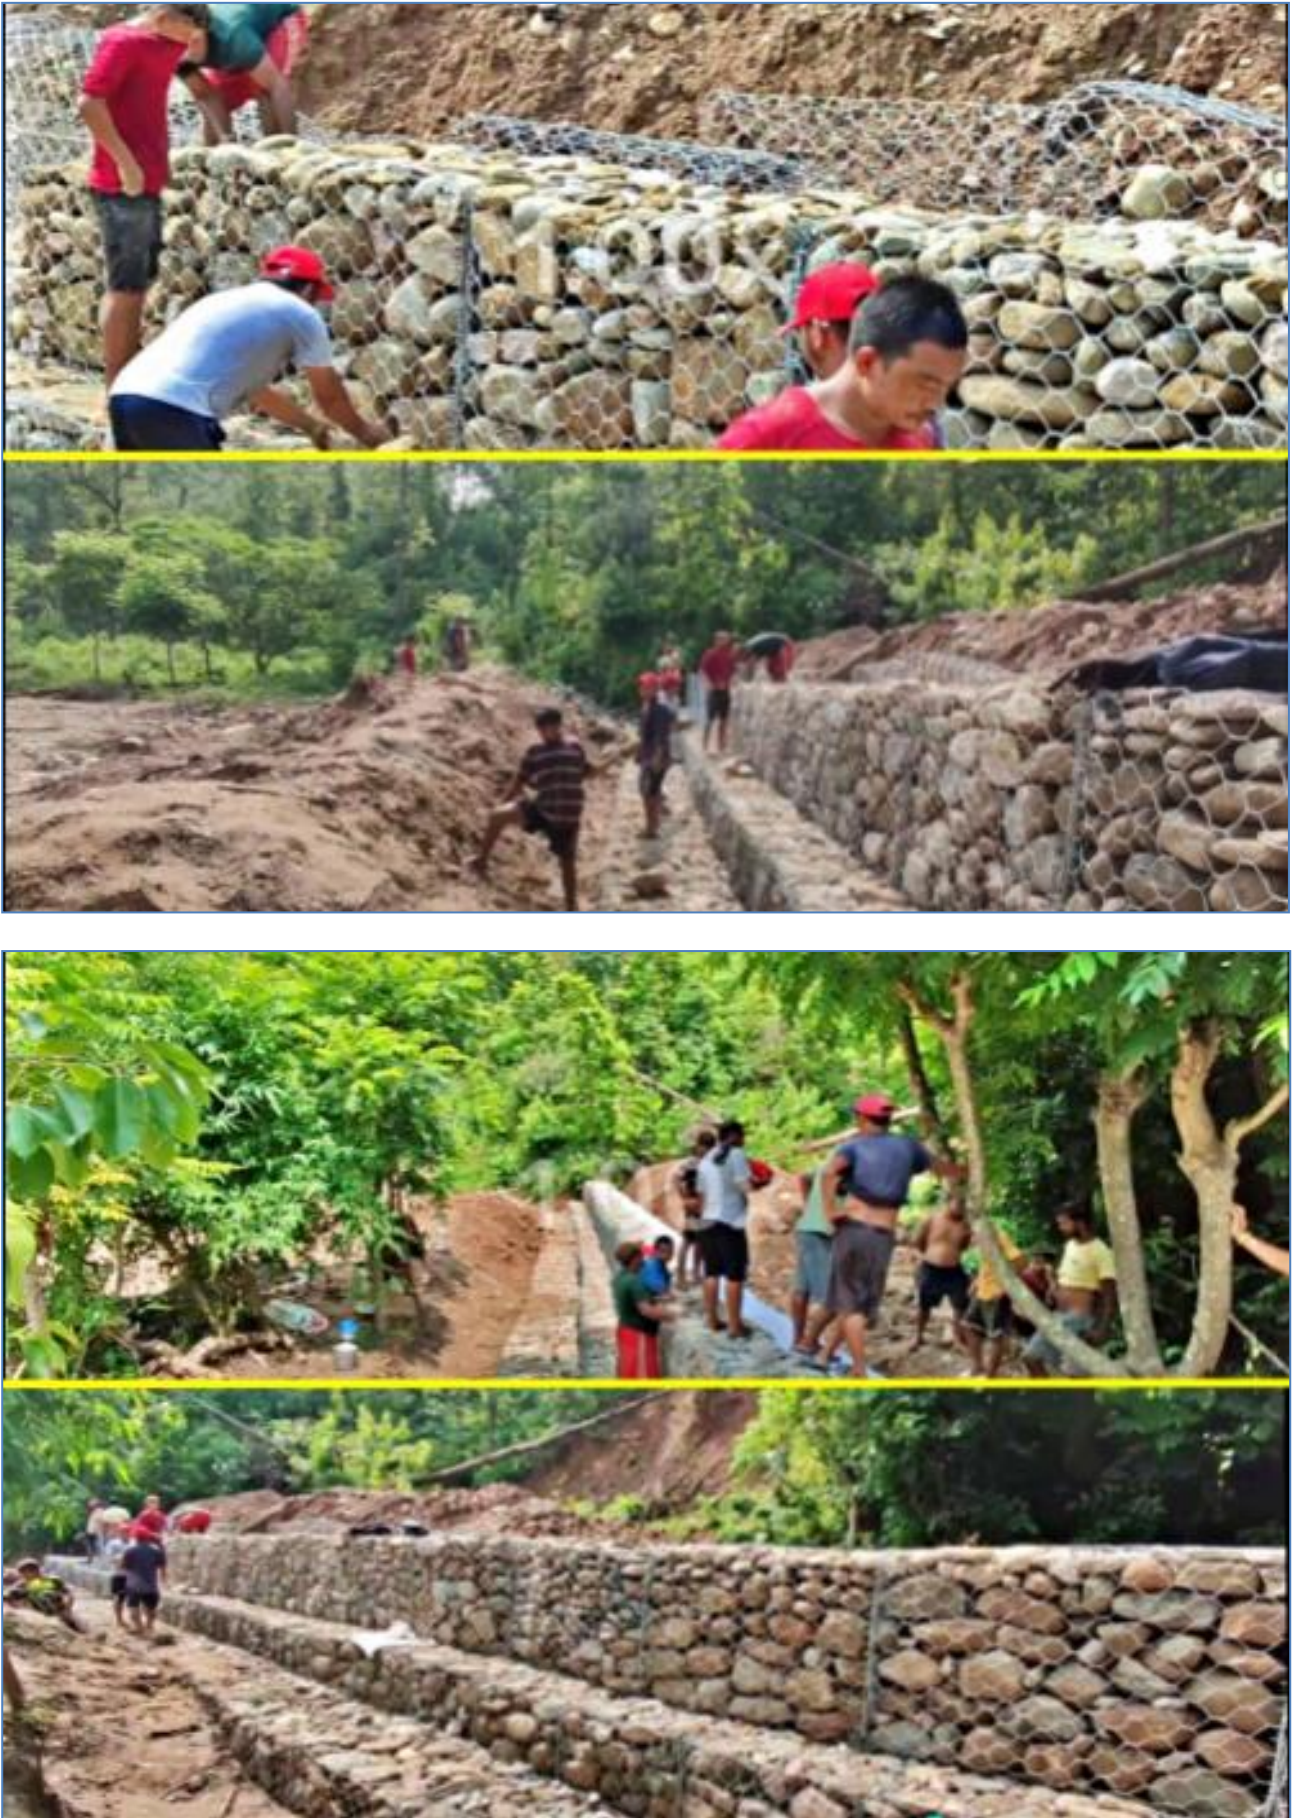
Figure 52: Dhandkhola Kalakhola Torrent Control

1	Program: Gully, Landslide and Torrent Control				
2	Location: District/Rural Municipality: Pyuthan/Sarumarani	Ward No: 3	Place: Dhadkhola, Kalakhola	F/Y: 079/80	
	Coordinate:	Latitude: 27.900828		Longitude: 82.794742	
3	Existing Site Problem: The torrent possess a risk of damage to the nearby settlement and agricultural land				
4	Cost:				
a	Estimated	Total: 1129287.52	Office: 999985.27	Users: 131756.26	Others:
b	Actual Expenditure	Total: 1124707.29	Office: 993666.92	Users: 131040.37	Others:
5	Objectives:	a) to reduce soil erosion and torrent bank cutting b) to reduce devastating effects on the downstream and surrounding area			
6	Technique Applied:	a) Structural: Gabion Embankment Construction (Gabion Box 126 Nos; Box size 1.5m*1m*1m=90 Nos.; Box size 1.5m*1m*0.50m=36 Nos. were used to construct 54m long Emabnkment)			
7	Implementation Process:	Co-ordination with Local Representatives, User Groups and other concerned authorities; Field Visits; Survey, Design & Cost Estimation; Provide funds for the purchase of Gabion Boxes, Skilled Labour cost, Hoarding Board Placing from Program cost; Unskilled Labour cost was contributed jointly through program cost and people participation; Monitoring & Evaluation

8	Employment:	646 md			
9	Gender/Social Consideration:	Both men and women were equally involved; More emphasis was given to the genuine participation of disadvantaged groups			
10	Effect/Impact:	To some extent, erosion and torent bank cutting has been reduced; Reduce the risk of damage to the settlement and agricultural land; Approximately 0.6ha of agricultural land has been conserved			
11	Benefitted HH:	Total: 60	Dalit: 30	Janajati: 10	Others: 20
12	Problem/Obstacles Faced:	No			
13	Maintenance/Sustainability:	5% amount of total payable amount has been deducted for the maintenance work, if some damage occurs.			
14	Lesson Learned:	If real needs of the community are to be addressed, villagers readily participate throughout the activity implementation process, thus greater achievements are possible even with small external support. The physical structures constructed should be accompanied by bio-engineering techniques to sustain the structures.

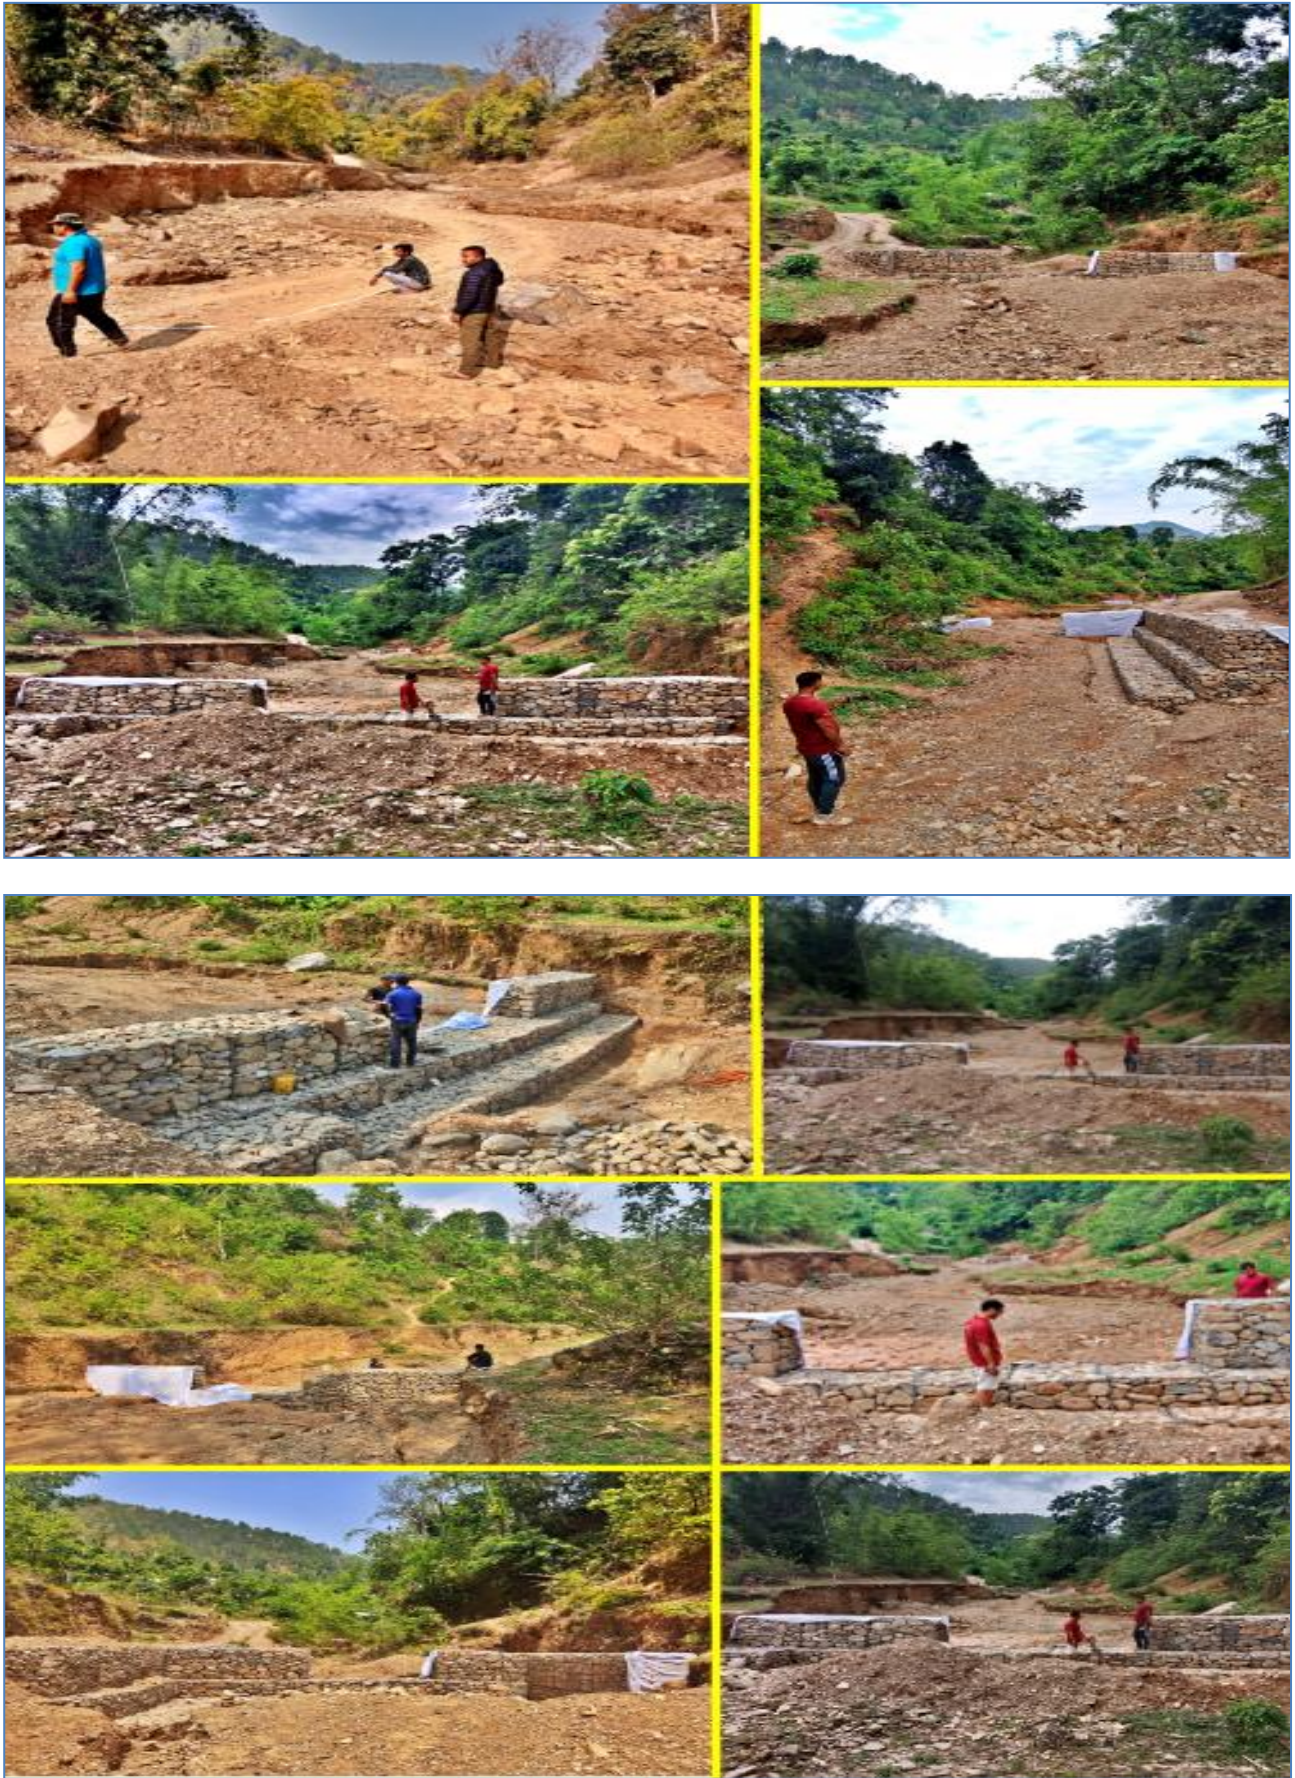
Figure 53: Barkhola Gully Treatment

1	Program: Gully, Landslide and Torrent Control				
2	Location: District/Municipality: Pyuthan/Pyuthan	Ward No: 3	Place: Barkhola	F/Y: 079/80	
	Coordinate:	Latitude: 28.112404	Longitude: 82.842191		
3	Existing Site Problem: The gully formation possess a risk of damage to the nearby settlement, rural road and agricultural land				
4	Cost:				
a	Estimated	Total: 1059996.31	Office: 949991.72	Users: 110004.59	Others:
b	Actual Expenditure	Total: 1059996.31	Office: 949991.72	Users: 110004.59	Others:
5	Objectives:	a) to <i>reduce soil erosion and check the gully</i> b) to <i>reduce devastating effects on the downstream and surrounding area</i>			
6	Technique Applied:	a) Structural: Gabion Check-Dam Construction (Gabion Box 109 Nos; Box size 1.5m*1m*1m=76 Nos.; Box size 1.5m*1m*0.50m=33 Nos. were used to construct 2 Nos. of check-dam)			
7	Implementation Process:	Co-ordination with Local Representatives, User Groups and other concerned authorities; Field Visits; Survey, Design & Cost Estimation; Provide funds for the purchase of Gabion Box, Skilled Labour cost, Hoarding Board from Program cost; Unskilled Labour cost was contributed jointly through program cost and people participation; Monitoring & Evaluation

8	Employment:	618 md			
9	Gender/Social Consideration:	Both men and women were equally involved; More emphasis was given to the genuine participation of disadvantaged groups			
10	Effect/Impact:	To some extent, erosion and gully formation has been controlled; Reduce the risk of damage to the settlement and rural road; Approximately 0.6 ha of agricultural land has been conserved			
11	Benefitted HH:	Total: 40	Dalit: 20	Janajati: 7	Others: 13
12	Problem/Obstacles Faced:	No			
13	Maintenance/Sustainability:	5% amount of total payable amount has been deducted for the maintenance work, if some damage occurs.			
14	Lesson Learned:	If real needs of the community are to be addressed, villagers readily participate throughout the activity implementation process, thus greater achievements are possible even with small external support. The physical structures constructed should be accompanied by bio-engineering techniques to sustain the structures.

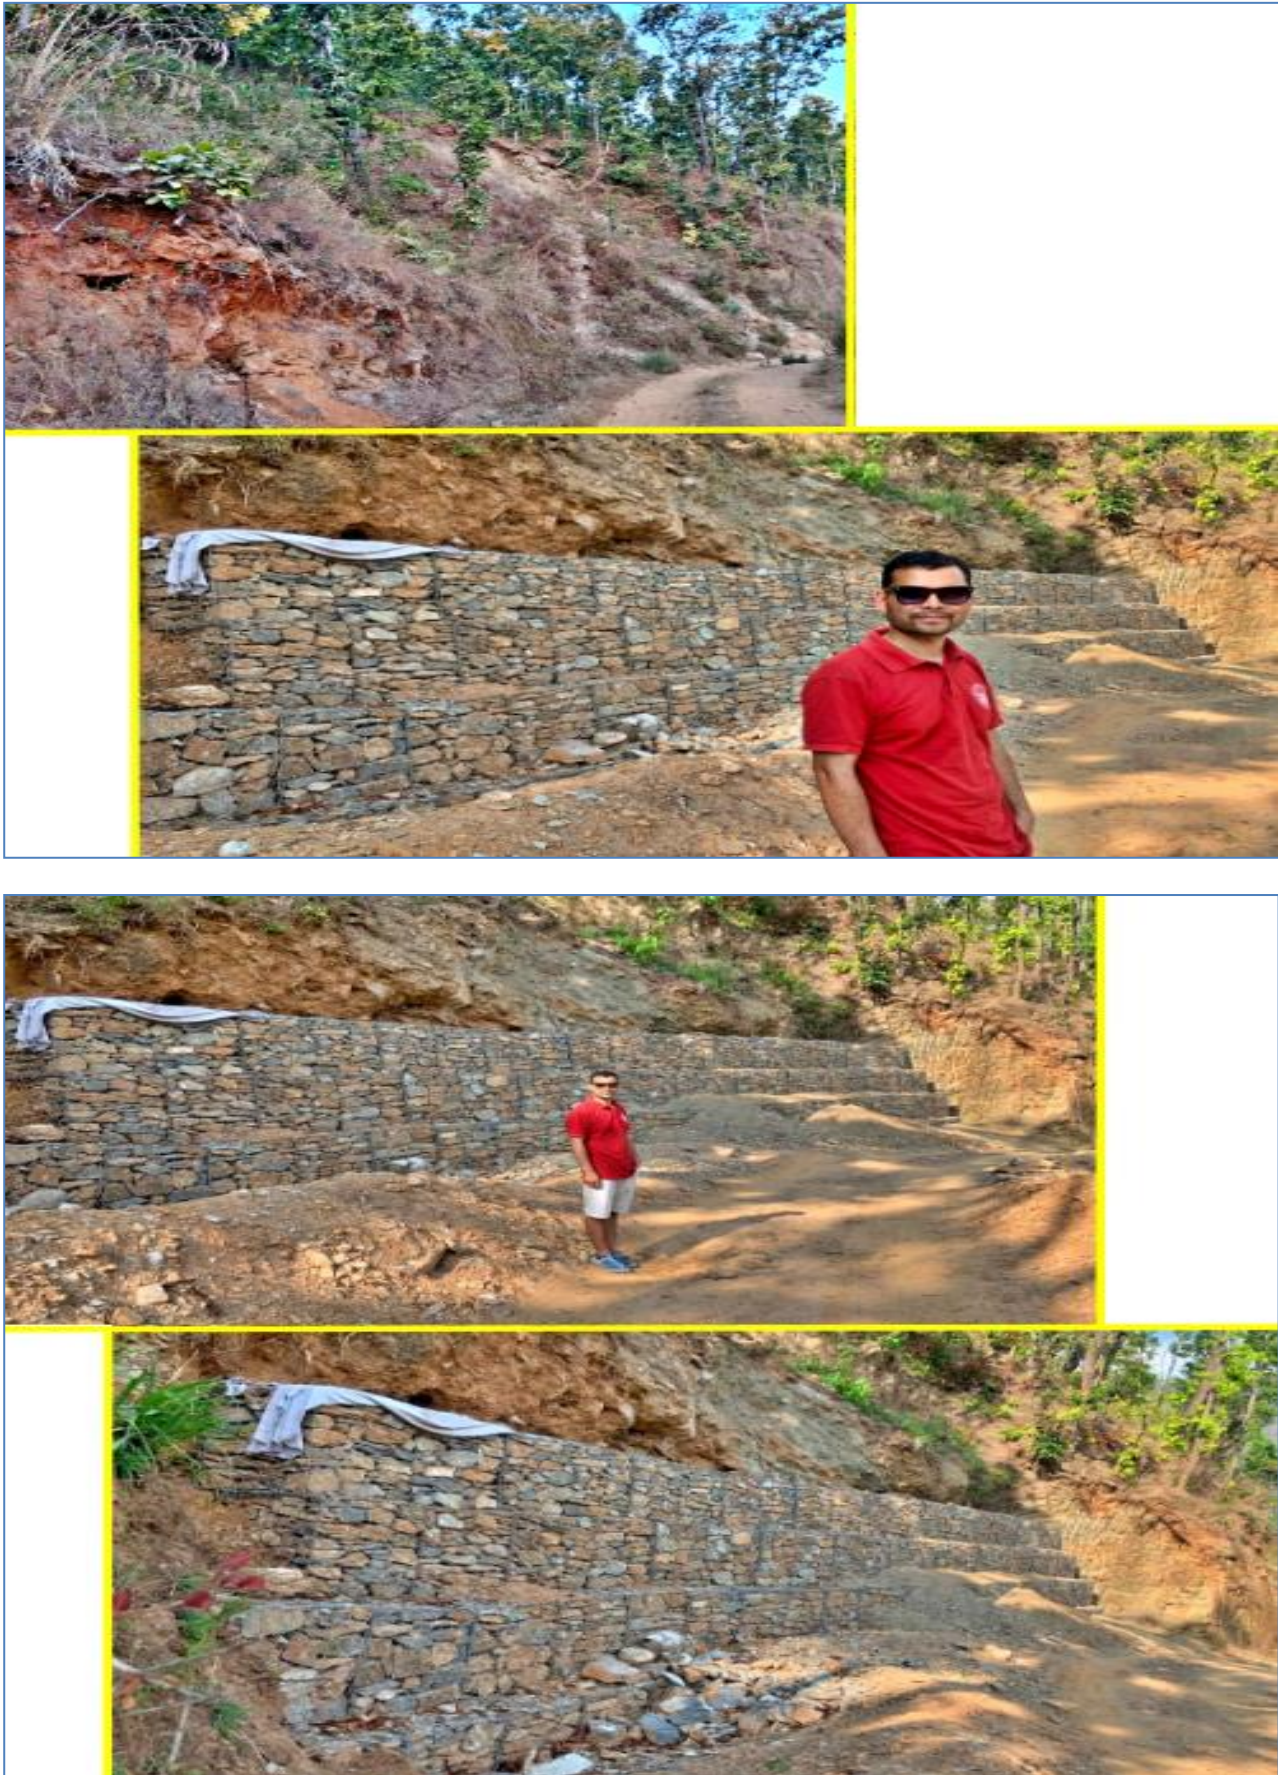
Figure 54: Tusara Chhipchipe Landslide Treatment

1	Program: Gully, Landslide and Torrent Control				
2	Location: District/Rural Municipality: Pyuthan/Jhimruk	Ward No: 7	Place: Tusara	F/Y: 079/80	
	Coordinate:	Latitude: 28.144266	Longitude: 82.955135		
3	Existing Site Problem: The landslide possess a risk of damage to the nearby settlement, rural road and agricultural land				
4	Cost:				
a	Estimated	Total: 1114402.56	Office: 999992.70	Users: 114409.86	Others:
b	Actual Expenditure	Total: 1114402.56	Office: 999992.70	Users: 114409.86	Others:
5	Objectives:	a) to <i>reduce soil erosion & mass movement from landslide</i> b) to <i>reduce devastating effects on the downstream and surrounding area</i>			
6	Technique Applied:	a) Structural: Gabion Retaining Wall Construction (Gabion Box 90 Nos; Box size 2m*1m*1m=52 Nos.; Box size 1.5m*1m*1m=38 Nos. were used to construct 16m long & 7m long Gabion Retaining Wall)			
7	Implementation Process:	Co-ordination with Local Representatives, User Groups and other concerned authorities; Field Visits; Survey, Design & Cost Estimation; Provide funds for the purchase of Gabion Boxes, Skilled Labour cost, Hoarding Board from Program cost; Unskilled Labour cost was contributed jointly through program cost and people participation; Monitoring & Evaluation

8	Employment:	650 md			
9	Gender/Social Consideration:	Both men and women were equally involved; More emphasis was given to the genuine participation of disadvantaged groups			
10	Effect/Impact:	To some extent, erosion & mass movement has been reduced; Reduce the risk of damage to the rural road & settlement; Approximately 0.45 ha of agricultural land has been conserved			
11	Benefitted HH:	Total: 40	Dalit: 10	Janajati:	Others: 30
12	Problem/Obstacles Faced:	No			
13	Maintenance/Sustainability:	5% amount of total payable amount has been deducted for the maintenance work, if some damage occurs.			
14	Lesson Learned:	If real needs of the community are to be addressed, villagers readily participate throughout the activity implementation process, thus greater achievements are possible even with small external support. The physical structures constructed should be accompanied by bio-engineering techniques to sustain the structures.
