ACTIVITY PROFILE

079/80

SOIL AND WATERSHED
MANAGEMENT OFFICE,
ROLPA

LUMBINI STATE GOVERNMENT
MINISTRY OF FORESTS AND ENVIRONMENT
SOIL AND WATERSHED MANAGEMENT OFFICE
MULPANI, ROLPA

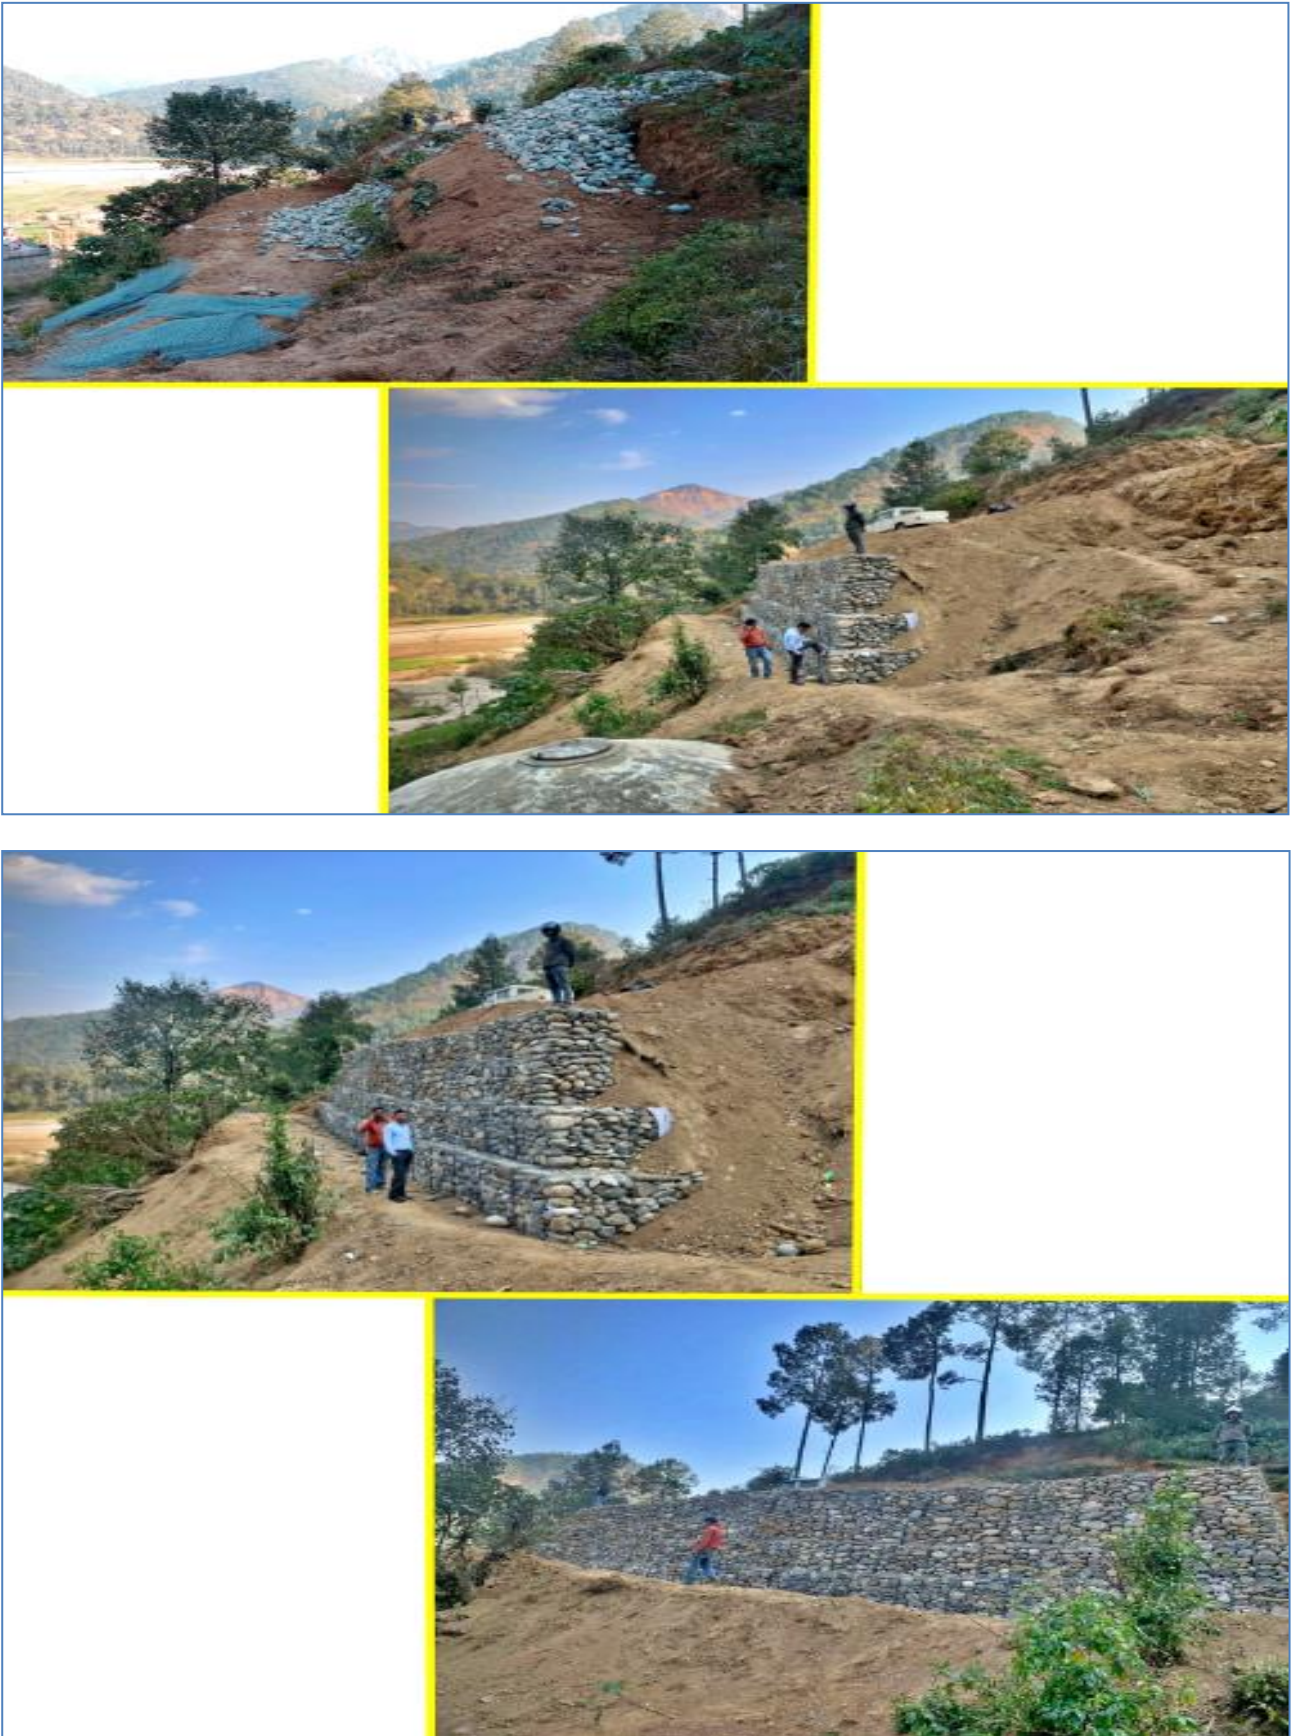
Figure 55: Kaprakhola Landslide Treatment

1	Program: Gully, Landslide and Torrent Control				
2	Location: District/Rural Municipality: Pyuthan/Jhimruk	Ward No: 7	Place: Kaprakhola	F/Y: 079/80	
	Coordinate:	Latitude: 28.157517		Longitude: 82.966528	
3	Existing Site Problem: The landslide possess a risk of damage to the nearby settlement, rural road and agricultural land				
4	Cost:				
a	Estimated	Total: 913228.03	Office: 799980.43	Users: 113247.60	Others:
b	Actual Expenditure	Total: 913228.03	Office: 799980.43	Users: 113247.60	Others:
5	Objectives:	a) to reduce soil erosion and mass movement from landslide b) to reduce devastating effects on the downstream and surrounding area			
6	Technique Applied:	a) Structural: Gabion Retaining Wall Construction (Gabion Box 66 Nos; Box size 2m*1m*1m=44 Nos. & Box size 1.5m*1m*1m=22 Nos. were used to construct 22m long & 4m high Gabion Retaining Wall			
7	Implementation Process:	Co-ordination with Local Representatives, User Groups and other concerned authorities; Field Visits; Survey, Design & Cost Estimation; Provide funds for the purchase of Gabion Boxes, Skilled Labour cost, Hoarding Board from Program cost; Unskilled Labour cost was contributed jointly through program cost and people participation; Monitoring & Evaluation

8	Employment:	517 md			
9	Gender/Social Consideration:	Both men and women were equally involved; More emphasis was given to the genuine participation of disadvantaged groups			
10	Effect/Impact:	To some extent, erosion and mass movement has been reduced; Reduce the risk of damage to the settlement and rural road; Approximately 0.2 ha of agricultural land has been conserved			
11	Benefitted HH:	Total: 40	Dalit: 10	Janajati: 5	Others: 25
12	Problem/Obstacles Faced:	No			
13	Maintenance/Sustainability:	5% amount of total payable amount has been deducted for the maintenance work, if some damage occurs.			
14	Lesson Learned:	If real needs of the community are to be addressed, villagers readily participate throughout the activity implementation process, thus greater achievements are possible even with small external support. The physical structures constructed should be accompanied by bio-engineering techniques to sustain the structures.

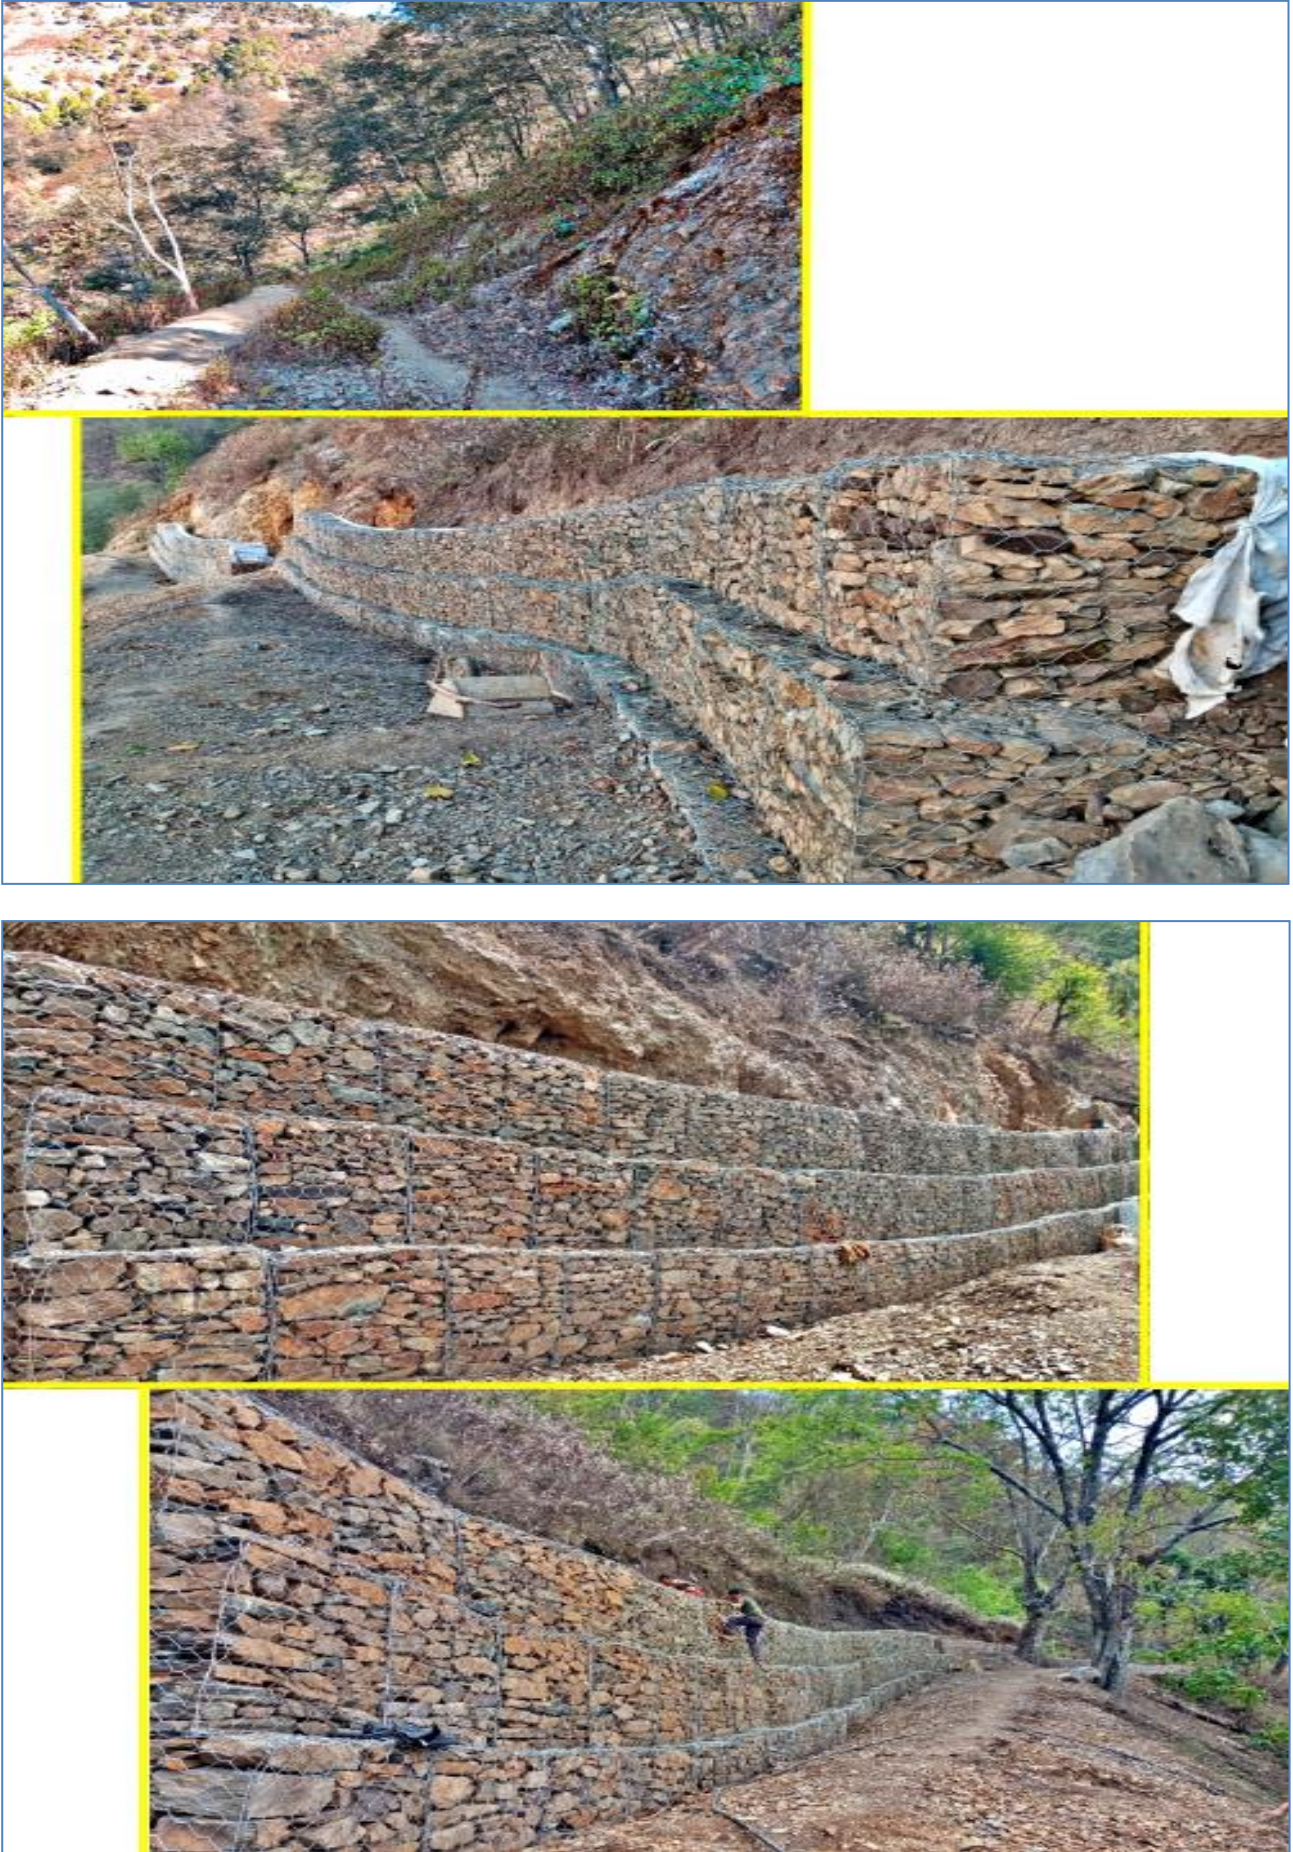
Figure 57: Ghatchaur Landslide Treatment

1	Program: Gully, Landslide and Torrent Control				
2	Location: District/Rural Municipality: Pyuthan/Jhimruk	Ward No: 1	Place: Ghatachaur	F/Y: 079/80	
	Coordinate:	Latitude: 28.109773		Longitude: 82.047257	
3	Existing Site Problem: The landslide possess a risk of damage to the nearby settlement, rural road , playgraound and agricultural land				
4	Cost:				
a	Estimated	Total: 1721929.33	Office: 1499990.15	Users: 221939.18	Others:
b	Actual Expenditure	Total: 1721929.33	Office: 1499990.15	Users: 221939.18	Others:
5	Objectives:	a) to reduce soil erosion and mass movement from landslide b) to reduce devastating effects on the downstream and surrounding area			
6	Technique Applied:	a) Structural: Gabion Retaining Wall Construction (Gabion Box 135 Nos; Box size 2m*1m*1m=81 Nos.; Box size 1.5m*1m*1m=54 Nos. were used to construct 54m long/3m high GabionRetaining Wall)			
7	Implementation Process:	Co-ordination with Local Representatives, User Groups and other concerned authorities; Field Visits; Survey, Design & Cost Estimation; Provide funds for the purchase of Gabion Boxes, Skilled Labour cost, Hoarding Board from Program cost; Unskilled Labour cost was contributed jointly through program cost and people participation; Monitoring & Evaluation

8	Employment:	975 md			
9	Gender/Social Consideration:	Both men and women were equally involved; More emphasis was given to the genuine participation of disadvantaged groups			
10	Effect/Impact:	To some extent, erosion and mass movement has been reduced; Reduce the risk of damage to the settlement, playground and rural road; Approximately 0.95ha of playground & agricultural land has been conserved			
11	Benefitted HH:	Total: 45	Dalit: 10	Janajati: 20	Others: 15
12	Problem/Obstacles Faced:	No			
13	Maintenance/Sustainability:	5% amount of total payable amount has been deducted for the maintenance work, if some damage occurs.			
14	Lesson Learned:	If real needs of the community are to be addressed, villagers readily participate throughout the activity implementation process, thus greater achievements are possible even with small external support. The physical structures constructed should be accompanied by bio-engineering techniques to sustain the structures.

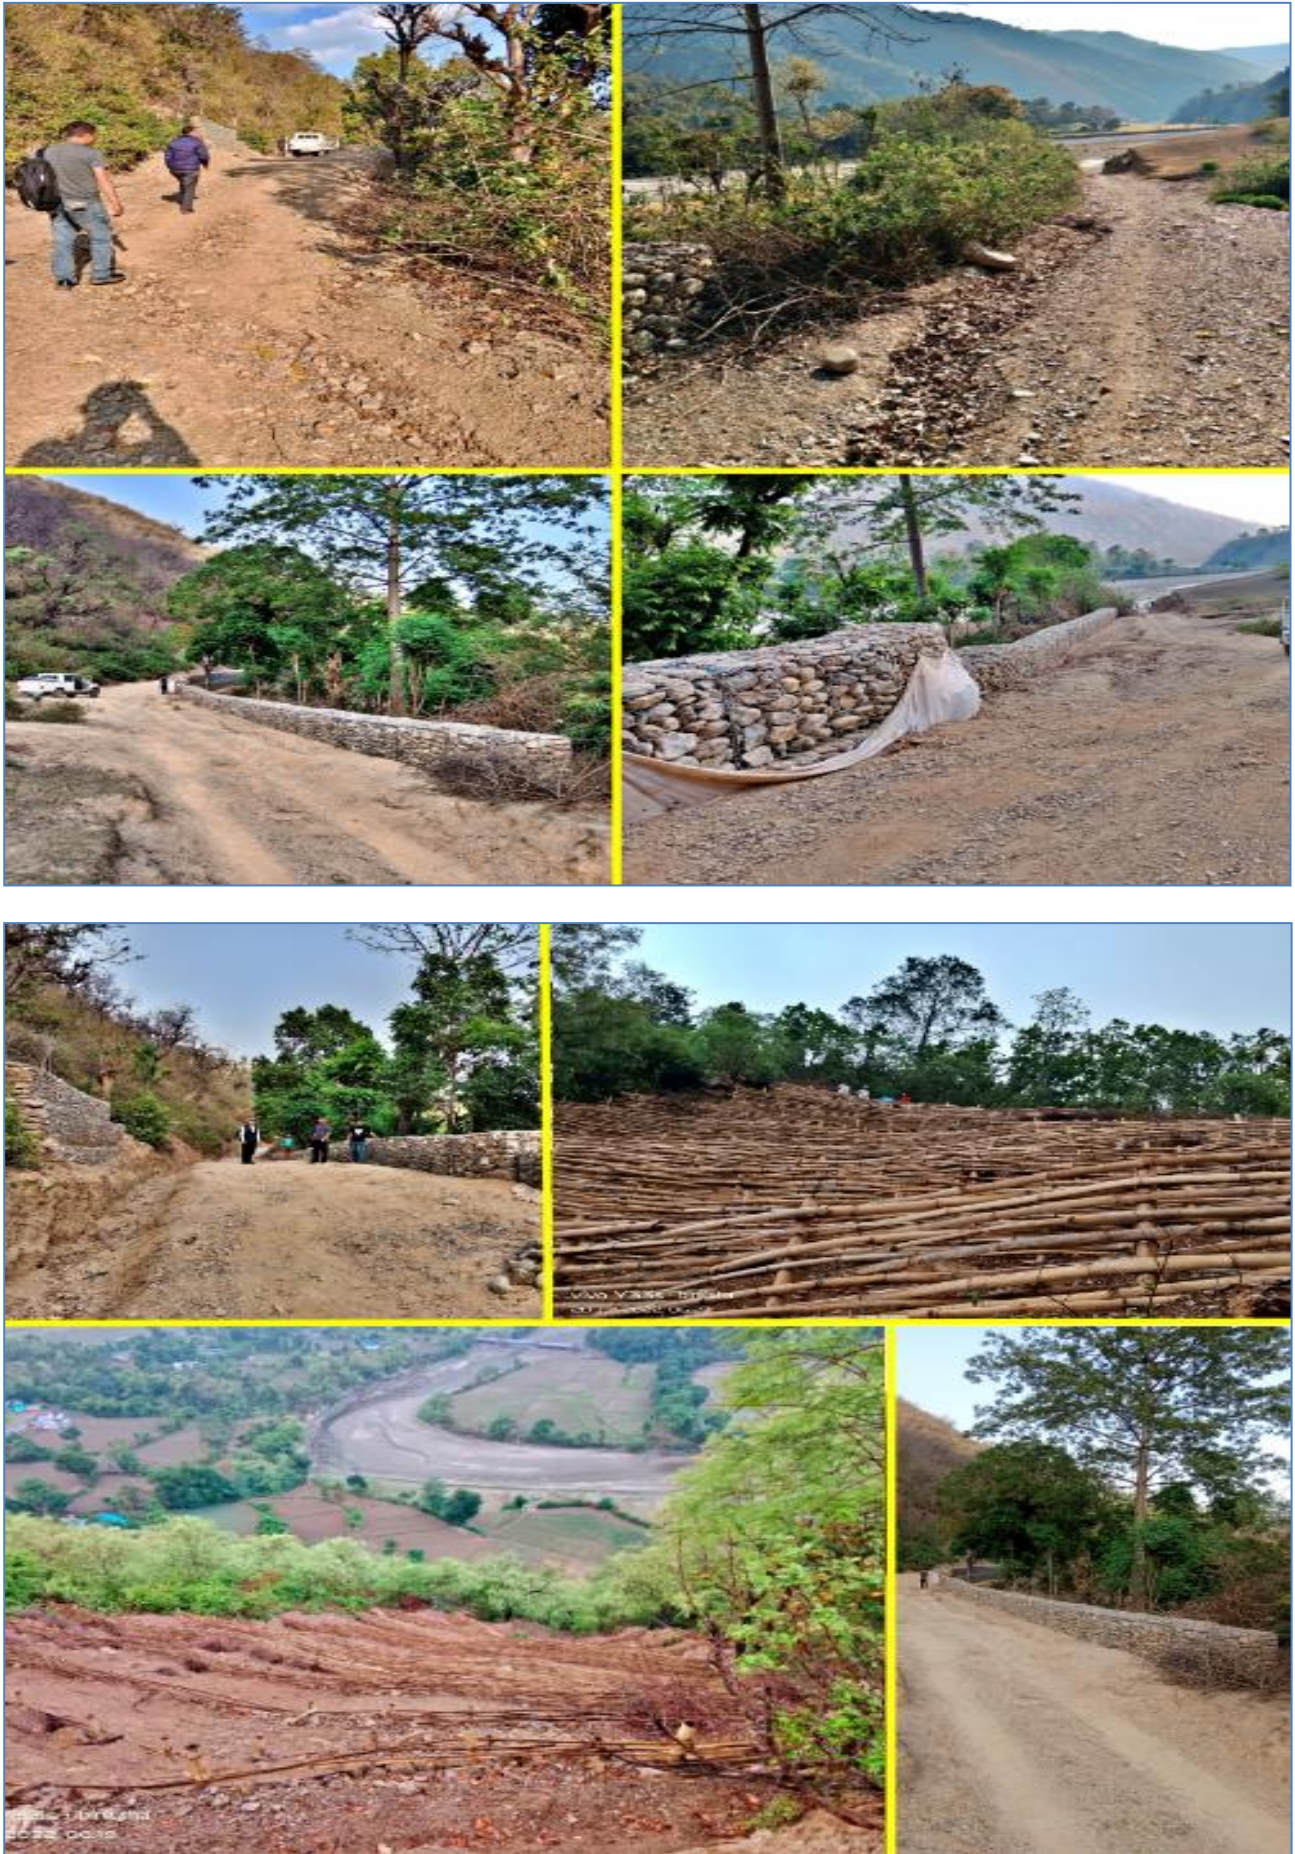
Figure 58: Siundada Landslide Treatment

1	Program: Gully, Landslide and Torrent Control				
2	Location: District/Rural Municipality: Pyuthan/Airawati	Ward No: 5	Place: Pyarpatti	F/Y: 079/80	
	Coordinate:	Latitude: 28.042906	Longitude: 82.867691		
3	Existing Site Problem: The landslide possess a risk of damage to the nearby settlement, rural road and agricultural land				
4	Cost:				
a	Estimated	Total: 796937.98	Office: 699980.20	Users: 96957.79	Others:
b	Actual Expenditure	Total: 790500.82	Office: 694808.93	Users: 95691.89	Others:
5	Objectives:	a) to reduce soil erosion and mass movement from landslide b) to reduce devastating effects on the downstream and surrounding area			
6	Technique Applied:	a) Structural: Gabion Retaining Wall Construction (Gabion Box 80 Nos; Box size 2m*1m*1m=20 Nos.; Box size 1.5m*1m*1m=60 Nos. were used to construct 40m long GabionRetaining Wall)			
7	Implementation Process:	Co-ordination with Local Representatives, User Groups and other concerned authorities; Field Visits; Survey, Design & Cost Estimation; Provide funds for the purchase of Gabion Boxes, Skilled Labour cost, Hoarding Board from Program cost; Unskilled Labour cost was contributed jointly through program cost and people participation; Monitoring & Evaluation

8	Employment:	452 md			
9	Gender/Social Consideration:	Both men and women were equally involved; More emphasis was given to the genuine participation of disadvantaged groups			
10	Effect/Impact:	To some extent, erosion and mass movement has been reduced; Reduce the risk of damage to the settlement and rural road; Approximately 0.9 ha of agricultural land has been conserved			
11	Benefitted HH:	Total: 20	Dalit: 3	Janajati: 15	Others: 2
12	Problem/Obstacles Faced:	No			
13	Maintenance/Sustainability:	5% amount of total payable amount has been deducted for the maintenance work, if some damage occurs.			
14	Lesson Learned:	If real needs of the community are to be addressed, villagers readily participate throughout the activity implementation process, thus greater achievements are possible even with small external support. The physical structures constructed should be accompanied by bio-engineering techniques to sustain the structures.

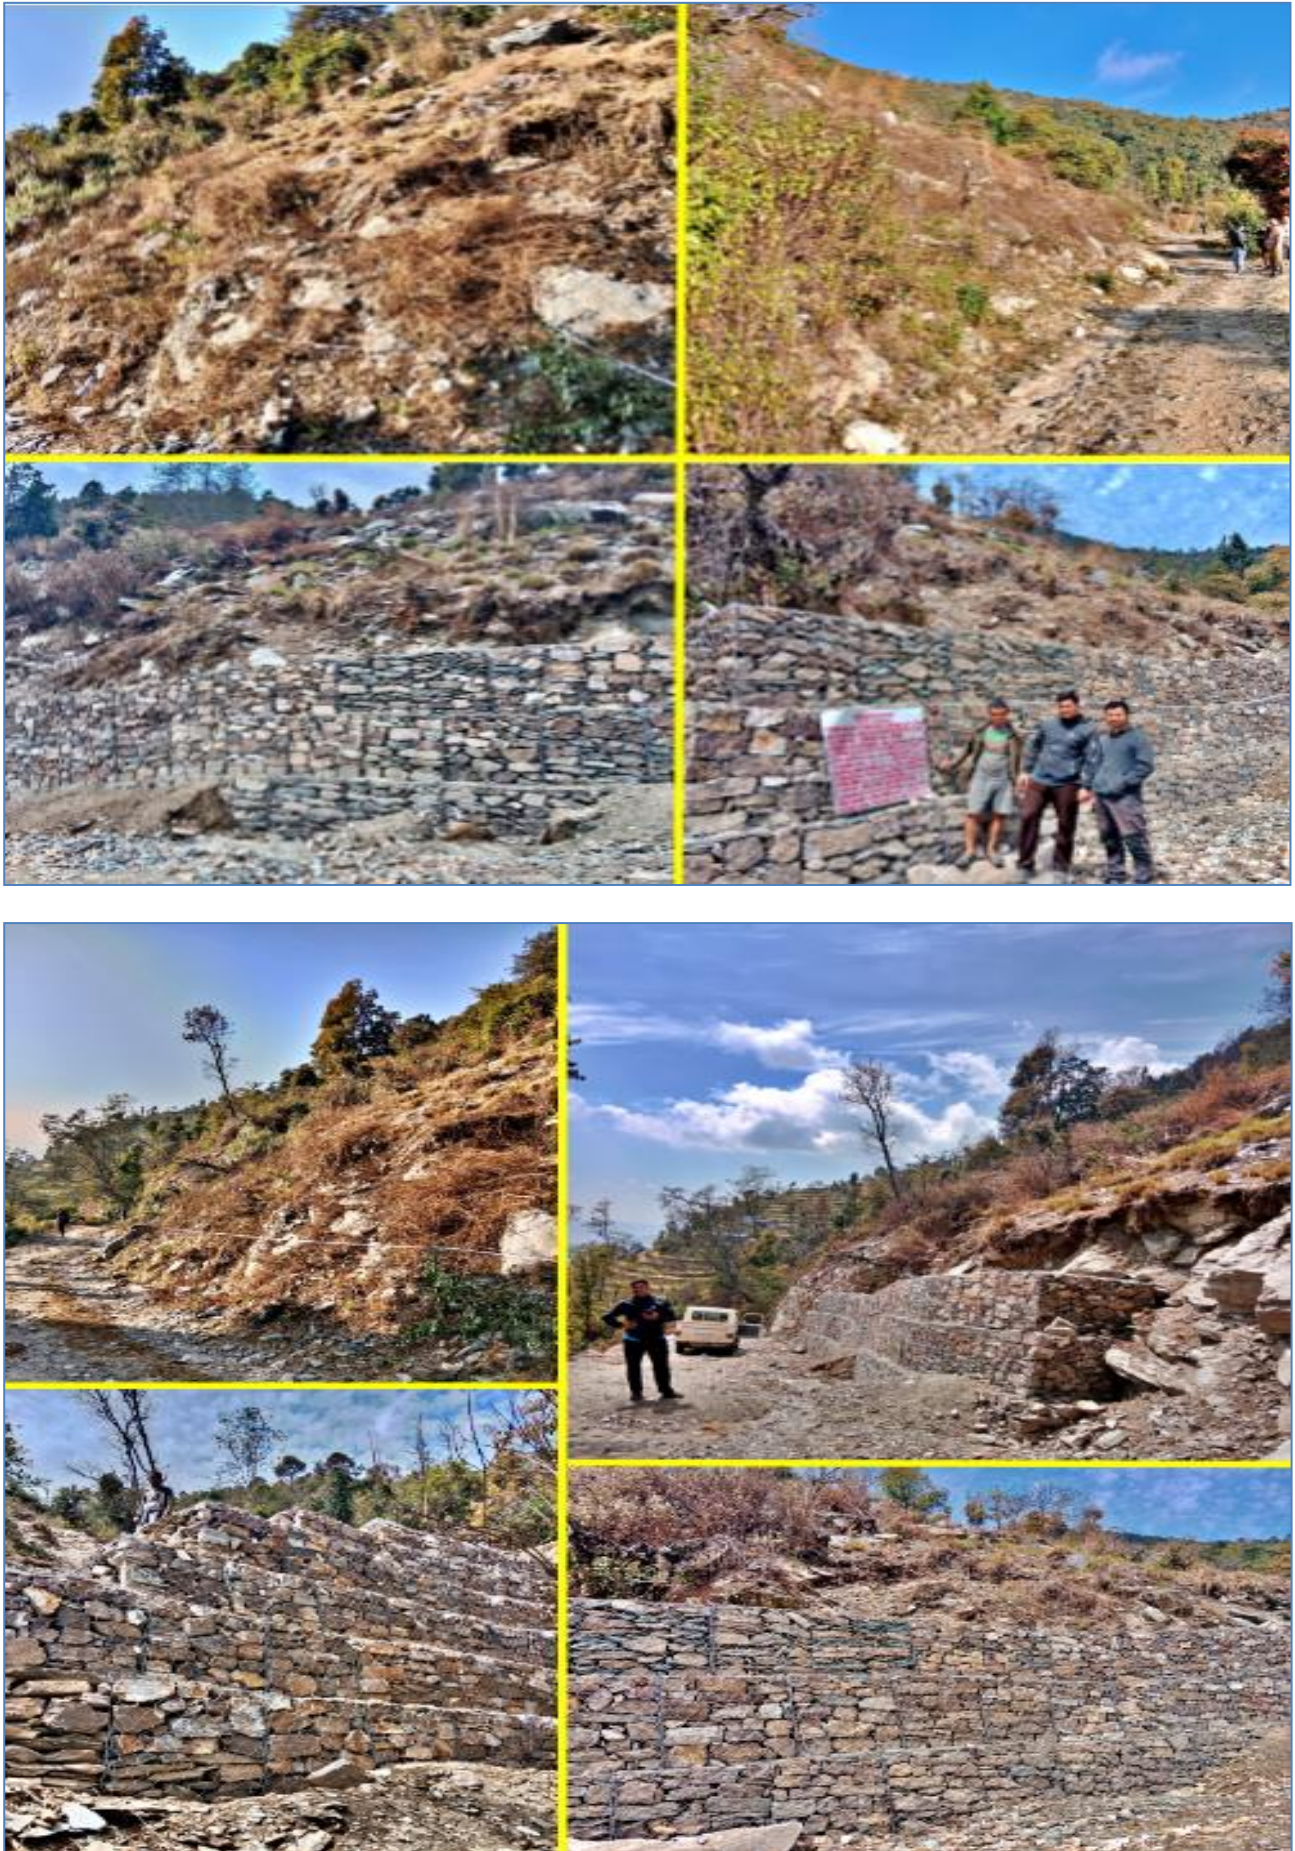
Figure 59: Daringe Landslide Treatment

1	Program: Gully, Landslide and Torrent Control				
2	Location: District/Rural Municipality: Pyuthan/Naubahini	Ward No: 7	Place: Daringe	F/Y: 079/80	
	Coordinate:	Latitude: 28.214154, 28.215791		Longitude: 82.872707, 82.272590	
3	Existing Site Problem: The landslide possess a risk of damage to the nearby settlement, rural road and agricultural land				
4	Cost:				
a	Estimated	Total: 910775.11	Office: 799986.98	Users: 110788.13	Others:
b	Actual Expenditure	Total: 910775.11	Office: 799986.98	Users: 110788.13	Others:
5	Objectives:	a) to reduce soil erosion and mass movement from landslide b) to reduce devastating effects on the downstream and surrounding area			
6	Technique Applied:	a) Structural: Gabion Retaining Wall Construction (Gabion Box 75 Nos; Box size 2m*1m*1m=45 Nos.; Box size 1.5m*1m*1m=30 Nos. ; were used to construct 30m long/3m high GabionRetaining Wall)			
7	Implementation Process:	Co-ordination with Local Representatives, User Groups and other concerned authorities; Field Visits; Survey, Design & Cost Estimation; Provide funds for the purchase of Gabion Boxes, Skilled Labour cost, Hoarding Board from Program cost; Unskilled Labour cost was contributed jointly through program cost and people participation; Monitoring & Evaluation

8	Employment:	520 md			
9	Gender/Social Consideration:	Both men and women were equally involved; More emphasis was given to the genuine participation of disadvantaged groups			
10	Effect/Impact:	To some extent, erosion and mass movement has been reduced; Reduce the risk of damage to the settlement and rural road; Approximately 0.7 ha of agricultural land has been conserved			
11	Benefitted HH:	Total: 30	Dalit: 7	Janajati: 15	Others: 8
12	Problem/Obstacles Faced:	No			
13	Maintenance/Sustainability:	5% amount of total payable amount has been deducted for the maintenance work, if some damage occurs.			
14	Lesson Learned:	If real needs of the community are to be addressed, villagers readily participate throughout the activity implementation process, thus greater achievements are possible even with small external support. The physical structures constructed should be accompanied by bio-engineering techniques to sustain the structures.

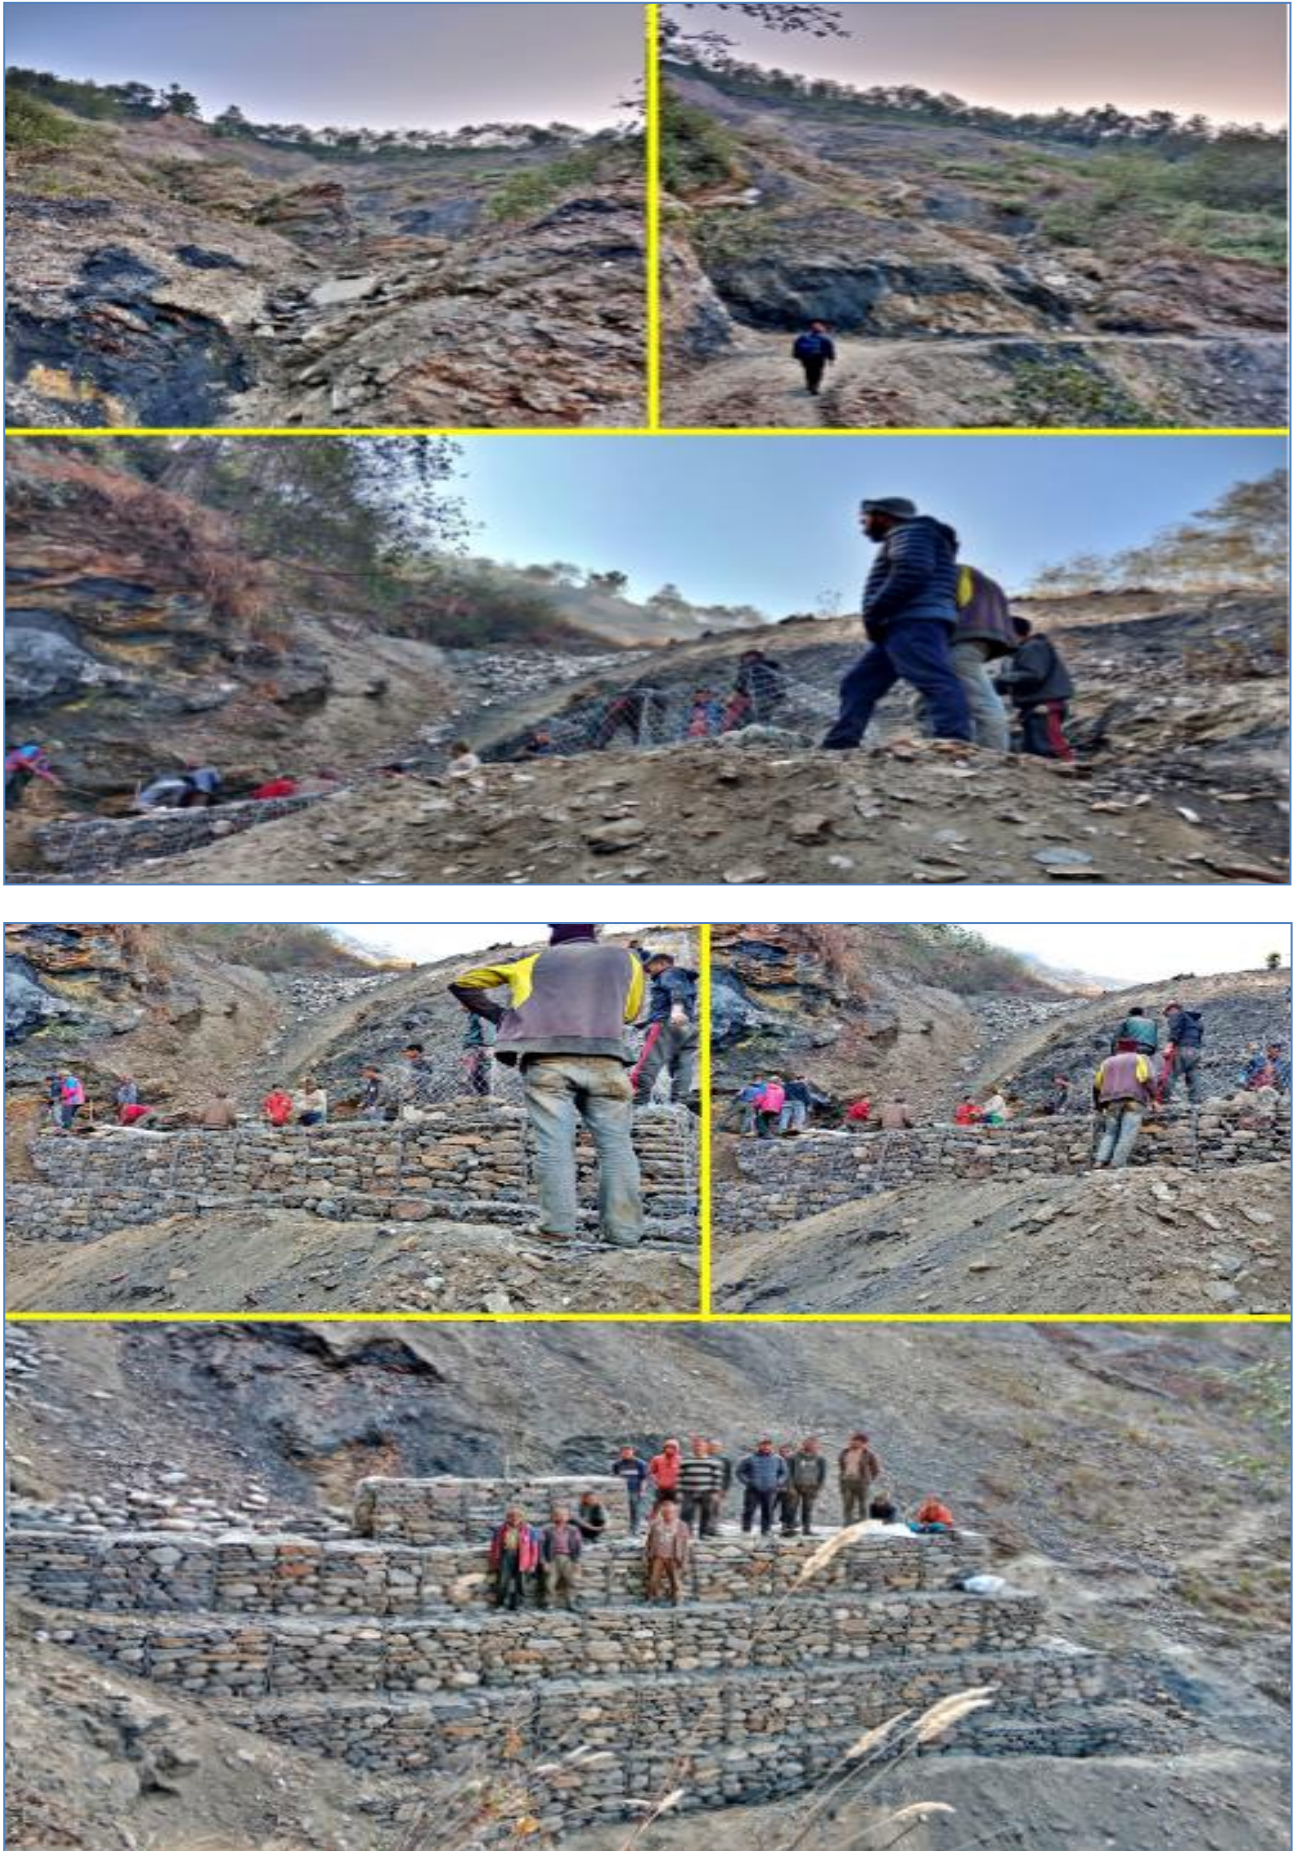
Figure 60: Dhamche Landslide Treatment

1	Program: Gully, Landslide and Torrent Control				
2	Location: District/Rural Municipality: Pyuthan/Naubahini	Ward No: 3	Place: Dhamche	F/Y: 079/80	
	Coordinate:	Latitude: 28.248594		Longitude: 82.942084	
3	Existing Site Problem: The landslide possess a risk of damage to the nearby settlement, rural road and agricultural land				
4	Cost:				
a	Estimated	Total: 558325.00	Office: 499982.00	Users: 58343.00	Others:
b	Actual Expenditure	Total: 558325.00	Office: 499982.00	Users: 58343.00	Others:
5	Objectives:	a) to reduce soil erosion and mass movement from landslide b) to reduce devastating effects on the downstream and surrounding area			
6	Technique Applied:	a) Structural: Gabion Retaining Wall Construction (Gabion Box 45 Nos; Box size 2m*1m*1m=27 Nos.; Box size 1.5m*1m*1m=18 Nos. ; were used to construct 10m long/5m high GabionRetaining Wall)			
7	Implementation Process:	Co-ordination with Local Representatives, User Groups and other concerned authorities; Field Visits; Survey, Design & Cost Estimation; Provide funds for the purchase of Gabion Boxes, Skilled Labour cost, Hoarding Board from Program cost; Unskilled Labour cost was contributed jointly through program cost and people participation; Monitoring & Evaluation

8	Employment:	325 md			
9	Gender/Social Consideration:	Both men and women were equally involved; More emphasis was given to the genuine participation of disadvantaged groups			
10	Effect/Impact:	To some extent, erosion and mass movement has been reduced; Reduce the risk of damage to the settlement and rural road; Approximately 0.1 ha of agricultural land has been conserved			
11	Benefitted HH:	Total: 45	Dalit:	Janajati: 15	Others: 30
12	Problem/Obstacles Faced:	No			
13	Maintenance/Sustainability:	5% amount of total payable amount has been deducted for the maintenance work, if some damage occurs.			
14	Lesson Learned:	If real needs of the community are to be addressed, villagers readily participate throughout the activity implementation process, thus greater achievements are possible even with small external support. The physical structures constructed should be accompanied by bio-engineering techniques to sustain the structures.

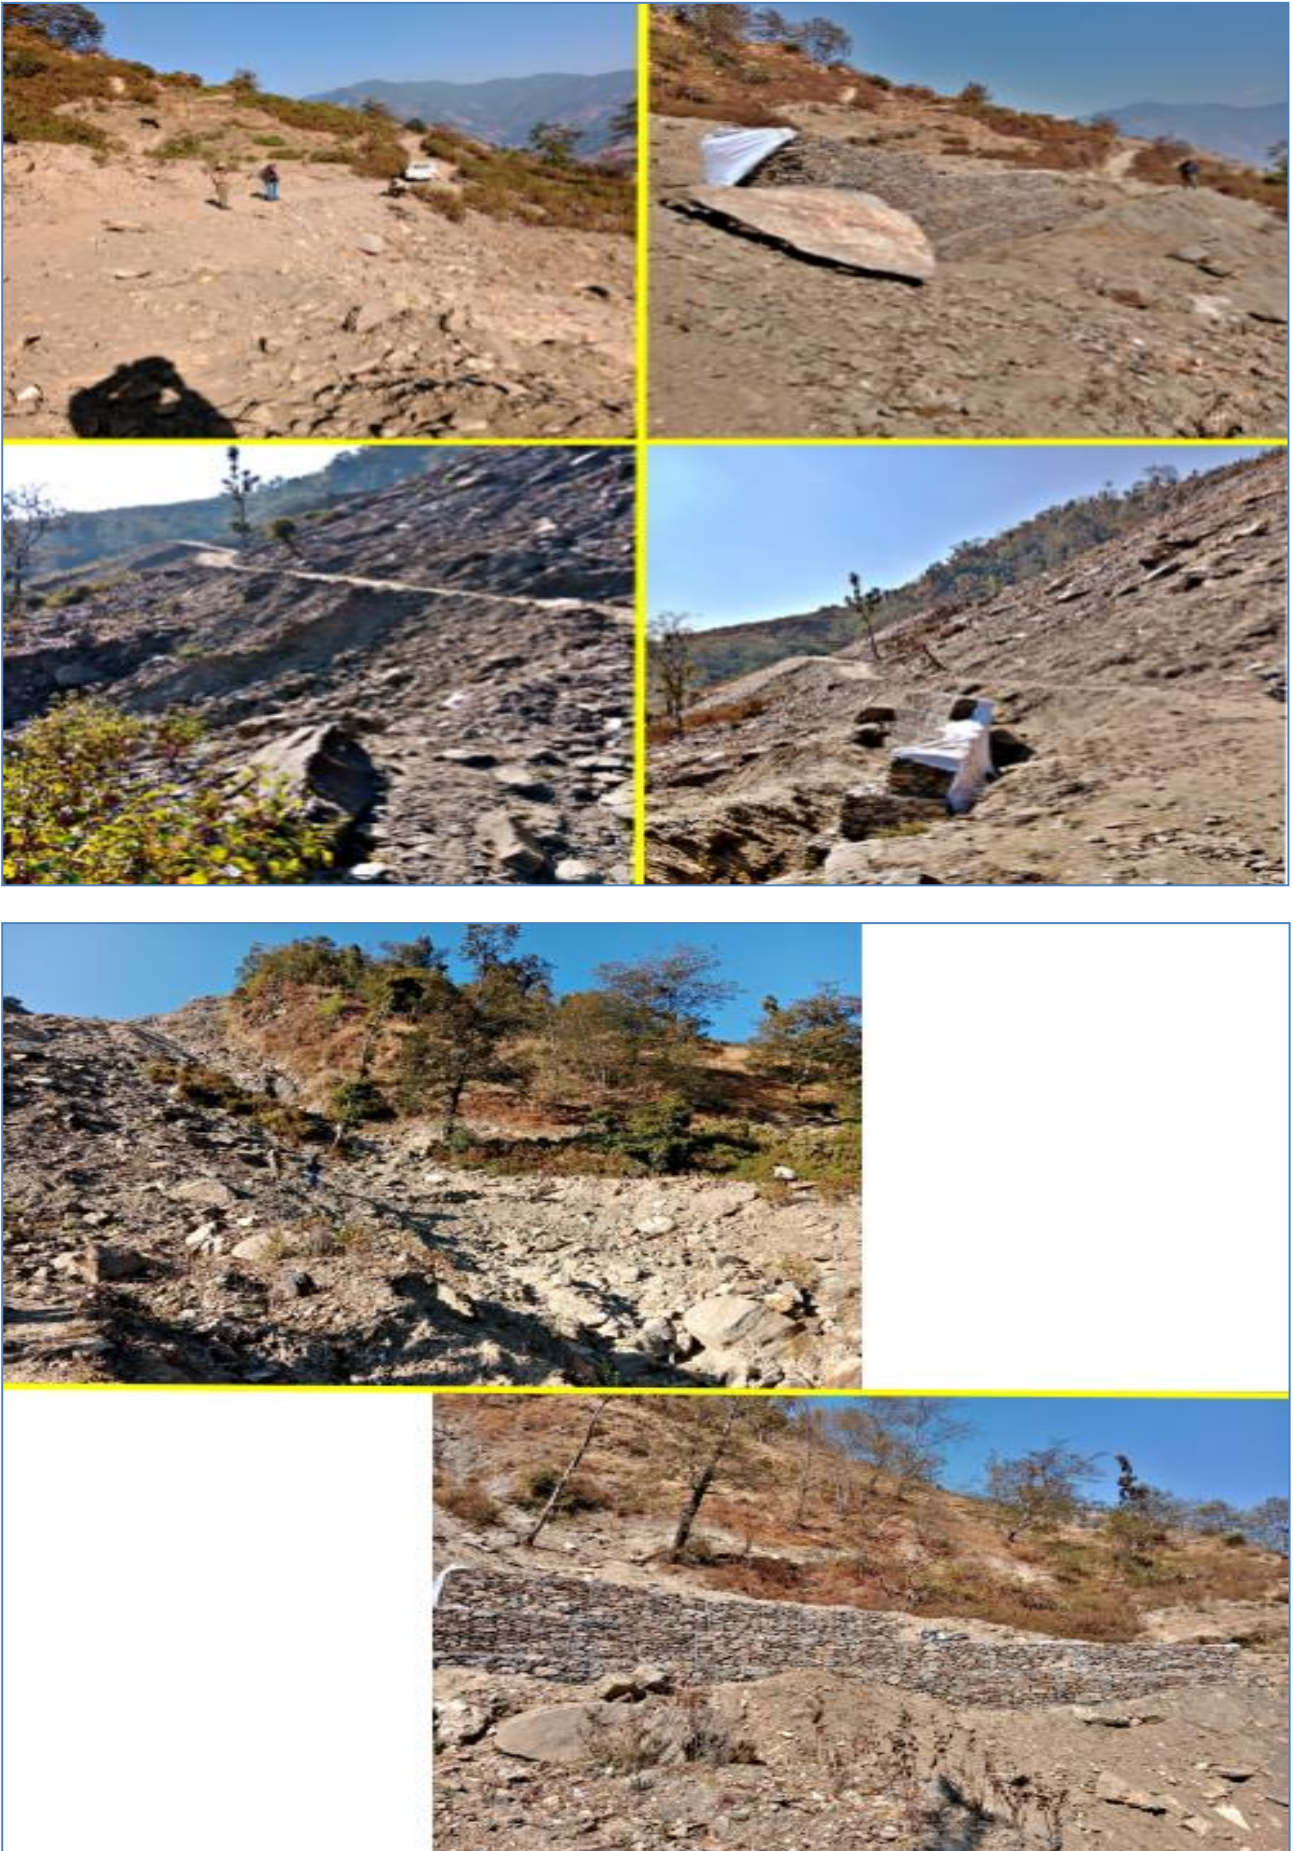
Figure 61: Jugekhola Landslide Treatment

1	Program: Gully, Landslide and Torrent Control				
2	Location: District/Rural Municipality: Pyuthan/Naubahini	Ward No: 2	Place: Jugekhola, Ligha	F/Y: 079/80	
	Coordinate:	Latitude: 28.244847	Longitude: 82.906579		
3	Existing Site Problem: The landslide possess a risk of damage to the nearby settlement, rural road and agricultural land				
4	Cost:				
a	Estimated	Total: 565191.86	Office: 499962.43	Users: 65229.43	Others:
b	Actual Expenditure	Total: 565191.86	Office: 499962.43	Users: 65229.43	Others:
5	Objectives:	a) to reduce soil erosion and mass movement from landslide b) to reduce devastating effects on the downstream and surrounding area			
6	Technique Applied:	a) Structural: Gabion Retaining Wall Construction (Gabion Box 46 Nos; Box size 2m*1m*1m=30 Nos.; Box size 1.5m*1m*1m=16 Nos. were used to construct 16m long/3m high GabionRetaining Wall)			
7	Implementation Process:	Co-ordination with Local Representatives, User Groups and other concerned authorities; Field Visits; Survey, Design & Cost Estimation; Provide funds for the purchase of Gabion Boxes, Skilled Labour cost, Hoarding Board from Program cost; Unskilled Labour cost was contributed jointly through program cost and people participation; Monitoring & Evaluation

8	Employment:	325md			
9	Gender/Social Consideration:	Both men and women were equally involved; More emphasis was given to the genuine participation of disadvantaged groups			
10	Effect/Impact:	To some extent, erosion and mass movement has been reduced; Reduce the risk of damage to the settlement and rural road; Approximately 0.2 ha of agricultural land has been conserved			
11	Benefitted HH:	Total: 30	Dalit: 7	Janajati: 15	Others: 8
12	Problem/Obstacles Faced:	No			
13	Maintenance/Sustainability:	5% amount of total payable amount has been deducted for the maintenance work, if some damage occurs.			
14	Lesson Learned:	If real needs of the community are to be addressed, villagers readily participate throughout the activity implementation process, thus greater achievements are possible even with small external support. The physical structures constructed should be accompanied by bio-engineering techniques to sustain the structures.

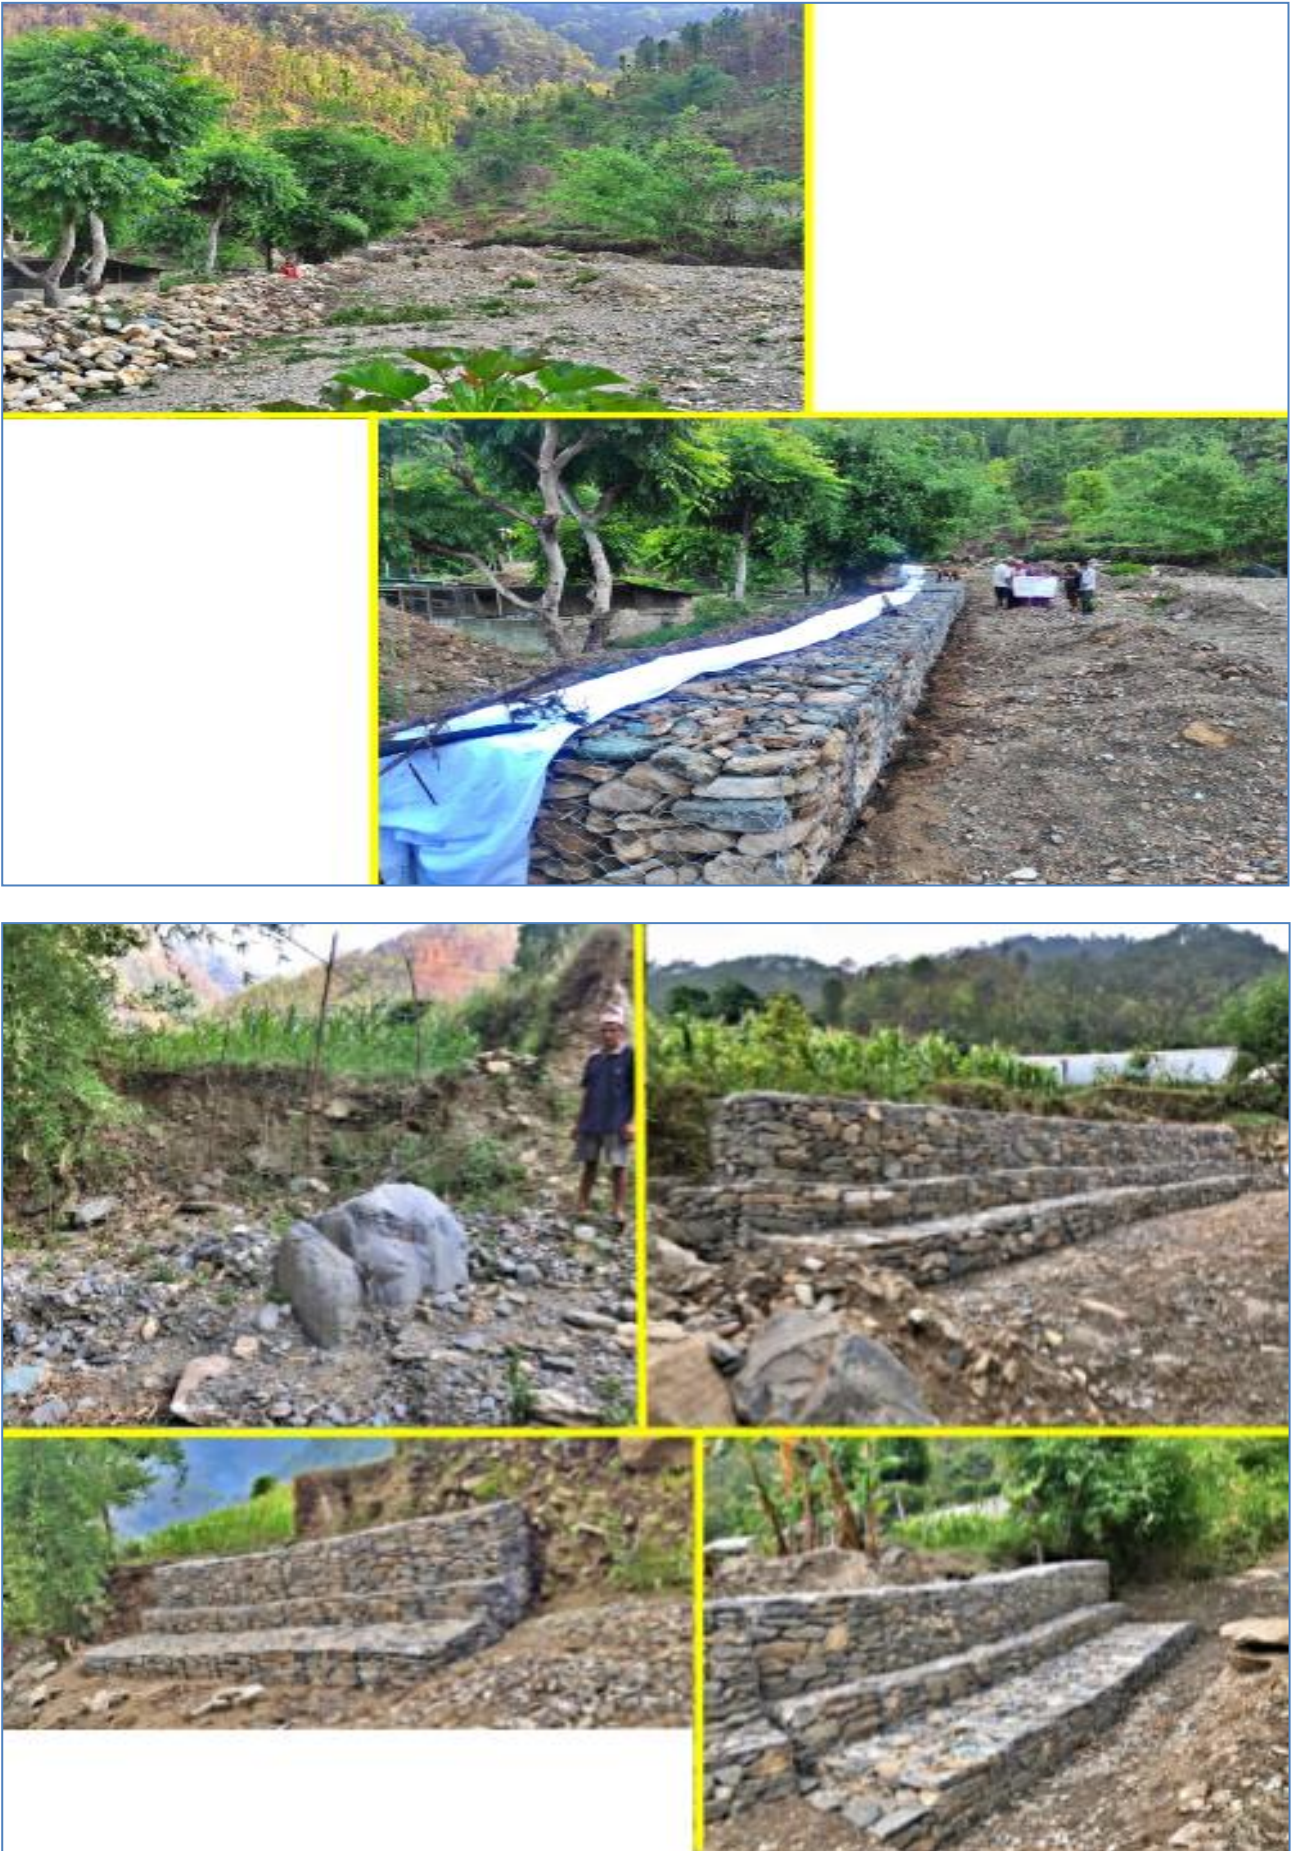
Figure 63: Chhatipata Landslide Treatment

1	Program: Emergency Landslide Protection				
2	Location: District/Rural Municipality: Pyuthan/Jhimruk	Ward No: 7	Place: Chhatipata	F/Y: 079/80	
	Coordinate:	Latitude: 28.147995		Longitude: 82.946420	
3	Existing Site Problem: The landslide possess a risk of damage to the settlement and agricultural land				
4	Cost:				
a	Estimated	Total: 1130580.13	Office: 999993.35	Users: 130586.78	Others:
b	Actual Expenditure	Total: 1125866.91	Office: 996113.73	Users: 129753.18	Others:
5	Objectives:	a) to reduce soil erosion and mass movement from landslide b) to reduce devastating effects on the downstream and surrounding area			
6	Technique Applied:	a) Structural: Gabion Retaining Wall Construction (Gabion Box 115 Nos; Box size 2m*1m*1m=8 Nos.; Box size 1.5m*1m*1m=80 Nos.; Box size 1.5m*1m*0.50m=27 Nos. were used to construct 27m long/2m high & 35m long Gabion Retaining Wall)			
7	Implementation Process:	Co-ordination with Local Representatives, User Groups and other concerned authorities; Field Visits; Survey, Design & Cost Estimation; Provide funds for the purchase of Gabion Boxes, Skilled Labour cost, Hoarding Board from Program cost; Unskilled labour cost was contributed jointly through program cost and people participation; Monitoring & Evaluation

8	Employment:	648 md			
9	Gender/Social Consideration:	Both men and women were equally involved; More emphasis was given to the genuine participation of disadvantaged groups			
10	Effect/Impact:	To some extent, erosion and mass movement has been reduced; Reduce the risk of damage to the settlement and rural road; Approximately 0.15 ha of agricultural land has been conserved			
11	Benefitted HH:	Total: 40	Dalit: 10	Janajati:	Others: 30
12	Problem/Obstacles Faced:	No			
13	Maintenance/Sustainability:	5% amount of total payable amount has been deducted for the maintenance work, if some damage occurs.			
14	Lesson Learned:	If real needs of the community are to be addressed, villagers readily participate throughout the activity implementation process, thus greater achievements are possible even with small external support. The physical structures constructed should be accompanied by bio-engineering techniques to sustain the structures.
