ACTIVITY PROFILE

079/80

SOIL AND WATERSHED
MANAGEMENT OFFICE,
ROLPA

LUMBINI STATE GOVERNMENT
MINISTRY OF FORESTS AND ENVIRONMENT
SOIL AND WATERSHED MANAGEMENT OFFICE
MULPANI, ROLPA

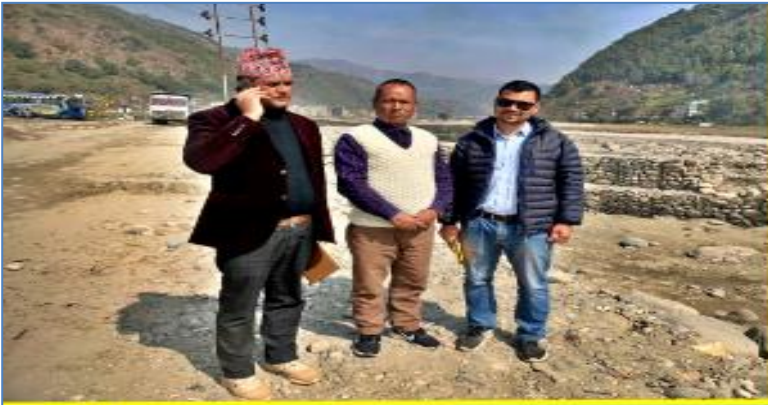
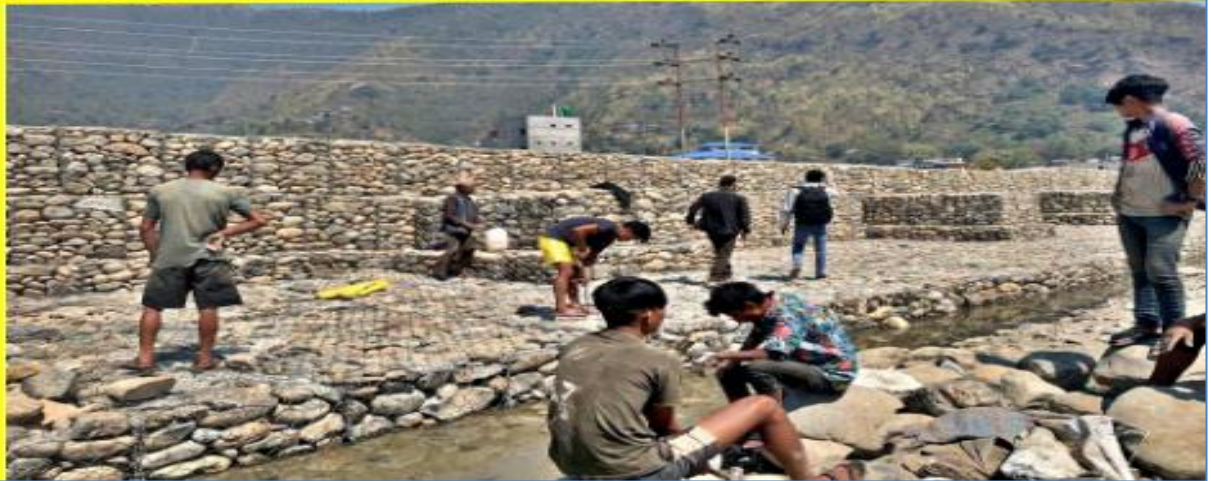
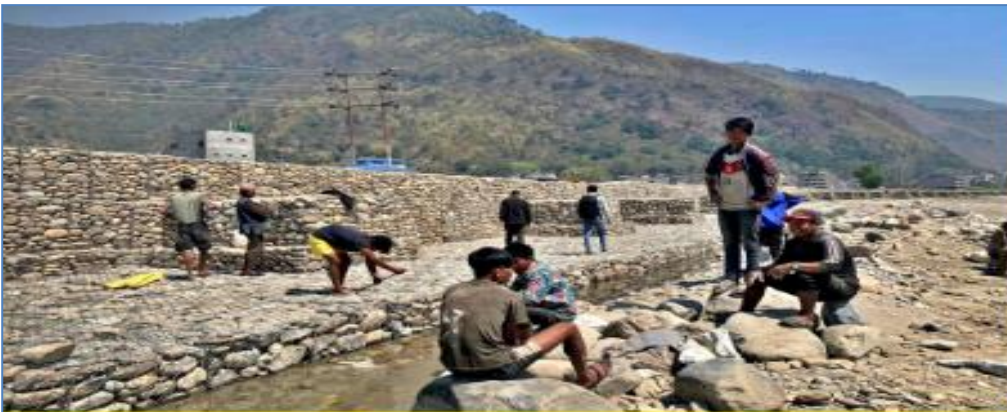
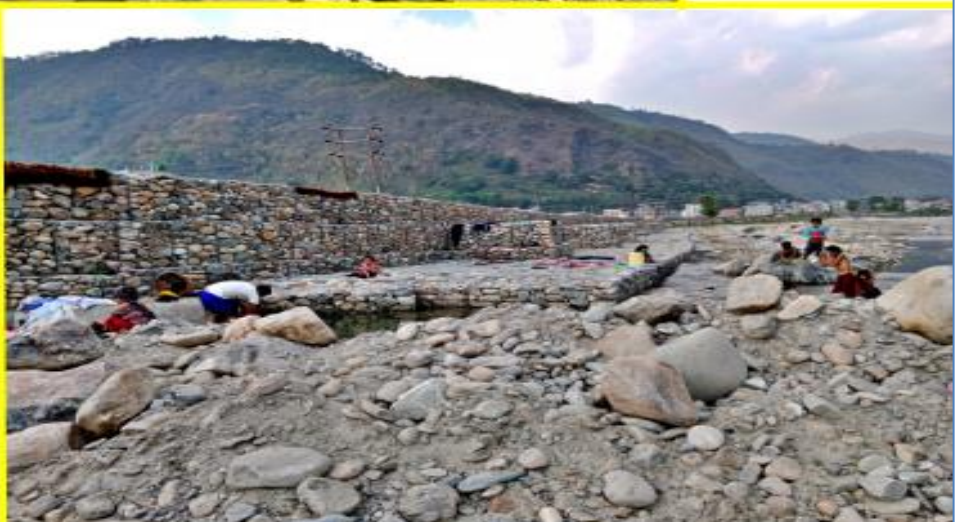
Figure 65: Jhimrukh River Bank Protection

1	Program: River/Stream Bank Protection				
2	Location: District/Municipality: Pyuthan/Pyuthan	Ward No: 3	Place: Jhimrukh Khola, Tikuri	F/Y: 079/80	
	Co-ordinates:	Latitude: 28.115232		Longitude: 82.876447	
3	Existing Site Problem: The Jhimrukh Khola possess a risk of damage to the settlement, rural road & agricultural land				
4	Cost:				
a	Estimated	Total: 1327611.63	Office: 1199976.24	Users: 127635.39	Others:
b	Actual Expenditure	Total: 1323533.12	Office: 1196262.00	Users: 127271.12	Others:
5	Objectives:	a) to prevent erosion & river bank cutting b) to reduce the devastating effects on the downstream & surrounding area			
	Technique Applied:	a) Structural: Gabion Embankment/Stud Construction (Gabion Box 111 Nos; Box size 2m*1m*1m=39 Nos.; Box size 1.5m*1m*1m=26 Nos.; Box size 3m*1m*1m=46 Nos.; 3m*1m*0.50m=10 Nos.were used to construct 26m long/3m high Gabion Embankment with stud)			
7	Implementation Process:	Co-ordination with Local Representatives, User Groups and other concerned authorities; Field Visits; Survey, Design & Cost Estimation; Provide funds for the purchase of Gabion Boxes, Skilled Labour, Hoarding Board from Program cost; Unskilled Labour cost was contributed jointly through program cost and people participation; Monitoring & Evaluation

8	Employment:	777 md			
9	Gender/Social Consideration:	Both men and women were equally involved; More emphasis was given to the genuine participation of disadvantaged groups			
10	Effect/Impact:	To some extent, river bank cutting and erosion has been controlled; Reduce the risk of damage to the settlement & rural road; Approximately 2 ha of agricultural land has been conserved			
11	Benefitted HH:	Total: 100	Dalit: 20	Janajati: 35	Others: 45
12	Problem/Obstacles Faced:	No			
13	Maintenance/Sustainability:	5% amount of total payable amount has been deducted for the maintenance work, if some damage occurs.			
14	Lesson Learned:	If real needs of the community are to be addressed, villagers readily participate throughout the activity implementation process, thus greater achievements are possible even with small external support. The physical structures constructed should be accompanied by bio-engineering techniques to sustain the structures.

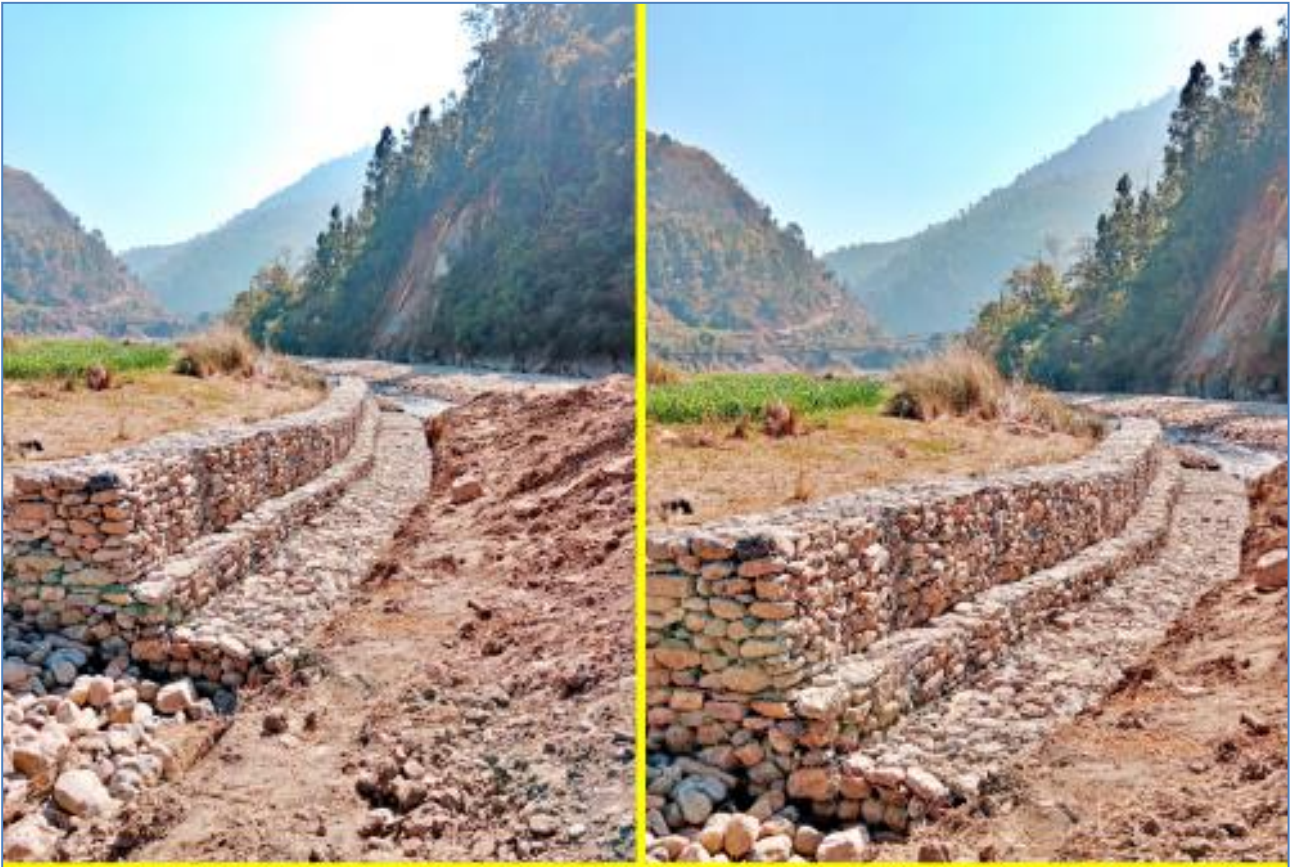
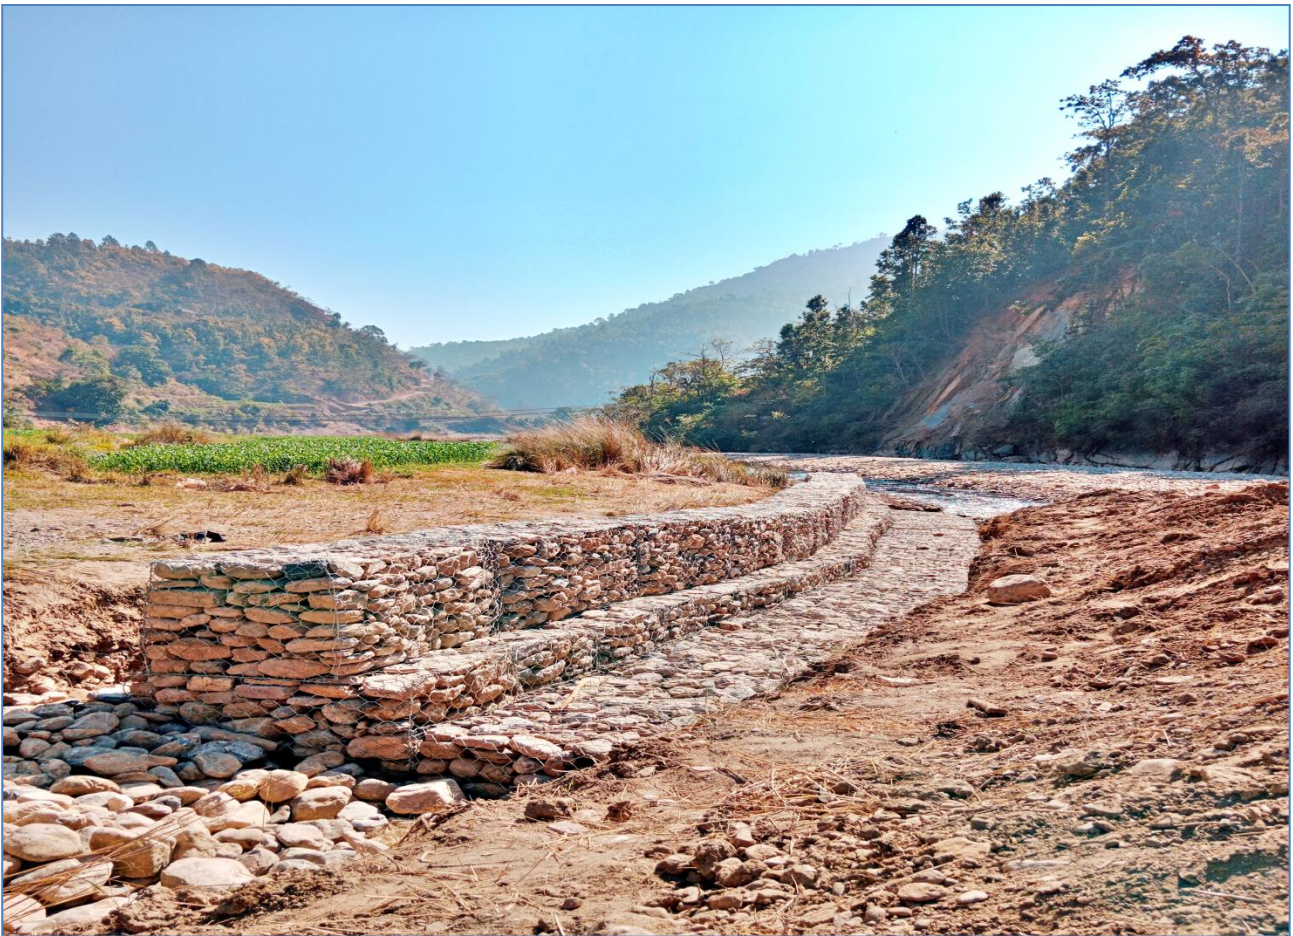
Figure 66: Todyar Arang Khola River Bank Protection

1	Program: River/Stream Bank Protection				
2	Location: District/Municipality: Pyuthan/Sworgadari	Ward No: 1	Place: Arang Khola, Todyar	F/Y: 079/80	
	Co-ordinates:	Latitude: 28.054062		Longitude: 82.678659	
3	Existing Site Problem: The Arang Khola possess a risk of damage to the settlement, suspension bridge & agricultural land				
4	Cost:				
a	Estimated	Total: 553756.93	Office: 499978.24	Users: 53778.69	Others:
b	Actual Expenditure	Total: 553756.93	Office: 499978.24	Users: 53778.69	Others:
5	Objectives:	a) to prevent erosion & river bank cutting b) to reduce the devastating effects on the downstream & surrounding area			
	Technique Applied:	a) Structural: Gabion Embankment Construction (Gabion Box 60 Nos; Box size 2m*1m*1m=12 Nos.; Box size 1.5m*1m*1m=24 Nos.; Box size 1.5m*1m*0.50m=24 Nos. were used to construct 24m long/2m high Gabion Embankment)			
7	Implementation Process:	Co-ordination with Local Representatives, User Groups and other concerned authorities; Field Visits; Survey, Design & Cost Estimation; Provide funds for the purchase of Gabion Boxes, Skilled Labour, Hoarding Board from Program cost; Unskilled Labour cost was contributed jointly through program cost and people participation; Monitoring & Evaluation

8	Employment:	325 md			
9	Gender/Social Consideration:	Both men and women were equally involved; More emphasis was given to the genuine participation of disadvantaged groups			
10	Effect/Impact:	To some extent, river bank cutting and erosion has been controlled; Reduce the risk of damage to the settlement & suspension bridge; Approximately 0.4 ha of agricultural land has been conserved			
11	Benefitted HH:	Total: 8	Dalit:	Janajati:	Others: 8
12	Problem/Obstacles Faced:	No			
13	Maintenance/Sustainability:	5% amount of total payable amount has been deducted for the maintenance work, if some damage occurs.			
14	Lesson Learned:	If real needs of the community are to be addressed, villagers readily participate throughout the activity implementation process, thus greater achievements are possible even with small external support. The physical structures constructed should be accompanied by bio-engineering techniques to sustain the structures.

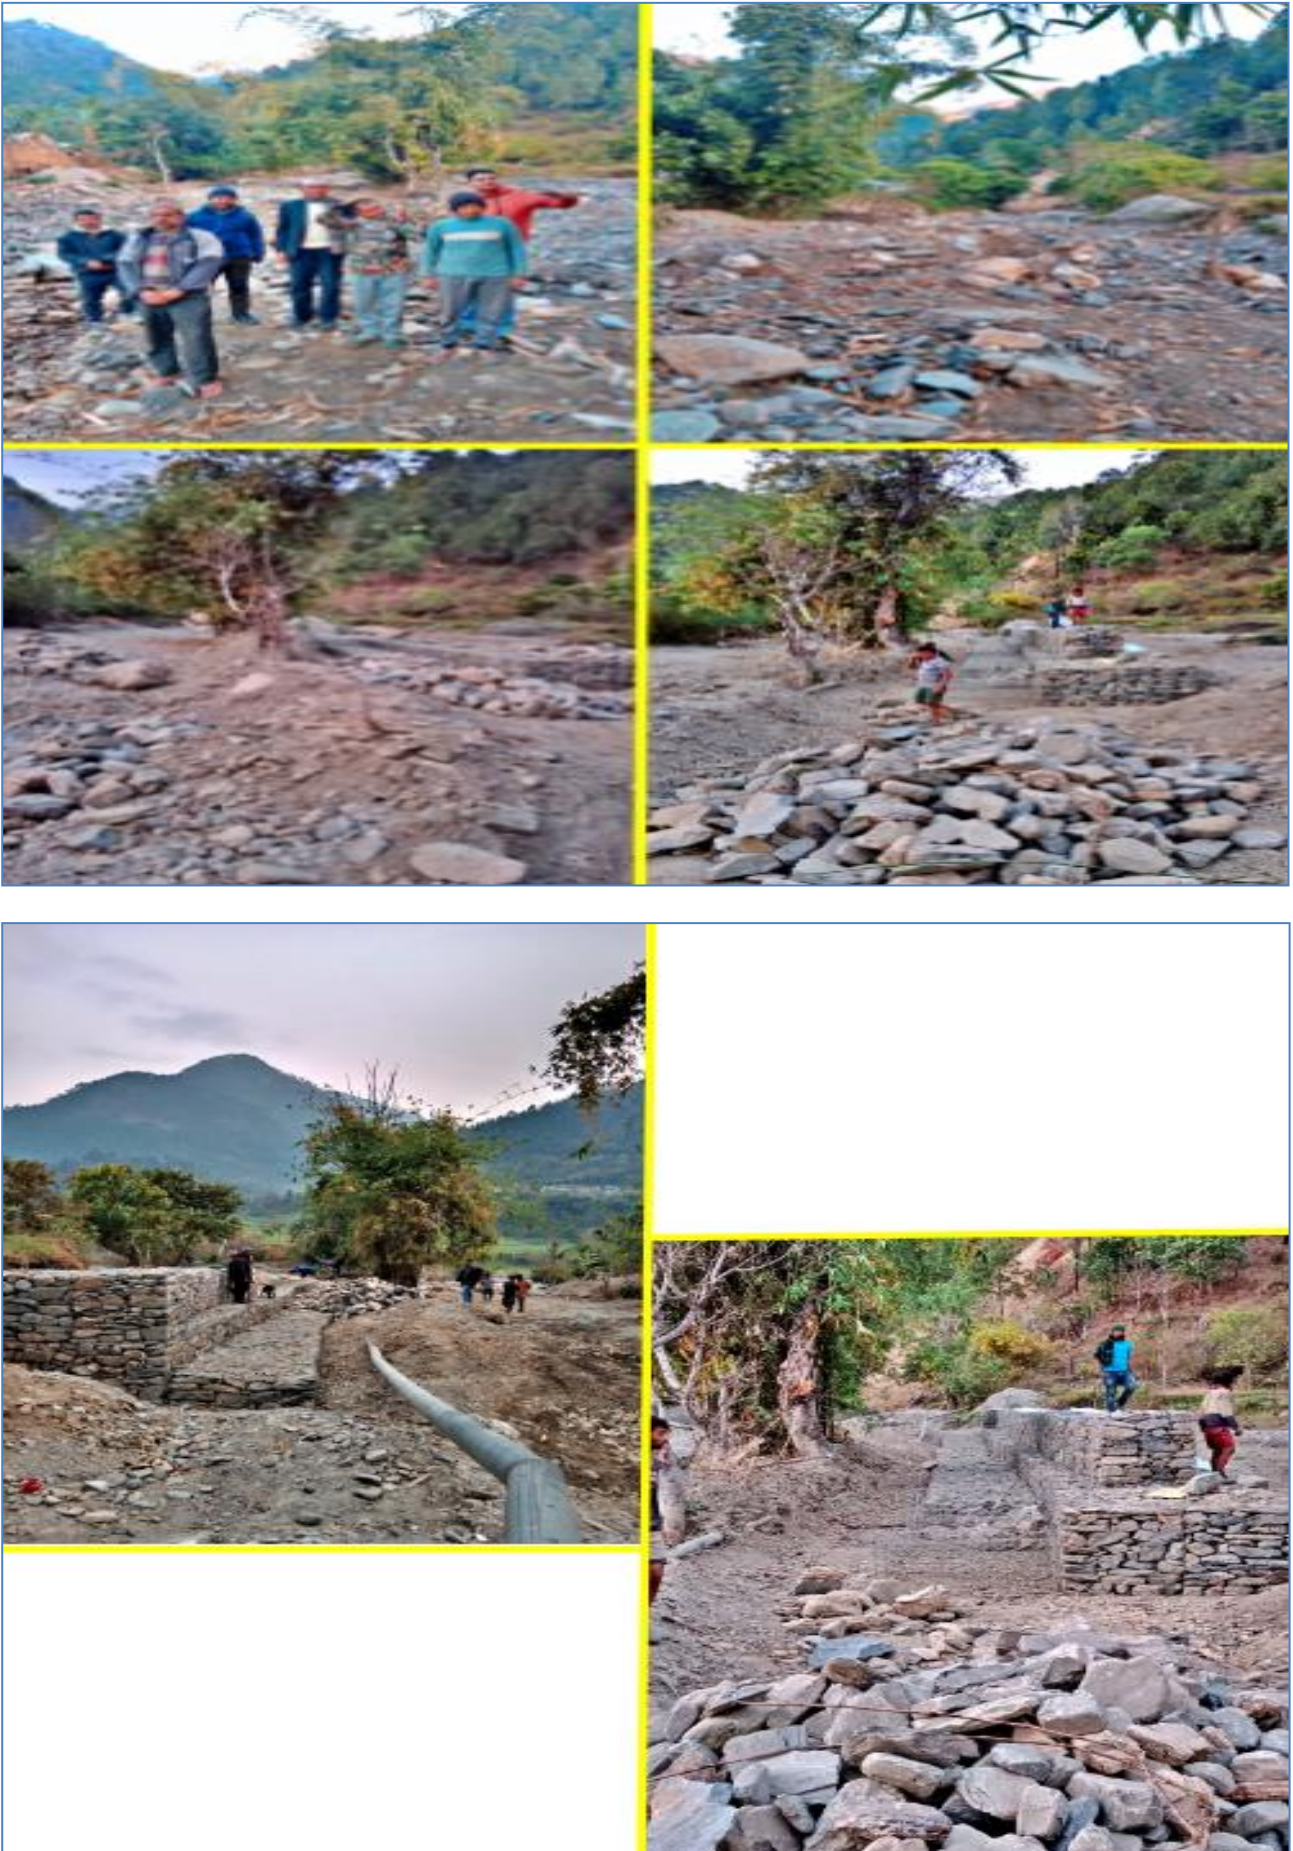
Figure 67: Chhatipata Lankuri Khola Stream Bank Protection

1	Program: River/Stream Bank Protection				
2	Location: District/Rura Municipality: Pyuthan/Jhimruk	Ward No: 7	Place: Chhatipata	F/Y: 079/80	
	Co-ordinates:	Latitude: 28.148436		Longitude: 82.946588	
3	Existing Site Problem: The Lankuri Khola possess a risk of damage to the settlement & agricultural land				
4	Cost:				
a	Estimated	Total: 1114575.23	Office: 999910.50	Users: 114664.74	Others:
b	Actual Expenditure	Total: 1114575.23	Office: 999910.50	Users: 114664.74	Others:
5	Objectives:	a) to prevent erosion & stream bank cutting b) to reduce the devastating effects on the downstream & surrounding area			
	Technique Applied:	a) Structural: Gabion Embankment Construction (Gabion Box 114 Nos; Box size 2m*1m*1m=24 Nos.; Box size 1.5m*1m*1m=45 Nos.; Box size 15m*1m*0.50m=45 Nos. were used to construct 45m long/2m high Gabion Embankment)			
7	Implementation Process:	Co-ordination with Local Representatives, User Groups and other concerned authorities; Field Visits; Survey, Design & Cost Estimation; Provide funds for the purchase of Gabion Boxes, Skilled Labour, Hoarding Board from Program cost; Unskilled Labour cost was contributed jointly through program cost and people participation; Monitoring & Evaluation

8	Employment:	650 md			
9	Gender/Social Consideration:	Both men and women were equally involved; More emphasis was given to the genuine participation of disadvantaged groups			
10	Effect/Impact:	To some extent, river bank cutting and erosion has been controlled; Reduce the risk of damage to the settlement; Approximately 0.8 ha of agricultural land has been conserved			
11	Benefitted HH:	Total: 30	Dalit:	Janajati:	Others: 30
12	Problem/Obstacles Faced:	No			
13	Maintenance/Sustainability:	5% amount of total payable amount has been deducted for the maintenance work, if some damage occurs.			
14	Lesson Learned:	If real needs of the community are to be addressed, villagers readily participate throughout the activity implementation process, thus greater achievements are possible even with small external support. The physical structures constructed should be accompanied by bio-engineering techniques to sustain the structures.

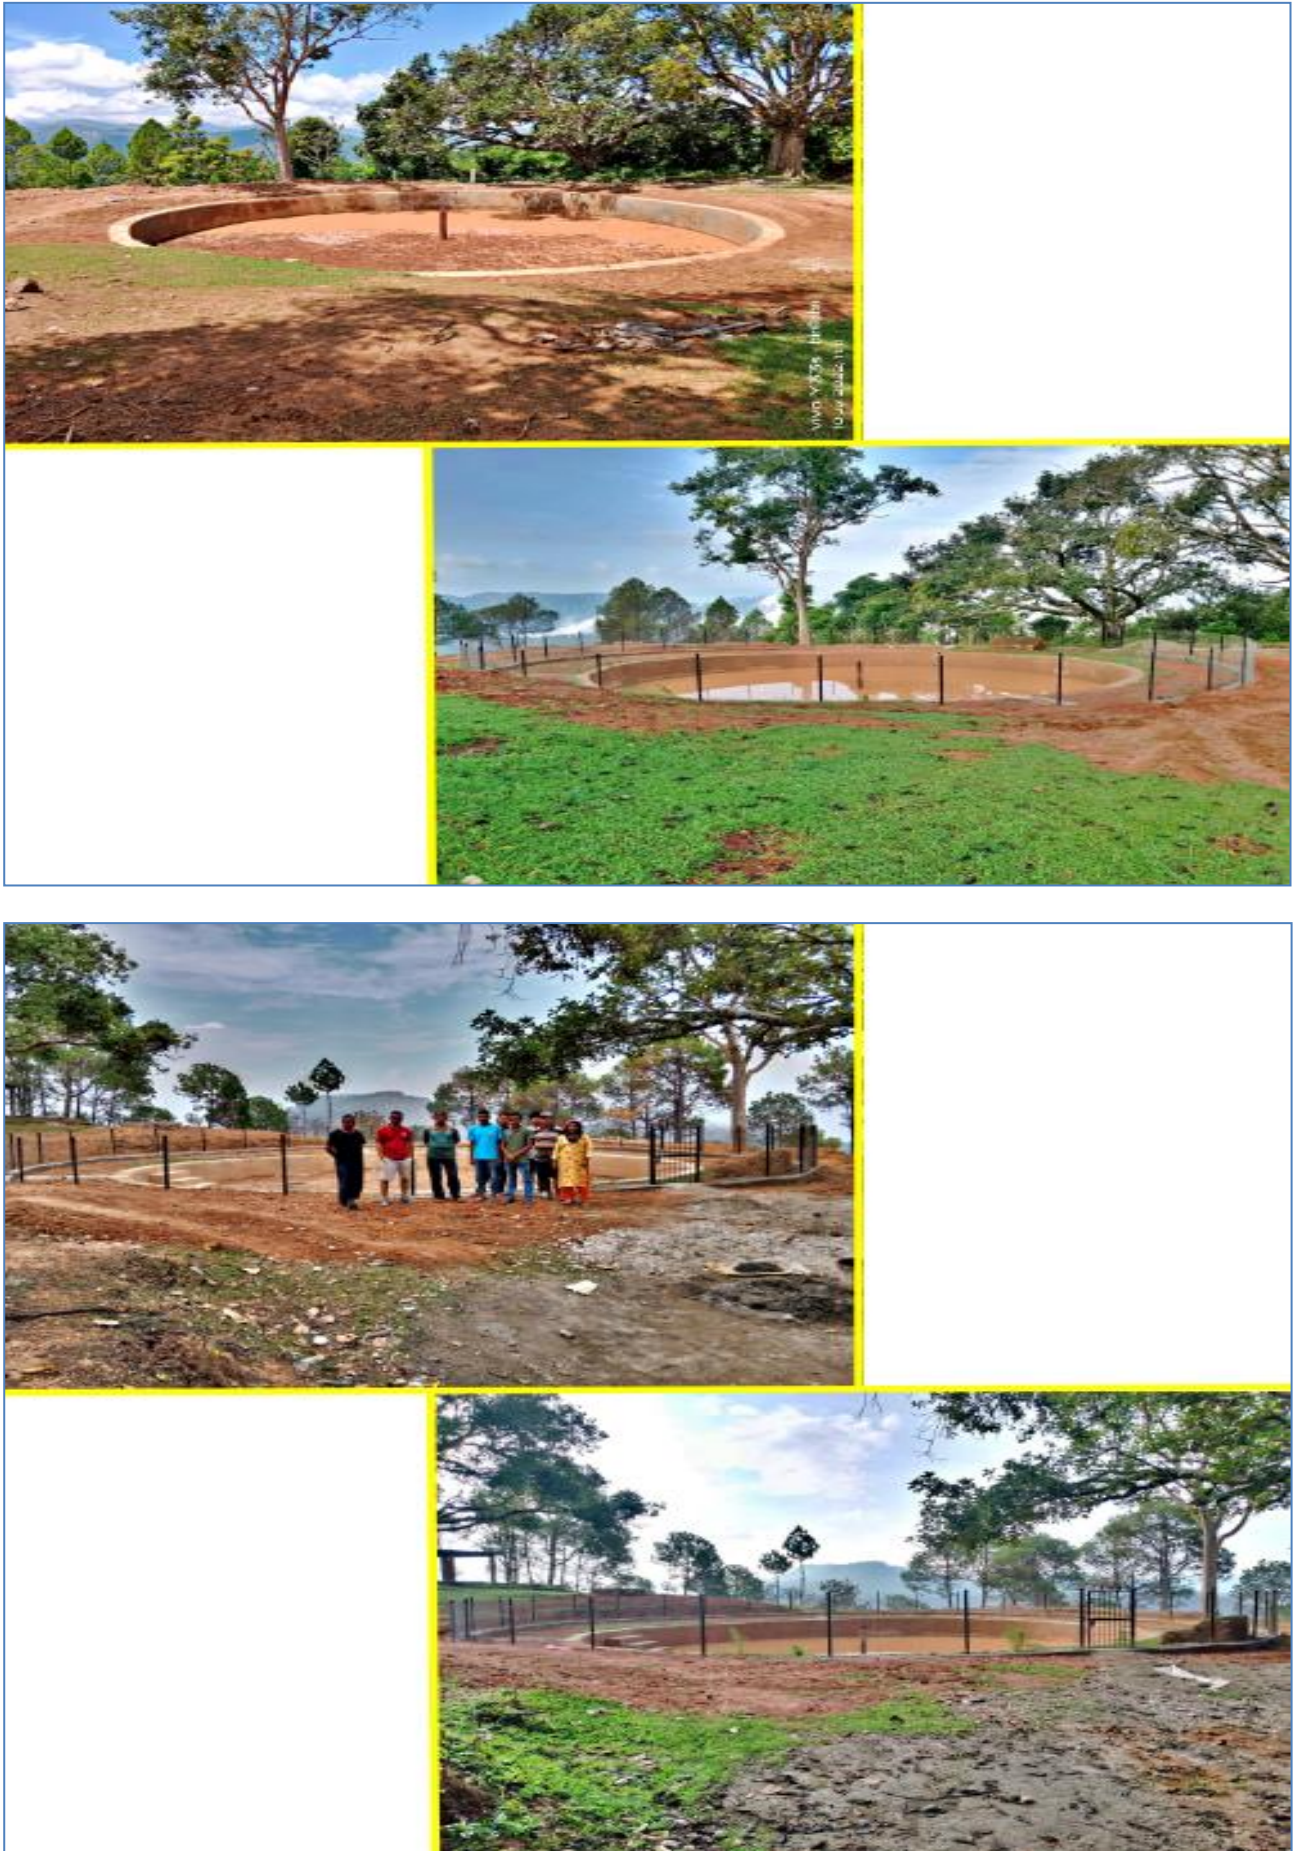
Figure 68: Khairakot Pond Maintenance & Fencing

1	Program: Water Source Protection/Conservation Pond				
2	Location: District/Municipality: Pyuthan/Pyuthan	Ward No: 1	Place: Khairakot	F/Y: 079/80	
	Coordinate:	Latitude: 28.077751		Longitude: 82.856174	
3	Existing Site Problem: The Pond constructed by the office in previous year possess a risk for children				
4	Cost:				
a	Estimated	Total: 335538.88	Office: 299882.65	Users: 35656.23	Others:
b	Actual Expenditure	Total: 337561.71	Office: 298844.06	Users: 38717.65	Others:
5	Objectives:	a) to harvest the runoff and source water b) to use the harvested runoff and source water for irrigation, livestock and other domestic purposes c) to reduce the risk of drowning for the children			
6	Technique Applied:	a) Structural: Masonary Wall Construction (L= 60m, B= 0.4.40m, H= 0.27m; Water Holding Capacity=226 m3); Chainink Fence Cnstruction (60m long/1m high)			
7	Implementation Process:	Co-ordination with Local Representatives, User Groups and other concerned authorities; Field Visits; Survey, Design & Cost Estimation; Provide funds for the purchase of Construction Materials, Skilled Labour, Hoarding Board Placing from Program cost; Unskilled Labour cost was contributed jointly through program cost and people participation; Monitoring & Evaluation

8	Employment:	194 md			
9	Gender/Social Consideration:	Both men and women were equally involved; More emphasis was given to the genuine participation of disadvantaged groups			
10	Effect/Impact:	Properly harvest the runoff and source water; Reduce the risk f drowning for children			
11	Benefitted HH:	Total: 50	Dalit: 10	Janajati: 12	Others: 28
12	Problem/Obstacles Faced:	No			
13	Maintenance/Sustainability:	5% amount of total payable amount has been deducted for the maintenance work, if some damage occurs.			
14	Lesson Learned:	If real needs of the community are to be addressed, villagers readily participate throughout the activity implementation process, thus greater achievements are possible even with small external support. The physical structures constructed should be accompanied by plantation of different tree species which supports for income generation.			
15	Others; Name of:	User Group: Kharkachaur Pokhari Marmat Tatha Nirman Samiti

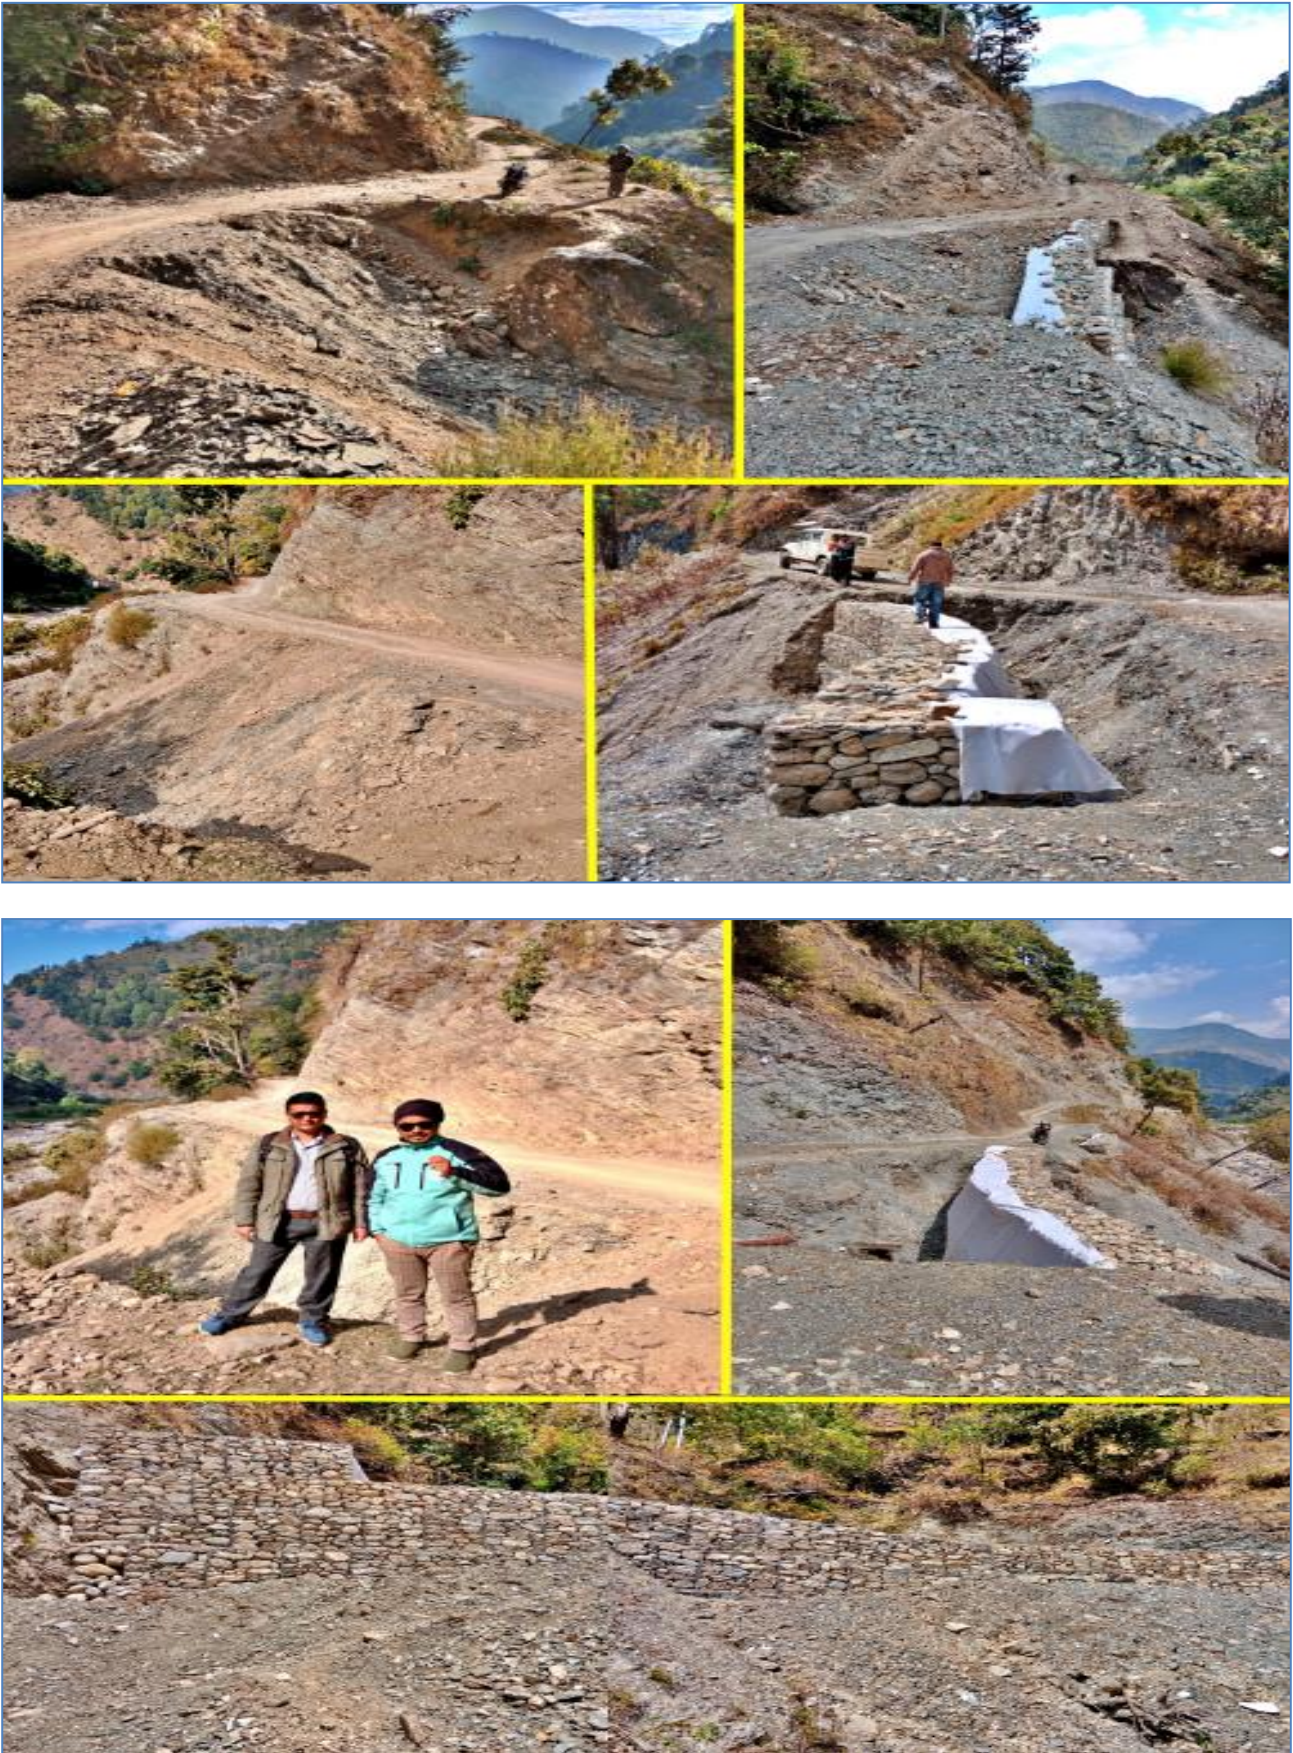
Figure 69: Balle Mairamare Rural Road Protection

1	Program: Soil Conservation Work Along Rural Road				
2	Location: District/Rural Municipality: Pyuthan/Naubahini	Ward No: 7	Place: Balle Mairamare	F/Y: 079/80	
	Coordinate:	Latitude: 28.1983175, 28.1993768		Longitude: 82.8711092, 82.8673581	
3	Existing Site Problem: The landslide & river bank cutting possess a risk of damage to the different sections of Balle Mairamare rural road				
4	Cost:				
a	Estimated	Total: 1118921.47	Office: 999996.47	Users: 118925.00	Others:
b	Actual Expenditure	Total: 1118921.47	Office: 999996.47	Users: 118925.00	Others:
5	Objectives:	a) to reduce erosion, landslide and stabilize the road slope b) to reduce devastating effects on the downstream and surrounding area			
6	Technique Applied:	a) Structural: Gabion Retaining Wall Construction (Gabion Box 95 Nos; Box size 2m*1m*1m=53 Nos.; Box size 1.5m*1m*1m=42Nos. were used to construct 28m long/4m high Gabion Retaining Wall)

7	Implementation Process:	Co-ordination with Local Representatives, User Groups and other concerned authorities; Field Visits; Survey, Design & Cost Estimation; Provide funds for the purchase of Gabion Boxes, Skilled Labour, Hoarding Board from Program cost; Unskilled Labour cost was contributed jointly through program cost and people participation; Monitoring & Evaluation			
8	Employment:	650 md			
9	Gender/Social Consideration:	Both men and women were equally involved; More emphasis was given to the genuine participation of disadvantaged groups			
10	Effect/Impact:	To some extent, erosion and river bank cutting has been reduced; Reduce the risk of damage to the rural road and settlement; Approximately 0.05 km of rural road & 0.6 ha of agricultural land has been conserved			
11	Benefitted HH:	Total: 80	Dalit: 20	Janajati: 25	Others: 35
12	Problem/Obstacles Faced:	No			
13	Maintenance/Sustainability:	5% amount of total payable amount has been deducted for the maintenance work, if some damage occurs.

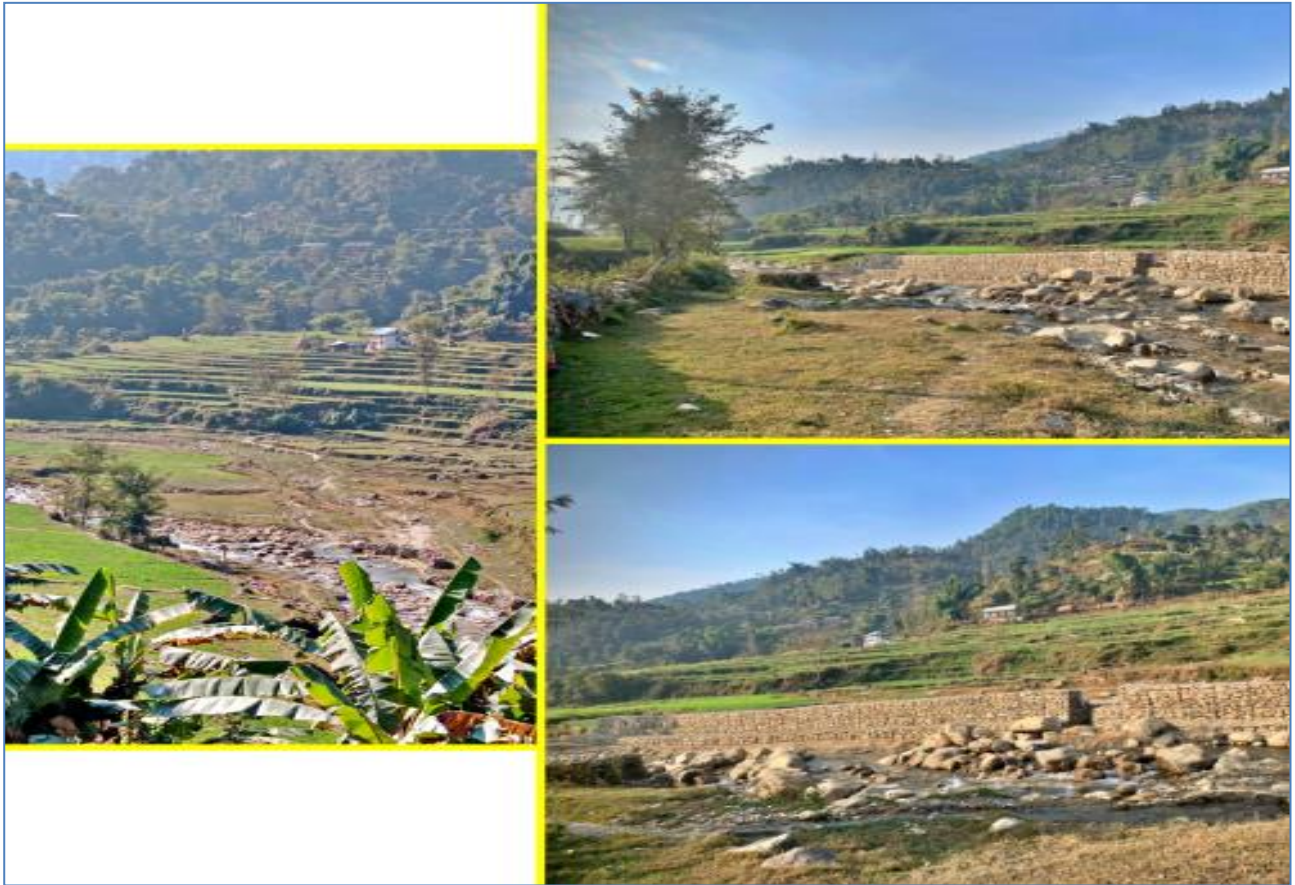
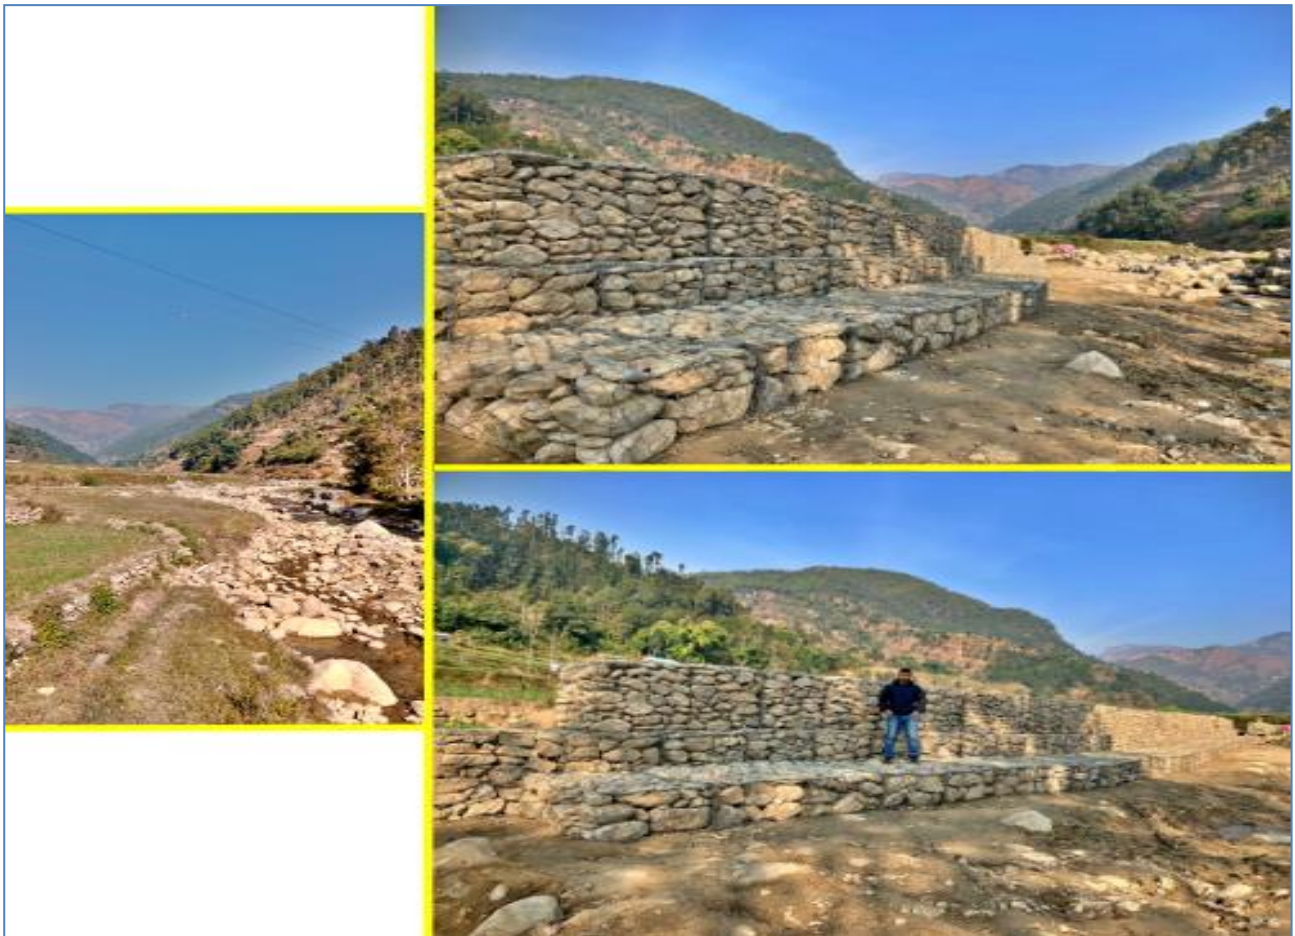
Figure 70: Jumri Khola Sensitive Watershed Area Protection

1	Program: Sensitive Watershed Area Protection				
2	Location: District/Municipality: Pyuthan/Pyuthan	Ward No: 3	Place: Jumri Khola, Jumri	F/Y: 079/80	
	Co-ordinates:	Latitude: 28.125894		Longitude: 82.836752	
3	Existing Site Problem: The Jumri Khola possess a risk of damage to the Irrigation canal & agricultural land				
4	Cost:				
a	Estimated	Total: 1101169.17	Office: 999996.46	Users: 101172.71	Others:
b	Actual Expenditure	Total: 1101169.17	Office: 999996.46	Users: 101172.71	Others:
5	Objectives:	a) to prevent erosion & river bank cutting b) to reduce the devastating effects on the downstream & surrounding area			
	Technique Applied:	a) Structural: Gabion Embankment Construction (Gabion Box 116 Nos; Box size 2m*1m*1m=26 Nos.; Box size 1.5m*1m*1m=45 Nos.; Box size 1.5m*1m*0.50m=45 Nos. were used to construct 45m long/2m high Gabion Embankment)			
7	Implementation Process:	Co-ordination with Local Representatives, User Groups and other concerned authorities; Field Visits; Survey, Design & Cost Estimation; Provide funds for the purchase of Gabion Boxes, Skilled Labour, Hoarding Board from Program cost; Unskilled Labour cost was contributed jointly through program cost and people participation; Monitoring & Evaluation

8	Employment:	650 md			
9	Gender/Social Consideration:	Both men and women were equally involved; More emphasis was given to the genuine participation of disadvantaged groups			
10	Effect/Impact:	To some extent, river bank cutting and erosion has been controlled; Reduce the risk of damage to the irrigation canal; Approximately 1..2 ha of agricultural land has been conserved			
11	Benefitted HH:	Total: 40	Dalit: 7	Janajati: 12	Others: 21
12	Problem/Obstacles Faced:	No			
13	Maintenance/Sustainability:	5% amount of total payable amount has been deducted for the maintenance work, if some damage occurs.			
14	Lesson Learned:	If real needs of the community are to be addressed, villagers readily participate throughout the activity implementation process, thus greater achievements are possible even with small external support. The physical structures constructed should be accompanied by bio-engineering techniques to sustain the structures.
